Tanker Structure Cooperative Forum 2010 Shipbuilders Meeting

*Information Paper on Cargo Tank Corrugated Bulkhead Damages of
Double Hull Tankers*

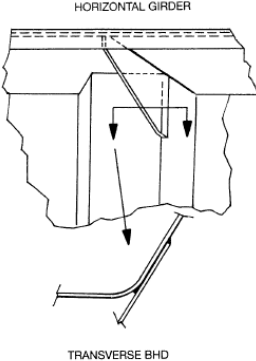
LOCATION:	Transverse bulkhead horizontal stringer	GROUP	No. 10
EXAMPLE No. 6:	Fractured bulkhead in way of stringer bracket connection		
TYPICAL DAMAGE		PROPOSED REPAIR

<p>HORIZONTAL GIRDER</p> <p>CRACK</p> <p>TRANSVERSE BHD</p>

<p>HORIZONTAL GIRDER</p> <p>TRANSVERSE BHD</p>

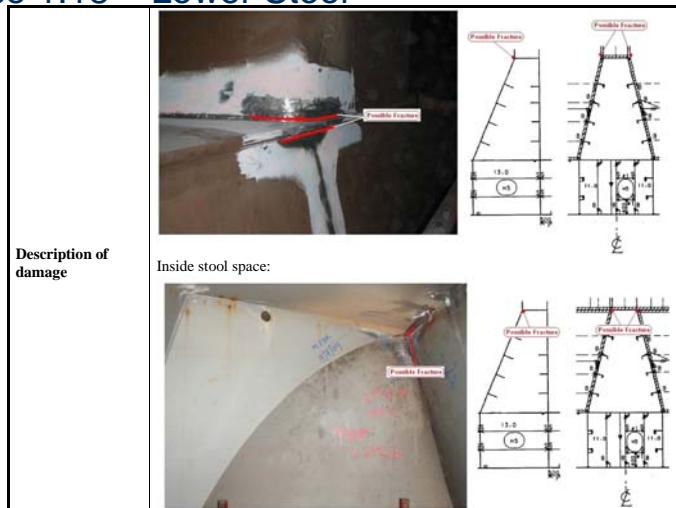
Case 1.18 – Lower Stool

Case 1.18				
Ship-Type	Product Tanker		Capacity [tdw]	46,000 tonnes
Year of build	2005	Vessels age when damage found		4 years
Main dimensions	L	174 m	B	32.2 m
	T	11	D	18.8 m
Bulkhead	Vertically corrugated		Transverse bulkhead	
	Height from tank top to deck		16.65	
Stool	Lower and upper stool			
Material	Grade A

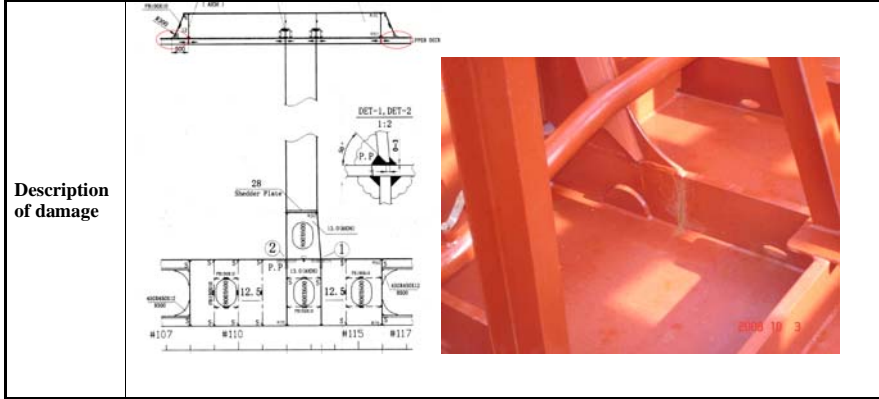
Case 1.6 - Overdeck Girder/Deck longitudinal connections

Case 1.6			
Ship-Type	Chemical tanker	Capacity [tdw]	29,000 tonnes
Year of build	2005	Vessels age when damage found	3 years
Main dimensions	Length	LPP: 167.00 m	Breadth mld. 29.20 m
	Draft mld.	9.50 m	Depth mld. 13.85 m
Bulkhead	Vertically corrugated	Transverse bulkhead	
Stool	No upper stool	Height lower stool	1400 mm
Material	Bulkhead Grade A	Damaged Area AH36	
Overview of damage location	Sketch (part of GAP)
