Outfitting Related Structural Defects

2010 Shipbuilders Meeting

►“Structure Defects on Double Hull Tankers”, Philip G. Rynn, American Bureau of Shipping, TSCF 2007 Shipbuilders Meeting

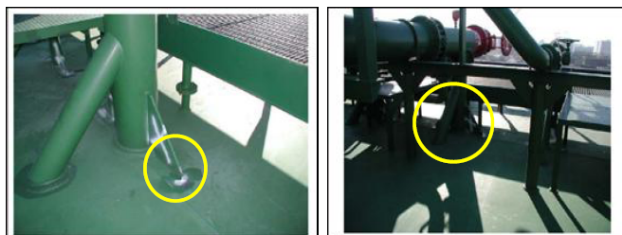
Main deck cargo line supports i.w.o. manifold area

Cracks at the pipe support bracket connection to main deck toe

- ▶ **Location:** Main deck cargo area (0,4L)
- ▶ **Category:** Design / Construction & Installation
- ▶ **Type of Defect:** Fracture
- ▶ **Cause:** Bracket toes of 50 mm, possible misalignment
- ▶ **Corrective Action:** Radius brackets, reduce the toe height to no more than 10-15mm, and support toe of bracket if on unsupported panel
- ▶ **Recommendation:** Toe height to be no more than 10-15mm. Support toe of bracket with underdeck stiffening if on unsupported deck plate and check alignment.

Corrective action

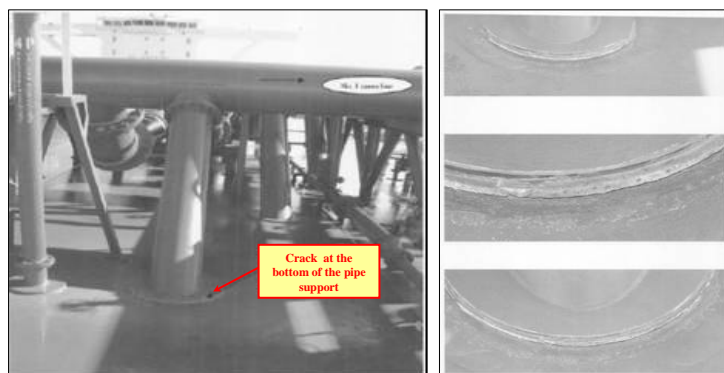
Main deck cargo line supports i.w.o. manifold area

- ▶ **Location:** Main deck cargo area (0,4L)
- ▶ **Category:** Design
- ▶ **Type of defect:** Transverse crack developed through main deck at the fillet weld toe
- ▶ **Cause:** No backing structure provided for pipe support doubler
- ▶ **Corrective Action:** Backing structure added.
- ▶ **Recommendation:** Proper backing structure is to be provided below deck or improved structure above deck is to be provided to better distribute the load. The support structure should preferably be made with open sections making alignment with under deck structure easier. Align with underdeck structure and fit well rounded brackets with soft toes, aligned with longitudinal below, with maximum toe height 10-15mm at connection of support to deck. If necessary additional under deck supports to be made to align with brackets.

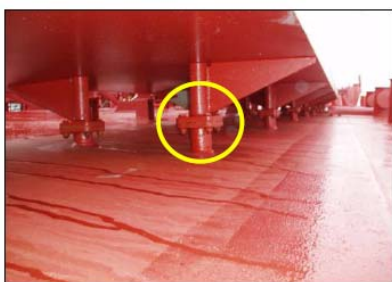
Midship Manifold Drip Tray Supports

Drip tray being modified from continuous to several separate sections

- ▶ **Location:** Main deck cargo area (0,4L)
- ▶ **Category:** Design
- ▶ **Type of defect:** In this vessel, the manifold drip trays are reported to be cracking where their supports are welded to the upper deck. The cracks have been located where the doubler is welded to the upper deck, but have not penetrated into the cargo tank. There are 9 pairs of supports for the drip tray, all landing on web frames or transverse stiffeners. The tray is 1.8 m wide and approx. 19 m long.

- ▶ **Cause:** It is believed that this is the result of the ship's structure bending in waves and while loading. The spill trays are quite stiff therefore large forces are created as the spill tray attempts to prevent the upper deck from moving.

- ▶ **Recommendation:** The drip tray to be constructed in several sections along the length of the drip tray to make it more flexible. The support structure to allow flexibility, while still adequate to resist the weight, wave impact, and buoyancy forces. Arrange thick phenol resin pad between the flanges on the pipe supports, and the holes in the flanges to be slotted to allow movement.

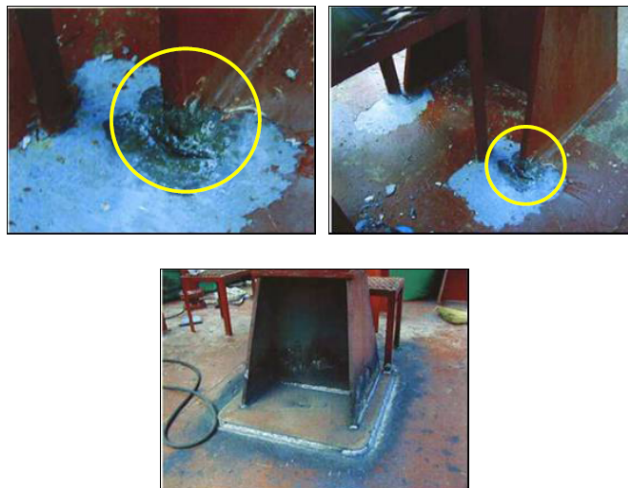
Main deck cargo line stanchion

- ▶ **Location:** Main deck cargo area (0,4L)
- ▶ **Category:** Design
- ▶ **Type of defect:** Cracks developed on upper deck around bracket toes of pipe line stanchions.
- ▶ **Cause:** This was a fatigue crack.
- ▶ **Corrective action:** A doubling plate was provided to reduce the stress induced by longitudinal moment. Soft toe type is also preferable way to reduce the stress level
- ▶ **Recommendation:** The support structure should align with the underdeck structure and fit well rounded brackets with soft toes, aligned with longitudinal below, with maximum toe height 10-15mm at connection of support to deck. If necessary additional under deck supports to be made to align with brackets.

Corrective action

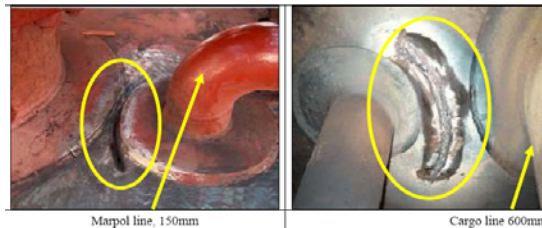
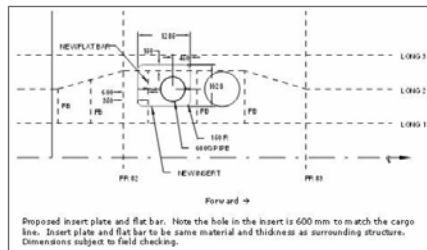
MARPOL line deck crack

- ▶ **Location:** Main deck cargo area (0,4L)
- ▶ **Category:** Design
- ▶ **Type of defect:** Cracking on MARPOL line deck penetration
- ▶ **Cause:** Most likely the result of deck penetrations placed closely, together with pipe movement. There are two large (855 mm diameter for 600 mm pipe) penetrations in line with each other, with a small (315 mm diameter for 150 mm pipe) penetration in close proximity.

- ▶ **Corrective actions:** Considered long term repair possibilities include:
 - Relocate the MARPOL line penetration through the upper deck aft by 1-2 meters.

- Insert the upper deck with similar thickness and grade of plating.
 - Add a transverse stiffener approx. 600 mm aft of the center of the #3 drop line, spanning the upper deck longitudinals at 840 and 1680 mm off centerline

- ▶ **Recommendation:** Allow sufficient space between penetrations. Doublers should be avoided, especially when the deck is made of Higher Tensile Steel

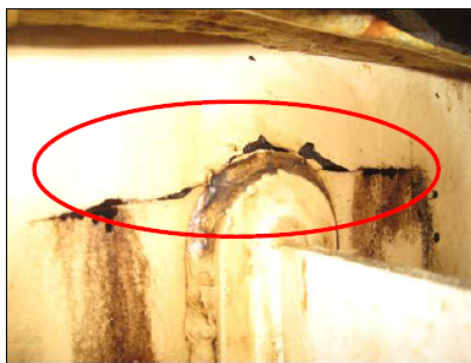
Ladder connection to oil tank

Crack in way of ladder lug doubler – connected to unsupported plate of oil tank. Vibration induced crack.

- ▶ **Location:** Engine room oil tank.
- ▶ **Category:** Design.
- ▶ **Type of Defect:** Crack in engine room oil tank bulkhead.
- ▶ **Cause:** Vibration
- ▶ **Recommendation:** The ladder lug should be located in way of internal stiffening structure. A bolted connection between the lug and ladder would be preferable.

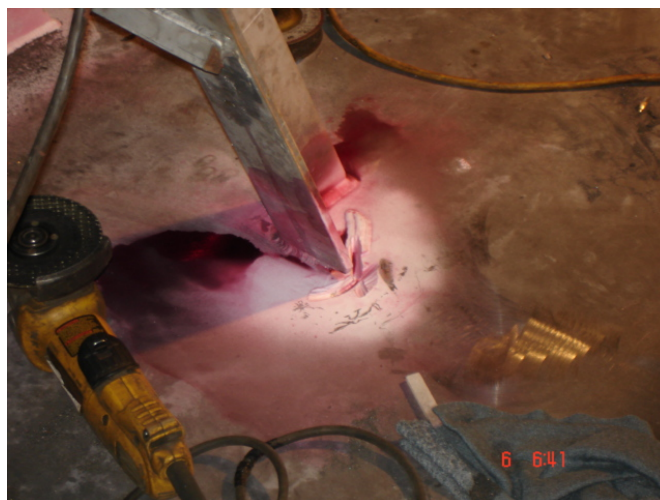
Ladder Support

- ▶ **Location:** Cargo area, tank bottom
- ▶ **Category:** Design / Construction & Installation
- ▶ **Type of Defect:** crack develop at the ladder connection to tank bottom
- ▶ **Cause:** No support
- ▶ **Recommendation:** Ladder should be welded on a doubling plate with backing structure below deck if the preferred bolted structure is not used.

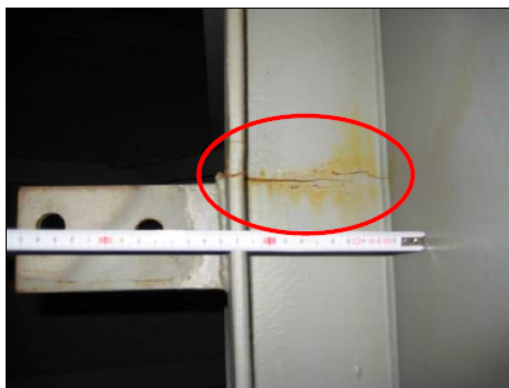
Staging lug left from new building stage

Non structural staging lug in fresh water tank. Abrupt connection and poor return weld detail resulted in the crack shown – vibration induced crack.

- ▶ **Location:** Fresh water tank in engine room.
- ▶ **Category:** Design / Construction & Installation
- ▶ **Type of Defect:** Crack in way of the fresh water tank stiffener that propagated into the bulkhead plating resulting in a leak.
- ▶ **Cause:** Vibration induced crack.
- ▶ **Recommendation:** Such lugs should have a "softer" shape and although not structural the welding condition should be improved by a smooth and correct profile. Removing the lug should also be considered, especially at locations where excessive vibration is expected.

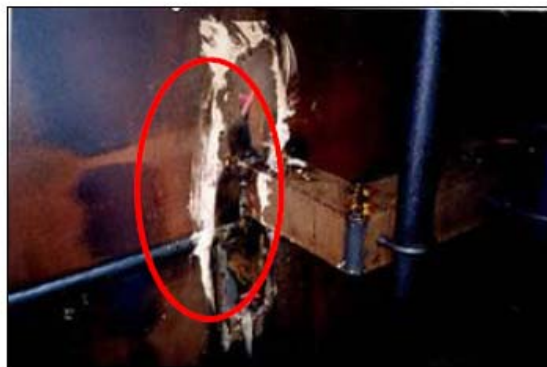
Instrument pipe support in cargo tanks

- **Location:** Cargo area (inside tank)
- **Category:** Design
- **Type of Defect:** The transverse BHD had a crack around fillet welding to pipe support.
- **Cause:** Doubling plate had not been provided at the connection. The cause of damage is vibration.
- **Recommendation:** A doubling plate should be provided and number of supports increased. Stiffeners to be considered, especially at locations where excessive vibration is expected.

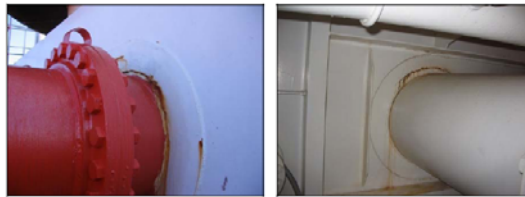
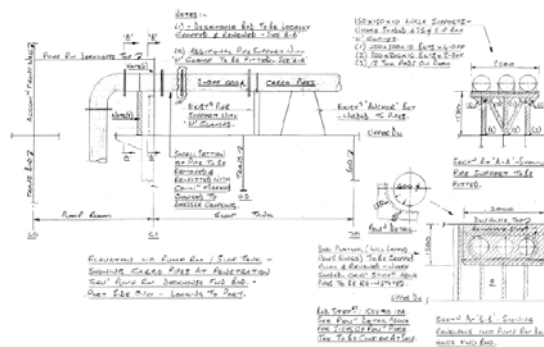
Pipe Penetration at Pump Room Bulkhead

- ▶ **Location:** Cargo area (aft)
- ▶ **Category:** Design
- ▶ **Type of defect:** Crack developed along with fillet welding of pipe penetration at a bulkhead.
- ▶ **Cause:** Vibration
- ▶ **Corrective action:** Making the bulkhead stiffener arrangement "softer" did not work. The pipes were supported inside the pump room deckhouse and the pipe securing arrangement outside the deckhouse made more flexible.
- ▶ **Recommendation:** To avoid vibration damages, additional stiffener on BHD plates and additional pipe supports were recommended. The pipe supporting arrangement should be more flexible (couplings).

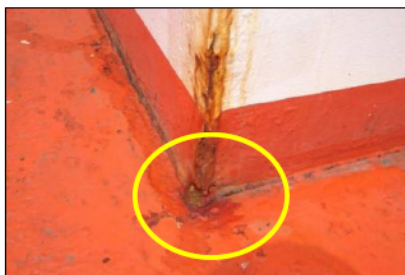
Deckhouse corner at connection to upper deck. Note crack in way of fillet welding and local scale

- **Location:** Main deck cargo area (0,4L)
- **Category:** Design
- **Type of Defect:** Cracking in way of the fillet welds at the corners of the deckhouse where the deckhouse connects to the upper deck and such cracks propagating into the upper deck plating.
- **Corrective Action:** The corner fillet weld to be gouged out and the location MPI tested. The fillet weld at the corners to be re-welded or if cracks are found in the upper deck plating the deck to be inserted the deck. Brackets fitted at the corners.
- **Recommendation:** Deck house sides should be aligned with under deck structures and brackets to be fitted at the corners of deckhouses / accommodation blocks etc.

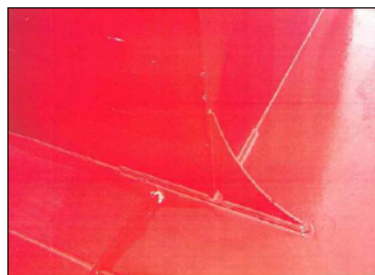
Deckhouse corner welding repaired and soft bracket fitted.

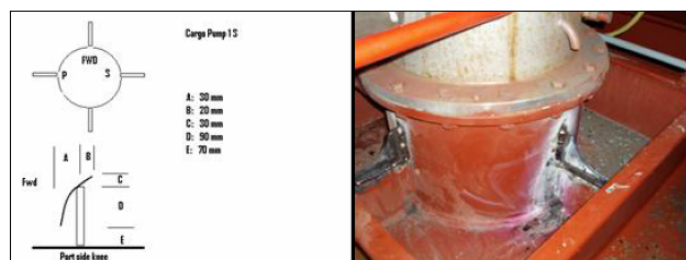
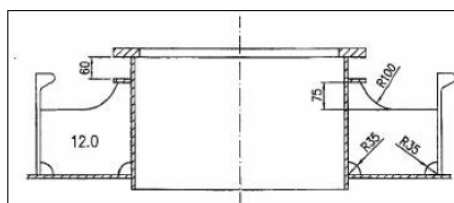
Submerged pump supports

- ▶ **Location:** Cargo area
- ▶ **Category:** Design
- ▶ **Type of Defect:** Fracture
- ▶ **Cause:** Stiffener fitted on submerged pump trunk created hard point (high distance between stiffener toe and trunk flange). Cracks developed through the trunk due to vibration of the trunk and the pump.
- ▶ **Recommendation:** Stiffener to be fitted with a soft toe bracket with bracket toe connected to trunk flange.
