Table A.1 Overview of corrugated bulkhead damages

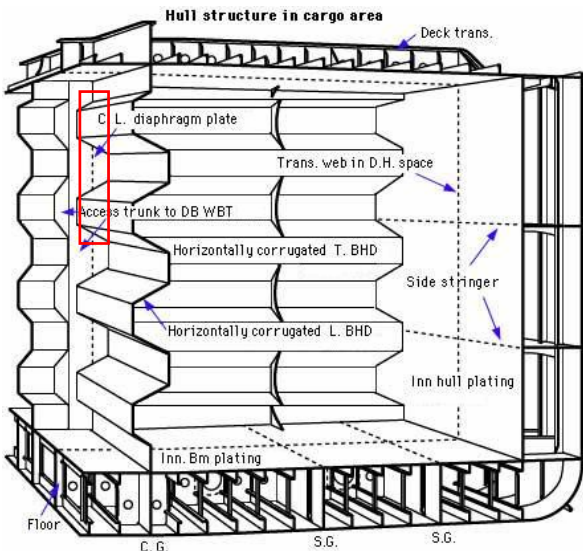
Description of damage	Cracks developed at longitudinal corrugated bulkhead (horizontal type) following fillet welding connection to access trunk wall. The crack initiated at crossing section with vertical stiffener of trunk wall on center line.

<p>Cracks were gouged out and re-welded, and carling was additionally fitted along web plate of longitudinal corrugated bulkhead in access trunk.</p>
Probable cause of Damage	<p>Detail design</p>
Recommendation for design improvement	<p>In case of horizontally corrugated bulkheads, additional carlings to be fitted also along with web plate of bulkhead in order to reduce stress concentration caused by longitudinal moment. Any connection between the corrugation web and crossing stiffeners or other structure must be supported by brackets or carlings.</p>

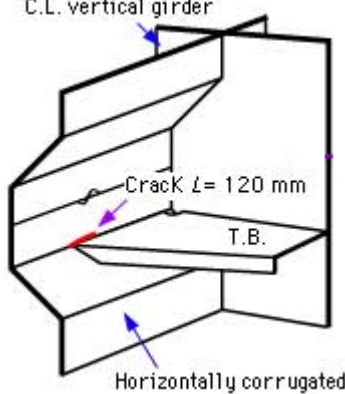
Description of damage	<p>Crack developed on corrugated bulkhead. The crack was initiated from a toe end of tripping bracket to C.L. girder.</p>

Probable cause of damage	Detail design			
Recommendation for design improvement	Soft end type bracket to be considered at such high stress area. Preferably the tripping brackets should be aligned with the inclined web of the corrugation.

Description of repair	<p>Cracked area of the bulkhead and the bracket were partly renewed. An additional small bracket was also fitted at toe end of the tripping bracket for reinforcement (reduce stress concentration).</p>

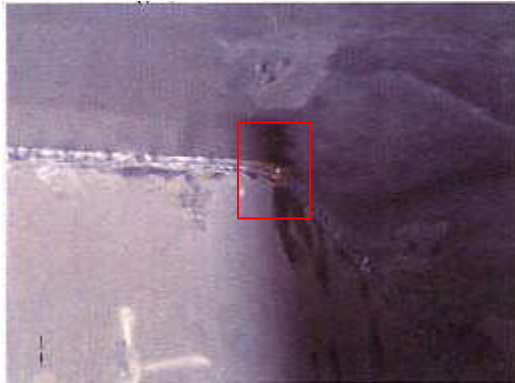
Description of damage	Crack developed on longitudinal corrugated bulkhead connection to upper deck. The crack initiated from fillet welding at the corrugation corner under a crane post.

Description of repair	Cracks were gouged and re-welded by full penetration welding.			
Probable cause of damage	Detail design, insufficient welding			
Recommendation for design improvement	Sufficient reinforcement from upper deck side is preferable due to restriction for reinforcement from tank side. Full penetration welding should be generally preferred in way of supporting structures if the connection is exposed to high stresses.

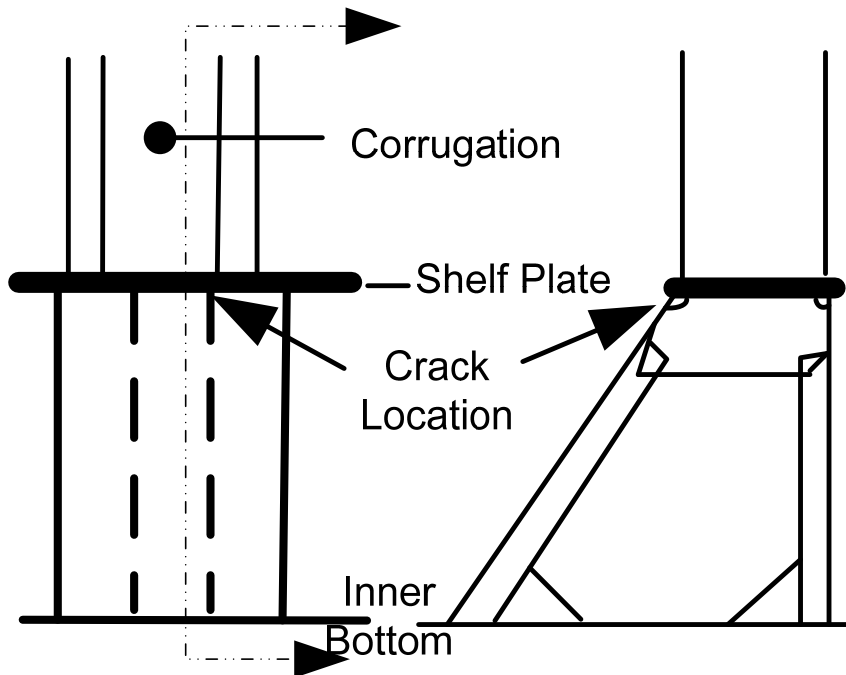
<p>Two cracks approx. 50mm in welds between bottom stool shelf plate and sloping plate in way of corrugation corners</p>			
Description of repair	Affected welds gouged from both sides and rewelded. Additionally collar plates have been fitted to scallops in way.			
Probable cause of damage	Stress concentrations in-way of the corrugation corner due to lack of web support and scallops.			
Recommendation

<p>No scallop</p> <p>Close Scallops in way of brackets below corrugation corners Carlings/brackets aligned with the corrugation webs should also be considered.</p>

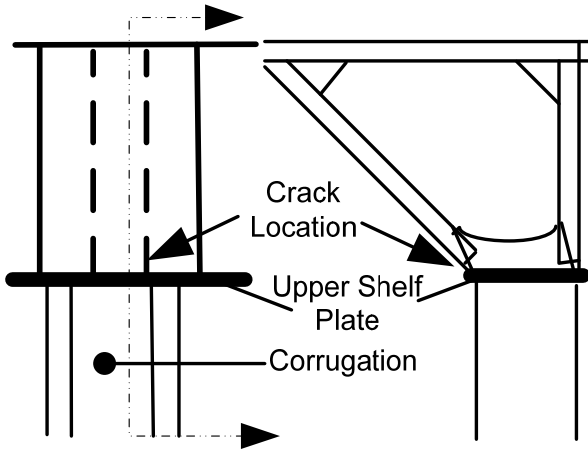
<p>Cracks in upper stool sloped plate near junction of upper stool sloped side plate and upper stool shelf plate.</p>			
Description of repair	<ol style="list-style-type: none">1) Upper stool shelf plating of void space cropped and part renewed with increased thickness2) Upper stool sloped side plating cropped and part renewed with increased thickness3) Longitudinal bracket at bottom of void space (11mm) connecting stool side stiffeners at bottom of void space modified4) Additional bracket fitted in line with corrugated bulkhead web underneath			
Probable cause of damage	Detail design

Recommendation for design improvement	Scallops/openings to be avoided in way of connection of sloped stool plate to shelf plate

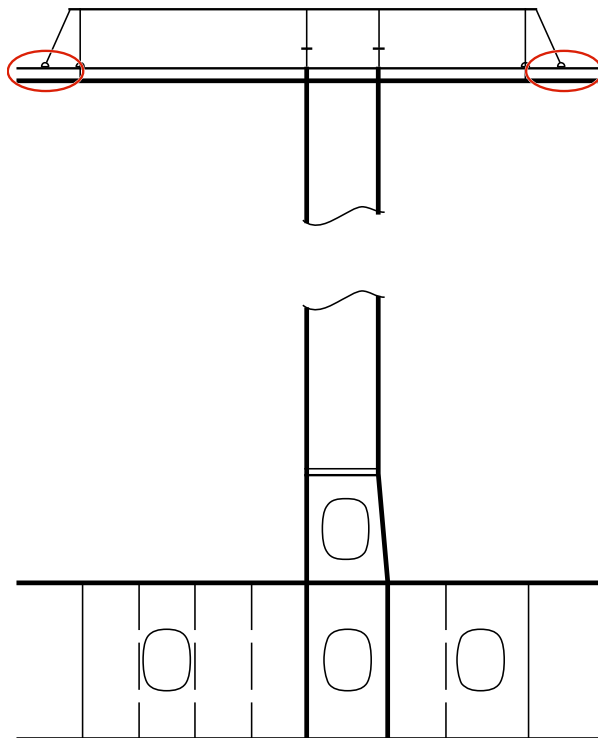
<p>Crack is developing in the deck longitudinals in way of the bracket toe at the forward or aft end of the partial girder supporting the top of the corrugated bulkhead. There are six such partial girders across the deck in way of each transverse bulkhead.</p>

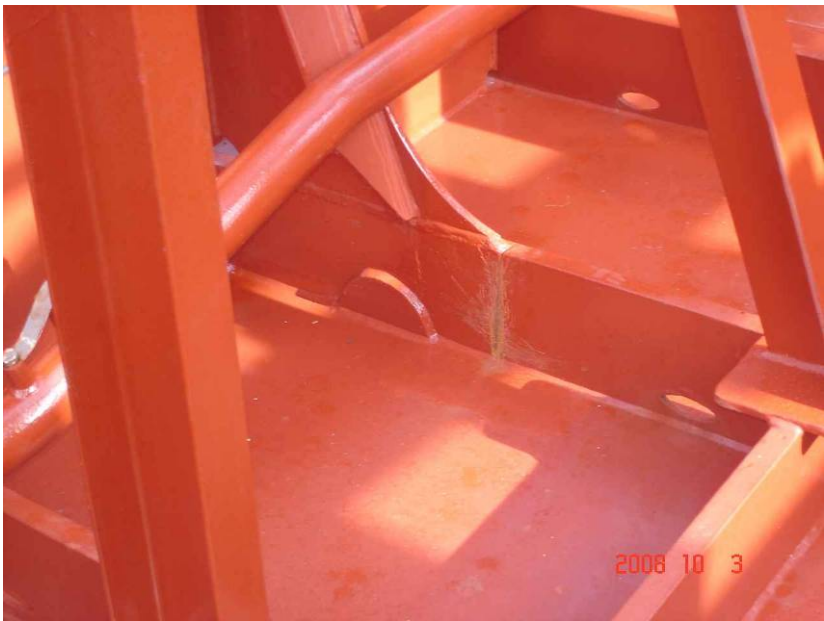
<p>Note: On above picture the deck longitudinal is cracked through to the deck plating. The majority of the other cracks found were less than 10 mm deep. On above picture a pipe support is landing adjacent to the bracket nose on the same deck longitudinal. This might have contributed to the problem at this position. However cracks are also appearing where there are no pipe supports.</p>
Description of repair	<p>Cracks in bracket toe welding and/or bulb:</p> <ul style="list-style-type: none"> • Determine extent of crack by dye penetration • Gouge out existing fillet welding 200 mm away from bracket toe. • Re-weld with full penetration. • Open crack in bulb by gouging and re-welding. • All welding to be ground smooth by means of pencil grinder (not disc grinder). <p>See also sketch below.</p>

- Determine extent of crack by dye penetration
- Stop drill crack at the crack tip by hole of diameter 50% higher than the profile thickness.
- Open crack in bulb by gouging and re-welding.
- Apply bracket as shown on above sketch of temporary repair
- All welding to be ground smooth by means of pencil grinder (not disc grinder).
- Drain holes within 200 mm from bracket nose to be closed by doubling plate.

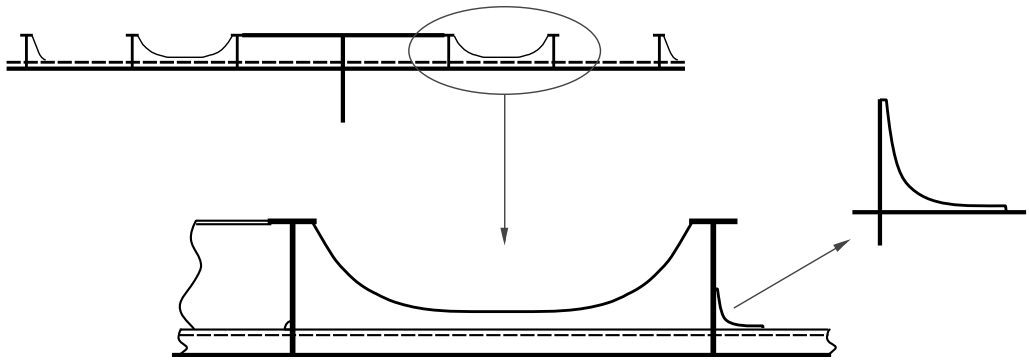
Probable cause of damage	<ul style="list-style-type: none"> • Poor detail design • No fatigue assessment at design stage • Support for deck piping close to the bracket nose has in some cases contributed to the problem.
Recommendation for design improvement	<p>For the vessels in question: See above</p> <p>For future newbuildings:</p> <p>The fatigue life of the structural interface between bulkhead and deck structure to be examined during design stage in order to obtain a design with sufficient structural redundancy.</p> <p>Pipe supports adjacent to the bracket nose shall be avoided.</p>

- Fit U-shape brackets to each end of the partial girder (see sketch below):

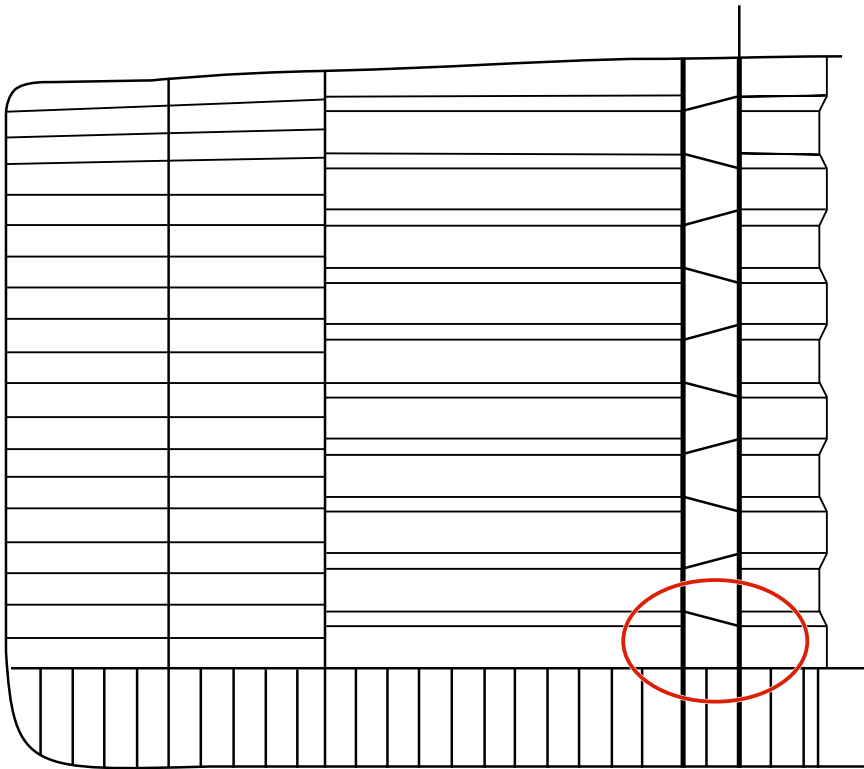
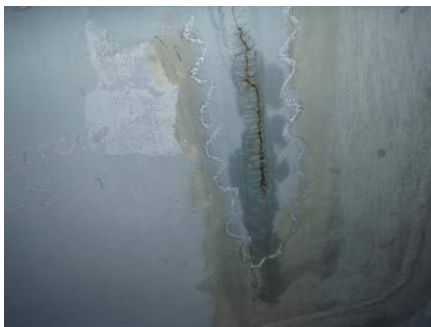
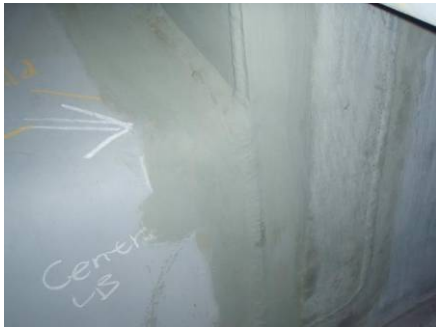
<p>1. Cracks found in CL in lower part of bulkhead/access trunk in way of replaced temporary access opening. Cracks have been found before in same location.</p> <div>

Description of repair	Gouging and rewelding, full pen, two sided.
Probable cause of damage	Detailed design
Recommendation for design improvement	<p>No. 1: Relocate such openings to lower stressed areas. Increase the width of the opening to reduce welding stresses.</p> <p>No. 2: Fit brackets inside trunk, aligned with corrugation webs.</p>

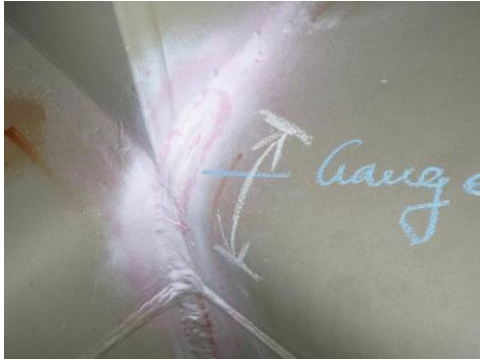
Case 1.7	
	<p>2. Cracks in the corner where transverse and longitudinal corrugations meet, lower corrugation.</p>

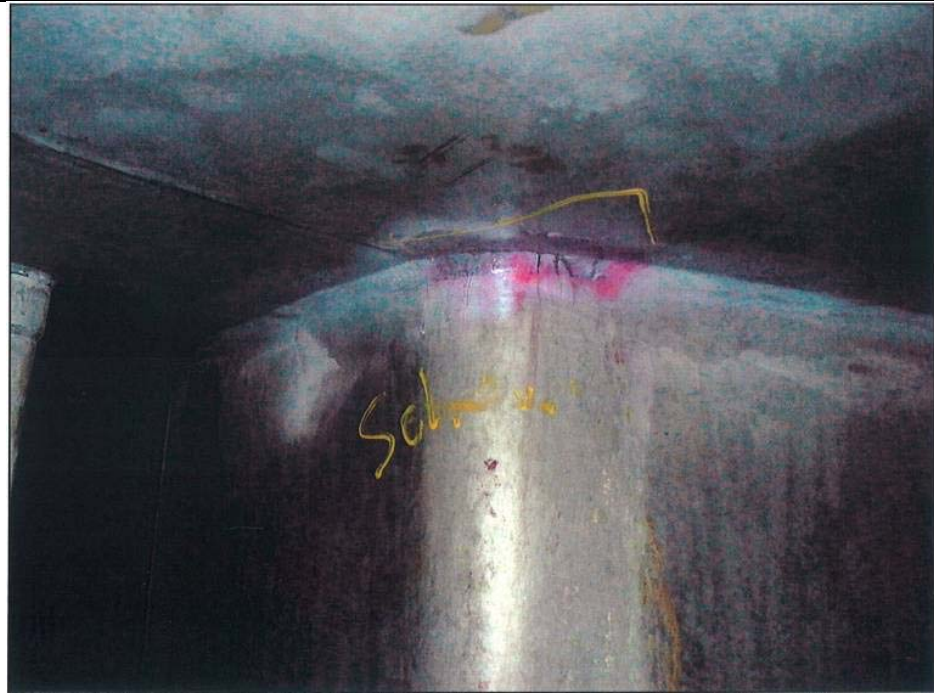
Description of damage	Cracks developed at corrugation corners in areas of intersection of longitudinal bulkheads and longitudinal deck girder.

Insufficient support

Cracks were re-welded. Brackets were installed above upper deck along web plate of longitudinal corrugated bulkhead between the longitudinal deck girders.

Continuous support of the web plate of the corrugated bulkhead to be provided on upper deck.

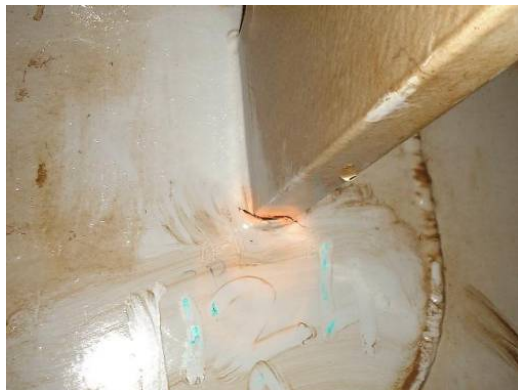
Description of damage	Cracks developed at penetrations of the inner bottom longitudinals through floors.

Probable cause of damage	Detail design Insufficient support
Recommendation for design improvement	Additional longitudinal stiffeners in line with face plate of corrugated bulkhead shall be arranged to support the load induced.

Description of repair	To increase rigidity of the longitudinals, additional stiffeners were fitted on original longitudinals with end brackets. In addition, transverse carlings were fitted at the mid area in floor spaces.

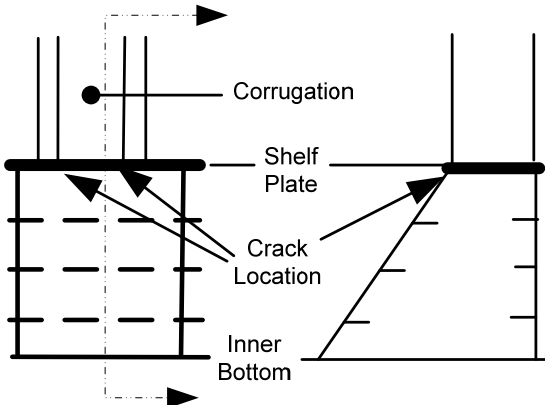
<p>Cracks at intersection of lower transverse bulkhead stool side plate connection to shelf plate in way of corners of corrugation flanges at locations where no backing structure for corrugation web</p>			
Description of repair	Backing brackets below web plate of corrugated bulkhead extended			
Probable cause of damage	Lack of Continuity			
Recommendation for design improvement	For corrugations of high tensile steel, backing brackets to be fitted below corrugation webs

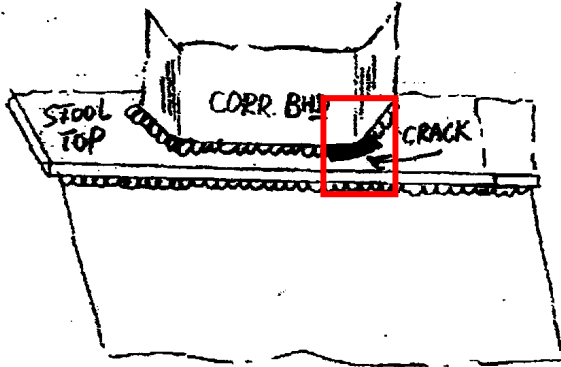
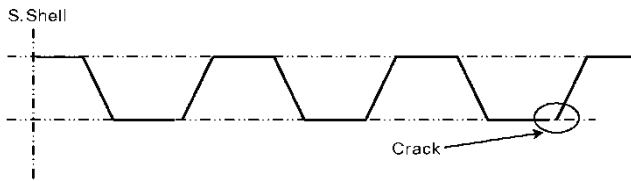
Description of damage	Cracks developed around transverse corrugated bulkhead connection to stool structure. Cracks were initiated mainly from corner area of corrugated bulkhead but also from stool slant plate connection to top plate just under the corner area.

Probable cause of Damage	Lack of continuity
Recommendation for design improvement	Same as above structural modification or increase scantling of corrugated bulkhead / stool structure.

Description of repair	Cracks were gouged and re-welded. As a reinforcement, an additional bracket was installed below web plate of corrugated bulkhead in lower stool.

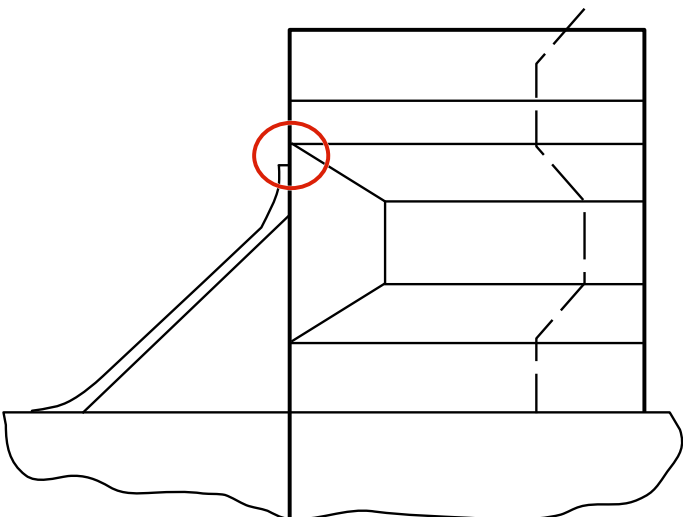
<p>Damage shown on sketch of original structure. Damage located in lower aft end termination of the longitudinal bulkhead.</p>

Probable cause of damage	<ul style="list-style-type: none"> • Detail design • Lack of continuity • Generally, the scarfing brackets are undersized.
Recommendation for design improvement	<ul style="list-style-type: none"> • See Sketch • For further improvement a bigger and softer bracket.

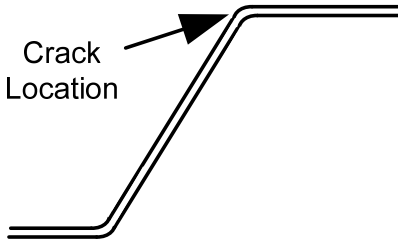
<p>Fillet welding between the shelf plate and sloped plating of lower stool cracked approx. 500 mm in the middle No.4 Cargo Tank (P) and No.4 Ballast Water Tank (P) and oil leaked into the bottom stool in No.4 B.W.T.(P). Cracks and paint cracks were found at the round end corners of transverse corrugated bulkhead inside of bottom stool in No.4 Cargo Oil Tank(P)/No.4 Ballast Water tank(P).</p>			
Description of repair	Brackets fitted side of bulkhead at frame 55,63,71 & 79 corrugation in way of shelf plate bottom connection and gauging out stool plate to self plate connection and welding back after examination with MPI. The above repair carried out at builder suggestion based on history of crack of sister vessel and on this vessel which found and gauged out during above repairs.

Probable cause of damage	Lack of continuity Insufficient throat thickness of fillet weld			
Recommendation for design improvement	Continuous support of corrugated bulkhead inside of bottom stool to be provided Full penetration welding

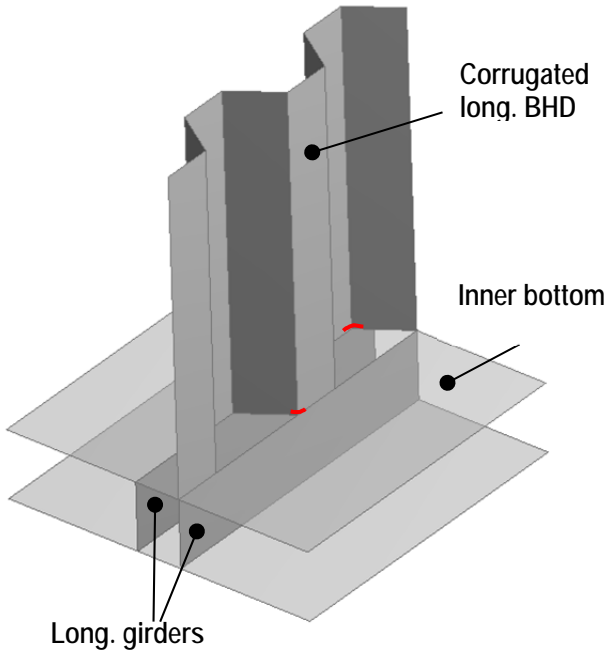
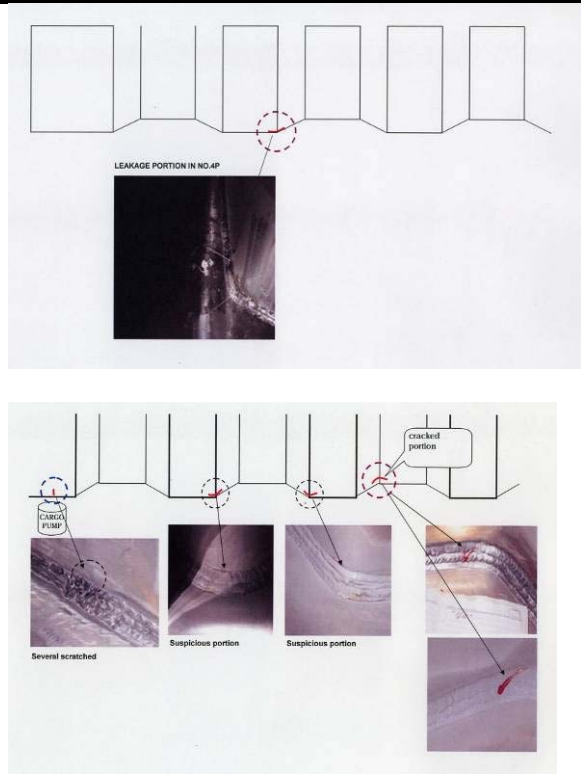
Description of damage	Cracks developed around corners of corrugated bulkhead connection to inner bottom plates.

Description of repair	Cracks were gouged and re-welded by full penetration welding.
Probable cause of damage	Detail design (insufficient support of corrugated bulkhead). Insufficient throat thickness of fillet weld.
Recommendation for design improvement	<p>Full penetration welding with grinding to smooth up welding bead or increase scantling of corrugated bulkheads.</p> <p>Continuous support along web plate of longitudinal corrugated bulkhead below inner bottom plate between the longitudinal girders to be provided as sketched below.</p>

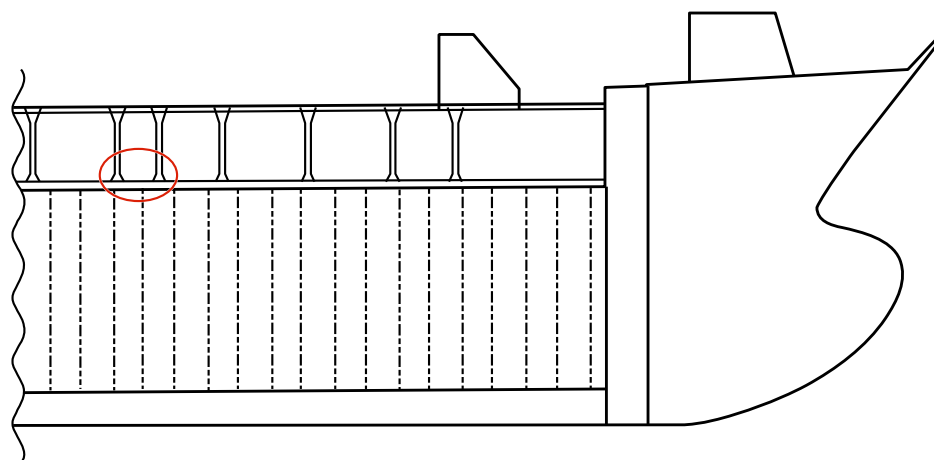
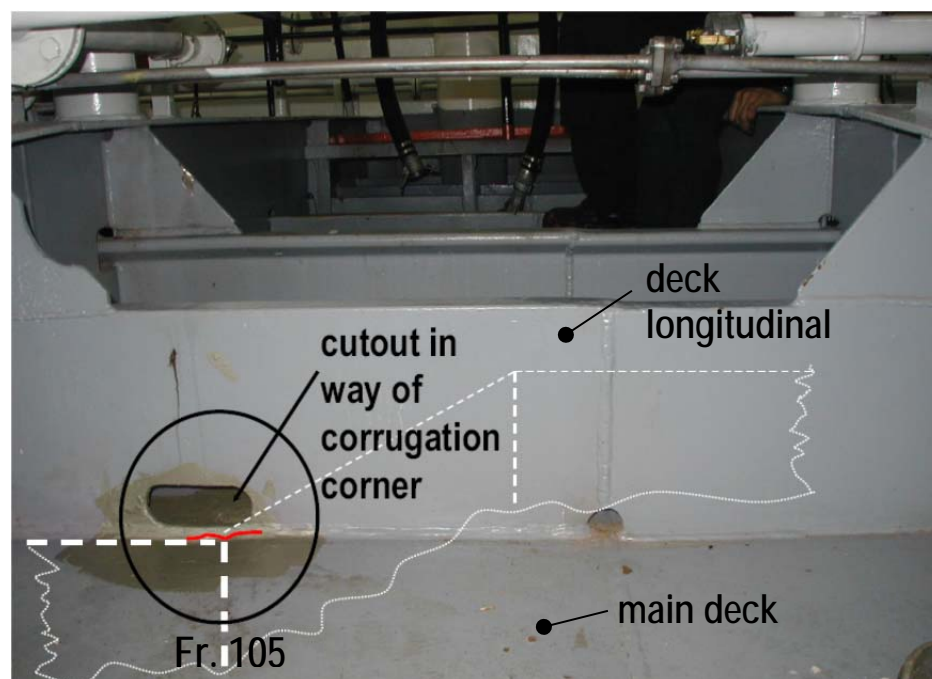
Description of damage	<ol style="list-style-type: none"> 1. Indent of longitudinal bulkhead occurred at half height of tank at frame 105. 2. Crack occurred between longitudinal bulkhead and main deck in way of corrugation corner below cutout in deck longitudinal at frame 105.
Description of repair	<ol style="list-style-type: none"> 1. Renewal of longitudinal bulkhead in way of frames 105-106. 2. Deck longitudinal was supported by HP200×11.5 in way of frames 105-106. Cutout in deck longitudinal was closed by insert.
Probable cause of damage	<ol style="list-style-type: none"> 1. Unknown 2. Poor detail design
Recommendation for design improvement	Discontinuities of supporting structure (e.g. cutouts in deck longitudinal girders) in way of corrugation corners are to be avoided.

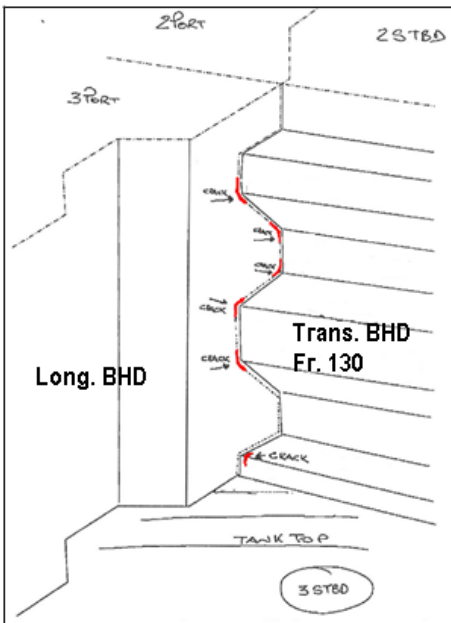
<p>Frame 130</p></div><div>

Cracks of 60mm to 250mm developed in longitudinal bulkhead at corrugation corners at frames 115 and 130 (connection to transverse bulkheads), and frame 119 (connection to tank top plate). One crack (250mm) developed in transverse bulkhead at corrugation corner at frame 130 (connection to longitudinal bulkheads).

Description of repair	All cracks were gouged and re-welded.
Probable cause of damage	Misalignment Insufficient throat thickness of fillet weld
Recommendation for design improvement	Full penetration welding.

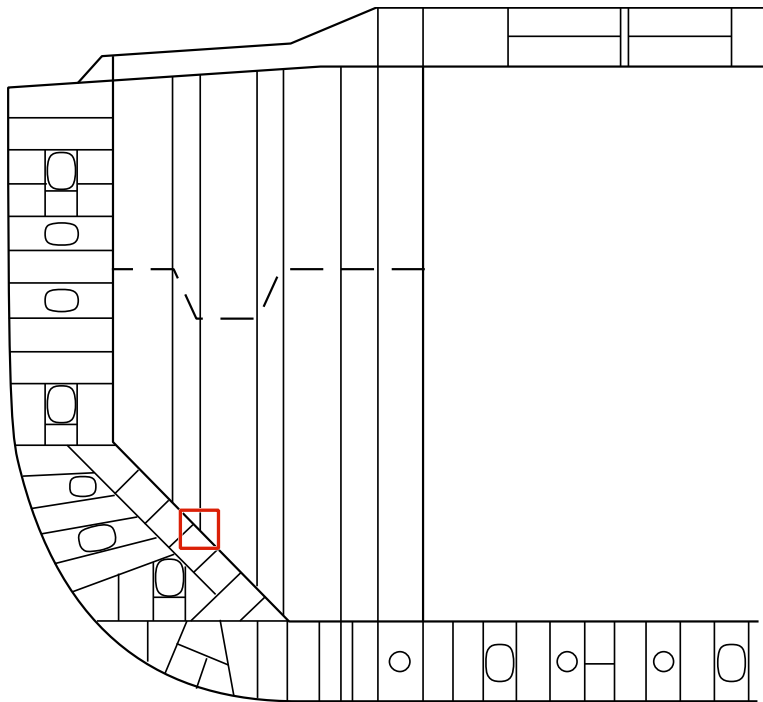
Case 1.17				
Ship-Type	Chemical Tanker		Capacity [dwt]	Abt.20,000
Year of build	1996	Vessels age when damage found:		7 years
Main dimensions	L	144 m	B	25 m
	T	-	D	12 m
Bulkhead	Vertically corrugated		Transverse bulkhead	
Stool	None fitted			
Material	Stainless steel			
Overview of damage location	The damage was located at the connection of the bottom of the corrugated bulkhead to the sloping hopper plating outside the parallel part of the cargo area.			
Description of damage	A crack developed at the connection between the transverse corrugated bulkhead and the hopper plate. The hopper plate angle to the horizontal changes along ship length (fore and aft) and this produces difficulties in alignment and welding of the corrugated bulkhead.

Description of repair	The cracks were gouged and re-welded.			
Probable cause of damage	<ul style="list-style-type: none">• Misalignment and poor fit up• Welding

Recommendation for design improvement	Special consideration should be given at the design and construction stages to ensuring accuracy of alignment & fitting as well as a good weld connection (type of edge preparation, full penetration, toe grinding, etc.) and proper support of the flanges and webs of the corrugations.

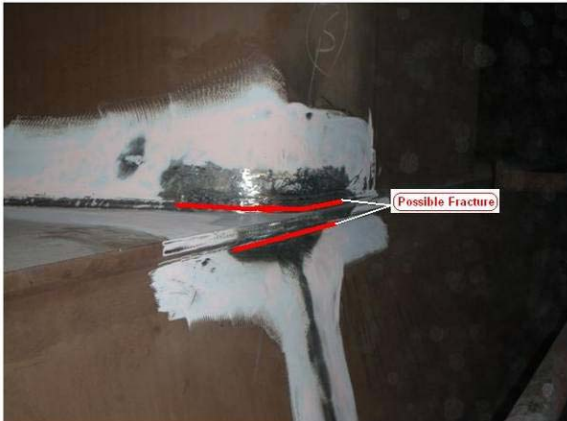
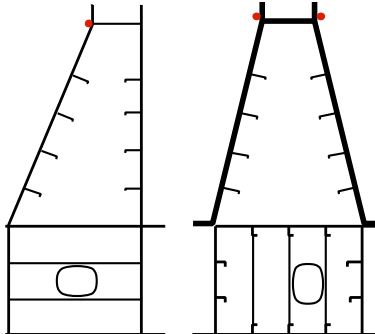
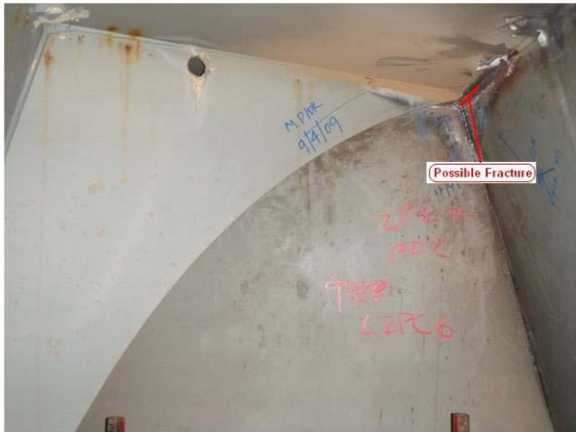
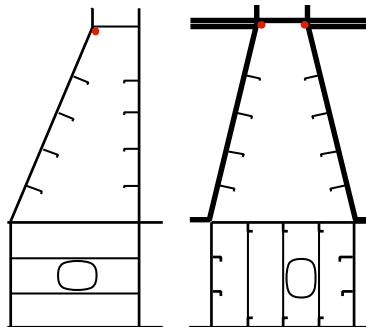
</div> <p>Cracks were found in the welds connecting the corrugated bulkhead to the shelf plate and the shelf plate to the sloping plate. The cracks were found in way of the radius of the corrugated bulkhead and at the toe of the bracket within the stool (water ballast tank).</p>			
Description of repair	<ul style="list-style-type: none">Welds gouged out, replaced with full penetration welds and groundBrackets modified as below to remove the toe of the bracket within the stool from the shelf plate/sloping plate weld

Probable cause of damage	Poor detail design and lack of full penetration welding, creating hotspot at toe of stool bracket in way of highly stressed corrugated bulkhead radius.
Recommendation for design improvement	Brackets in stools, backing up corrugated bulkhead webs, should preferably be continuous and extend down the sloping plate. If in conflict with the normal brackets inside the stool, the brackets should be terminated close to the middle of the shelf plate.

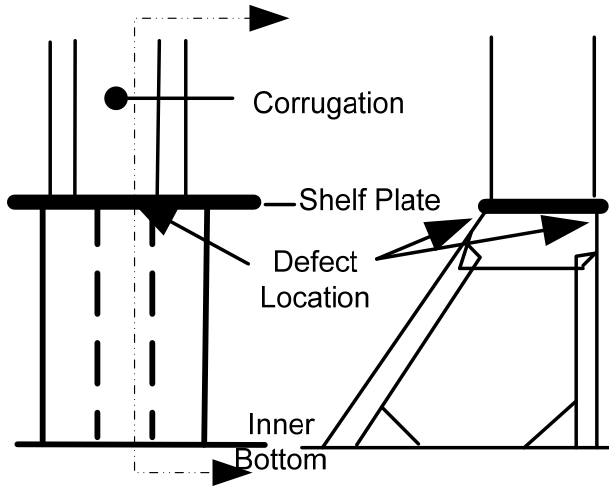
<p>Magnetic Particle Inspection of forward and aft corrugated bulkhead weld seams at the connection with the lower stools revealed porosities and lack of penetration.</p>			
Description of repair	Above affected weld seams were gouged and full penetration welded. Existing scallops in way of the water ballast tank internals (stool spaces) were closed with welded collar plates.			
Probable cause of damage	Poor welding control.			
Recommendation for design improvement	Scallops/openings to be avoided in way of connection of sloped stool plate to shelf plate. Weld connection between bulkhead and stool to be full penetration and to be confirmed with ultrasonic testing.

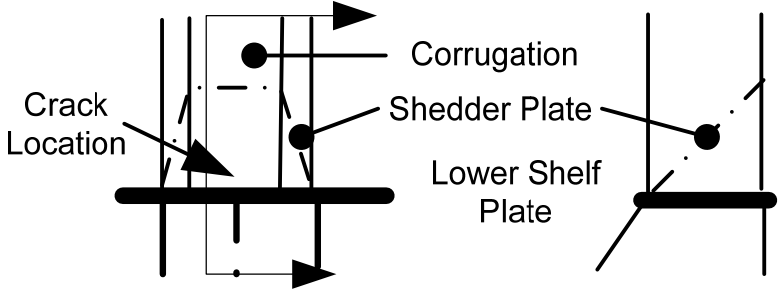
<p>Note: Shedder plate to lower stool connected by full penetration welding</p> <p>Aft bulkhead of Cargo Oil tank numbers 2 and 4 cracked at connection of outermost corrugation shedder plate lower edge to lower shelf plate on starboard side.</p>			
Description of repair	Cracked areas of plating cropped and part renewed as found necessary. On completion repairs examined and found satisfactory, tested tight.			
Probable cause of damage	Poor welding control, poor alignment between shedder plate and stool sloping plate.			
Recommendation for design improvement	Ensure weld between shedder plate and shelf plate is full penetration through ultrasonic testing. Ensure good alignment between shedder plate lower edge and stool sloping plating.

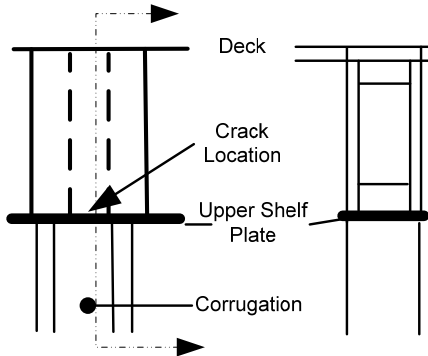
<p>Welding cracked at intersection of upper transverse bulkhead stool side plate connection to shelf plate.</p>			
Description of repair	Weld gouged and re-welded.			
Probable cause of damage	Welding defects			
Recommendation for design improvement	None

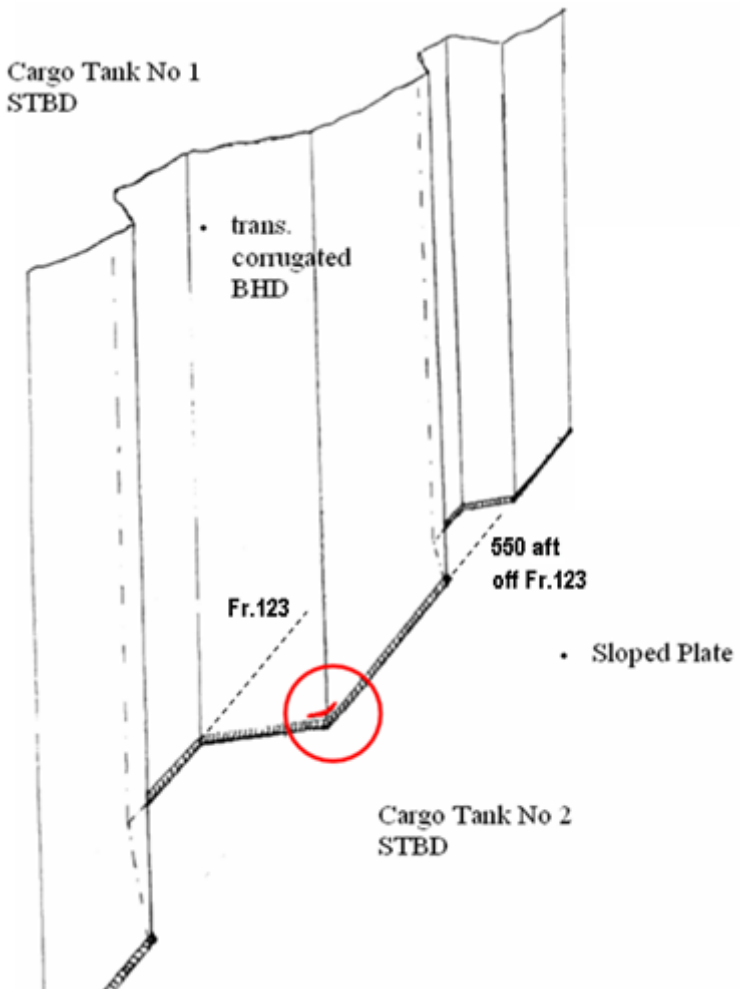
<p>Cargo Tank No 1 STBD</p> <ul style="list-style-type: none"> trans. corrugated BHD Fr.123 550 aft off Fr.123 Sloped Plate Cargo Tank No 2 STBD <p>Crack of approx. 70mm developed in transverse corrugated bulkhead 550mm aft of Fr.123 running parallel to weld seam between the transverse bulkhead and ballast tank at a height of about 3.5m above the bottom of the cargo tank.</p>
<p>Description of repair</p>	<p>Crack was gouged and re-welded.</p>
<p>Probable cause of damage</p>	<p>Insufficient throat thickness of fillet weld. Misalignment between transverse corrugated bulkhead and supporting bracket in ballast tank.</p>
<p>Recommendation for design improvement</p>	<p>Full penetration welding and good alignment.</p>

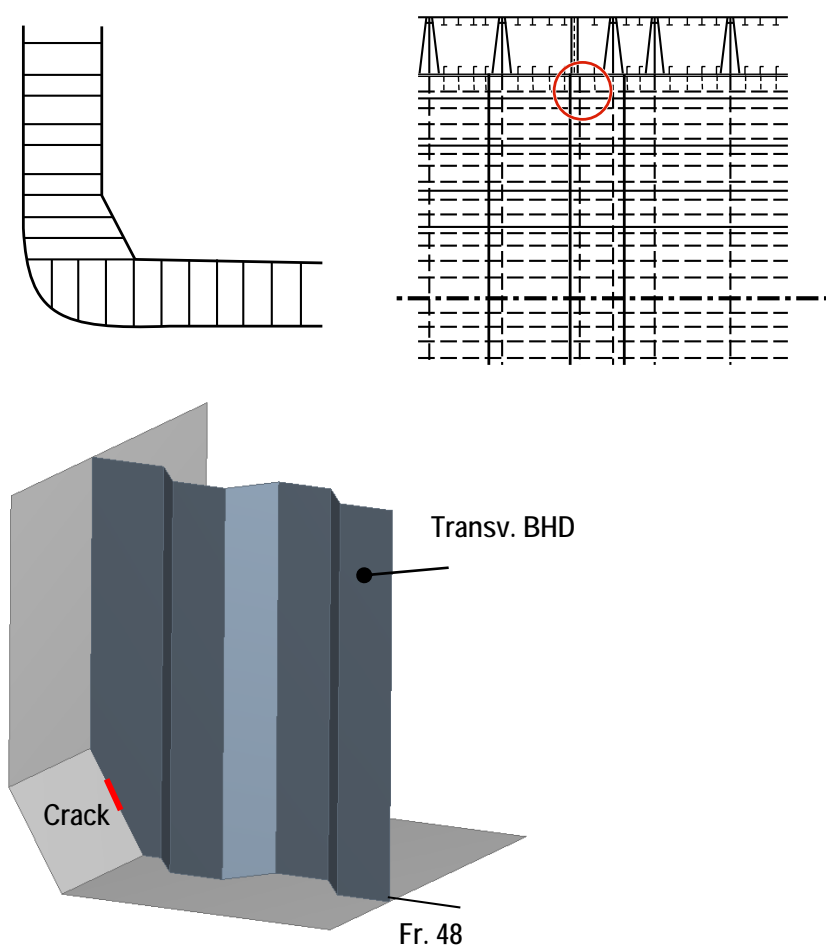
<p>Crack developed at weld seam of transverse corrugated bulkhead (Fr. 47 3/5) in way of lower slope of ballast tank.</p></div>

Case 1.23	
Description of repair	Insert plate in the transverse corrugated bulkhead and the slope of double bottom tank
Probable cause of damage	Insufficient throat thickness of fillet weld. Misalignment between transverse corrugated bulkhead and wing web frame.
Recommendation for design improvement	Full penetration welding and good alignment.
