Tanker Structure Co-operative Forum

Outfitting related structural defects

The paper reviews the outfitting defects based on TSCF member experience and provides analysis on potential causes and repair proposals.

Reference	Revision N°	Revision Date
IP 001/2011	0	2011/03/31

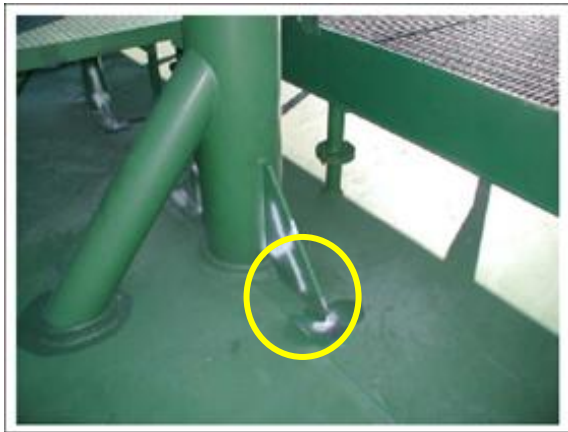
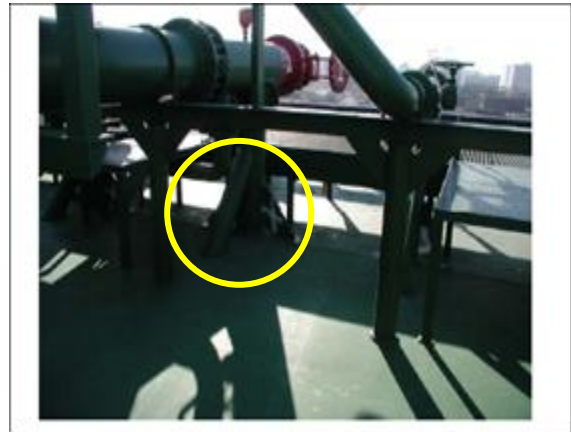
Location:	Main deck cargo area (0,4L)
Category:	Design / Construction & Installation
Type of Defect:	Fracture
Cause:	Bracket toes of 50 mm, possible misalignment
Corrective Action:	Radius brackets, reduce the toe height to no more than 10-15mm, and support toe of bracket if on unsupported panel
Recommendation:	Toe height to be no more than 10-15mm. Support toe of bracket with underdeck stiffening if on unsupported deck plate and check alignment

Cracks at the pipe support bracket connection to main deck toe

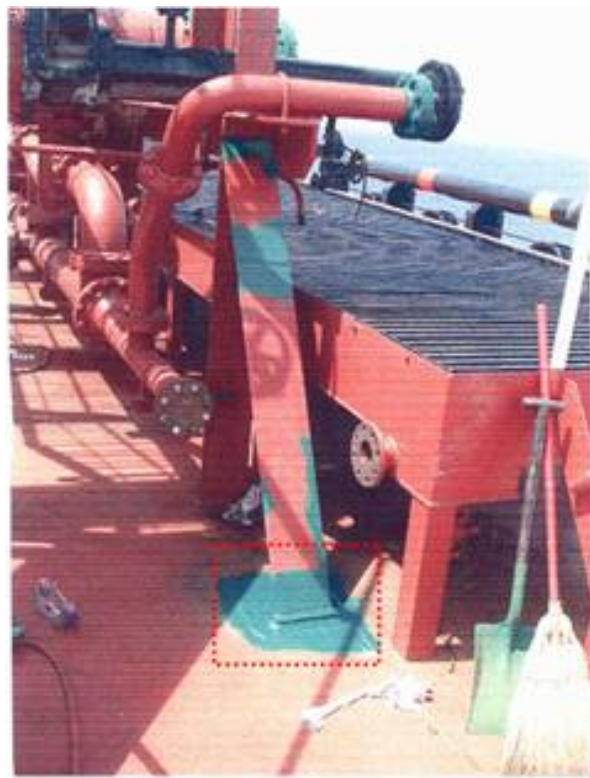
Location:	Main deck cargo area (0,4L)
Category:	Design / Construction & Installation
Type of Defect:	Transverse crack developed on upper deck along the fillet welding of a doubling plate for pipe support
Cause:	Fatigue and poor underdeck support
Corrective Action:	Fit doubler with radiused corners
Recommendation:	Align with underdeck structure and fit well rounded brackets with soft toes, with maximum toe height 10-15mm at connection of support to deck. Smooth grinding to the fillet welding to reduce local stress. Modify details to interrupt the length of the support

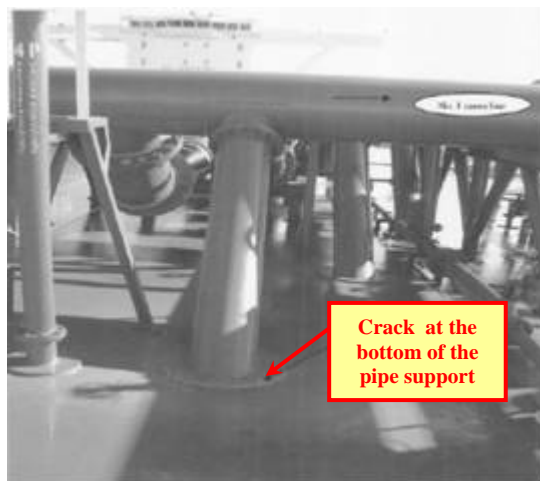
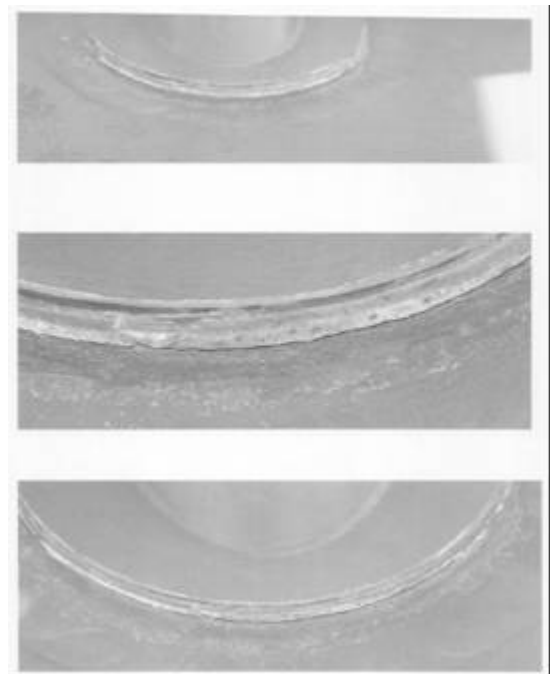
3 Main deck cargo line supports in way of manifold area (c)

Location:	Main deck cargo area (0,4L)
Category:	Design
Type of Defect:	Transverse crack developed through the main deck at the fillet weld toe
Cause:	No backing structure provided for pipe support doubler
Corrective Action:	Backing structure added
Recommendation:	Proper backing structure is to be provided below deck or improved structure above deck is to be provided to better distribute the load. The support structure should preferably be made with open sections making alignment with under deck structure easier. Align with underdeck structure and fit well rounded brackets with soft toes, aligned with longitudinal below, with maximum toe height 10-15mm at connection of support to deck. If necessary additional under deck supports to be made to align with brackets

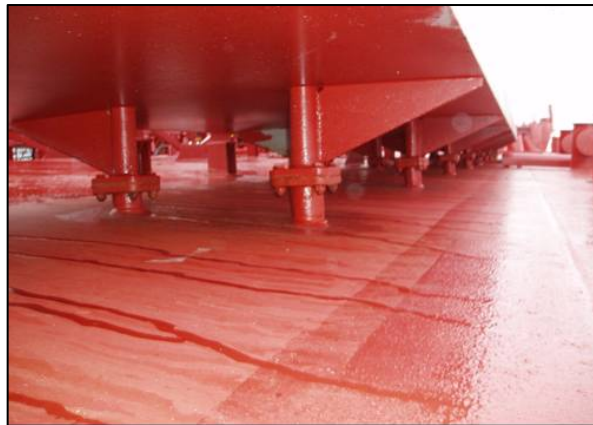
4 Midship manifold drip tray supports (a)

Location:	Main deck cargo area (0,4L)
Category:	Design
Type of Defect:	Cracks in upper deck plating in way of drip tray supports
Cause:	The drip tray participates in the longitudinal hull girder bending and this in turn is transferred to the connection of the drip tray support at the connection to the upper deck
Corrective Action:	Flange connection introduced in way of drip tray supports i.e. oversize bolt holes and Teflon type packing (see picture). Other means of ensuring flexibility could also be considered, e.g. flat bar supports
Recommendation:	Drip tray supports to be fitted in way of underdeck stiffening. The supports to be flexible and / or soft brackets to be fitted where the supports connect to the upper deck

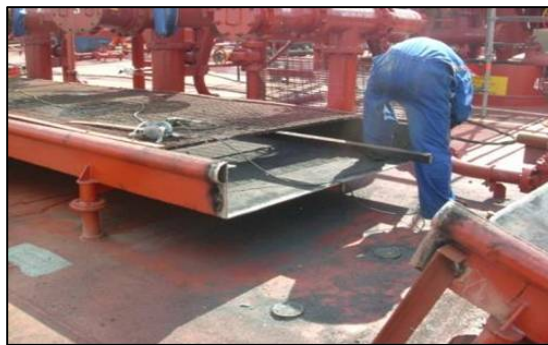
5 Midship manifold drip tray supports (b)

Location:	Main deck cargo area (0,4L)
Category:	Design
Type of Defect:	Cracks in upper deck plating in way of drip tray supports
Cause:	The drip tray participates in the longitudinal hull girder bending and this in turn is transferred to the connection of the drip tray support at the connection to the upper deck
Corrective Action:	The drip tray to be rebuilt in several sections
Recommendation:	The drip tray to be constructed in several sections along the length of the drip tray to make it more flexible

Drip tray being modified from continuous to several separate sections

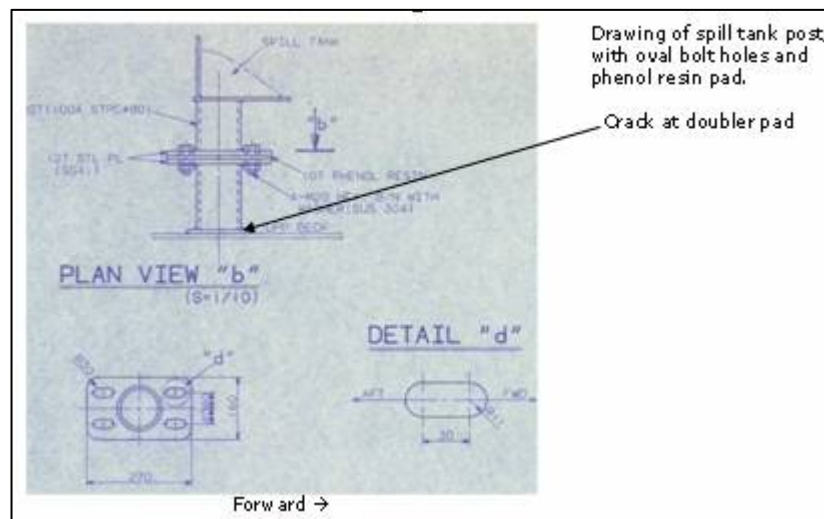
Location:	Main deck cargo area (0,4L)
Category:	Design
Type of Defect:	In this vessel, the manifold drip trays are reported to be cracking where their supports are welded to the upper deck. The cracks have been located where the doubler is welded to the upper deck, but have not penetrated into the cargo tank. There are 9 pairs of supports for the drip tray, all landing on web frames or transverse stiffeners. The tray is 1.8 m wide and approx. 19 m long
Cause:	It is believed that this is the result of the ship's structure bending in waves and while loading. The spill trays are quite stiff therefore large forces are created as the spill tray attempts to prevent the upper deck from moving
Recommendation:	<p>Suggested long term repairs include:</p> <ul style="list-style-type: none"> • Cutting the spill tank into two pieces, thereby reducing its length and the effect of hull bending. Drainage arrangements (i.e. piping) between the two spill pans should allow complete draining without pockets that may freeze. Regulatory impact should be checked. The location of the joint should not be below a discharge flange. • Modifying the support structure to allow greater flexibility. Currently the supports are 100 mm schedule 80 pipe. One such support could be kept for fixity, and the others replaced with an arrangement to allow more flexibility while still adequate to resist the weight, wave impact, and buoyancy forces. • The design drawings show a 12 mm thick phenol resin pad between the flanges on the pipe supports, and the holes in the flanges are slotted to allow movement.

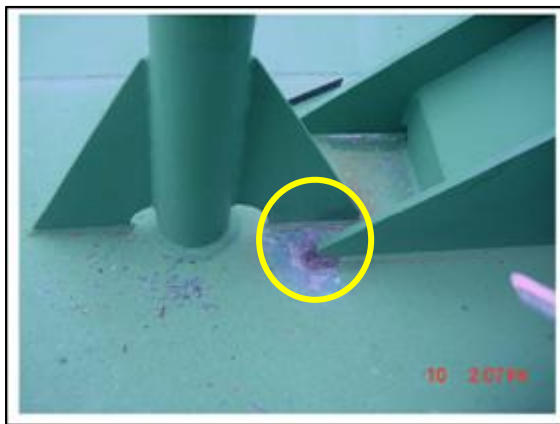
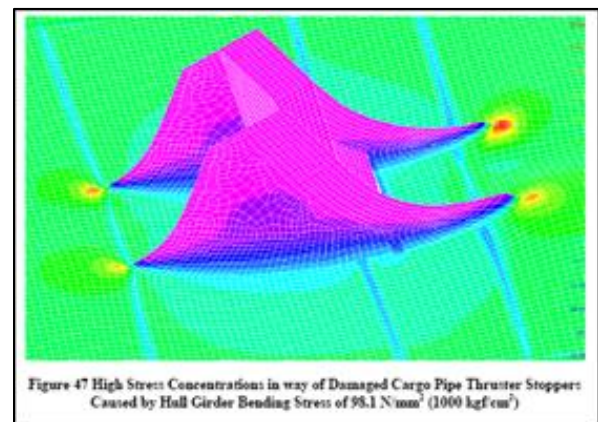
7 Thrust Stopper

Location:	Pipe Thrust Stopper
Category:	Design
Type of Defect:	Cracks occurred at the toe of the brackets
Cause:	These brackets were originally designed with radii and 10-15 mm toes. The stoppers were not aligned with underdeck longitudinals and were instead supported by transverse stiffeners. Fracture due to stress concentration. As stoppers were not aligned directly with longitudinals, the brackets terminated on soft plate, leading to a stress concentration. Analysis carried out after the incident indicated that the underdeck structure was sufficient for the loads induced by the pipes, however the toes of the brackets did increase the stress in the deck. This stress concentration quickly led to cracks in an already highly stressed deck
Corrective Action:	The vessel in service was retrofitted with additional underdeck support and doublers were added in way of the toes. The doubler pads reduced the stress concentration in the deck sufficiently to eliminate cracking in this area. For the follow ships in this series, it was recommended that the stoppers be aligned with longitudinals or integral doubler plates

Crack at the pipe stopper connection to main deck toe

Recommendation:	Align with underdeck structure and fit well rounded brackets with soft toes, aligned with longitudinal below, with maximum toe height 10-15mm at connection of support to deck. If necessary additional under deck supports to be made to align with brackets

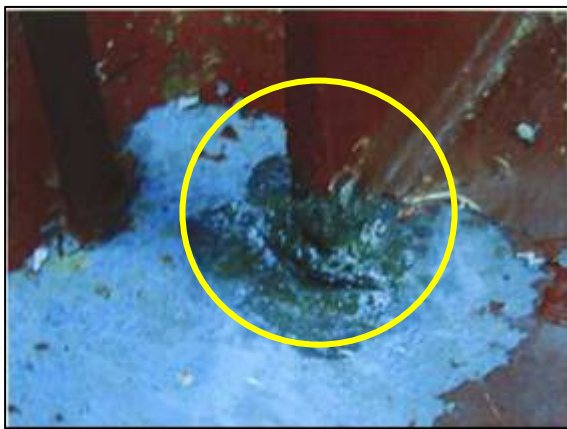
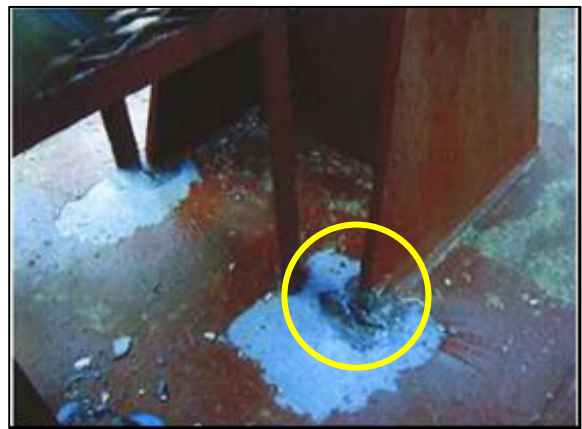
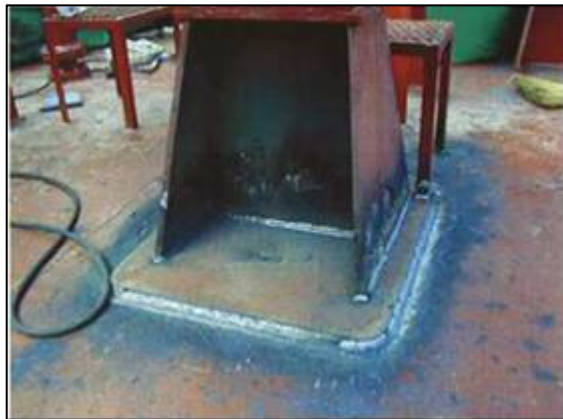
Location:	Main deck cargo area (0,4L)
Category:	Design
Type of Defect:	Cracks developed on upper deck around bracket toes of pipe line stanchions
Cause:	This was a fatigue crack
Corrective Action:	A doubling plate was provided to reduce the stress induced by longitudinal moment. Soft toe type is also preferable way to reduce the stress level
Recommendation:	The support structure should align with the underdeck structure and fit well rounded brackets with soft toes, aligned with longitudinal below, with maximum toe height 10-15mm at connection of support to deck. If necessary additional under deck supports to be made to align with brackets

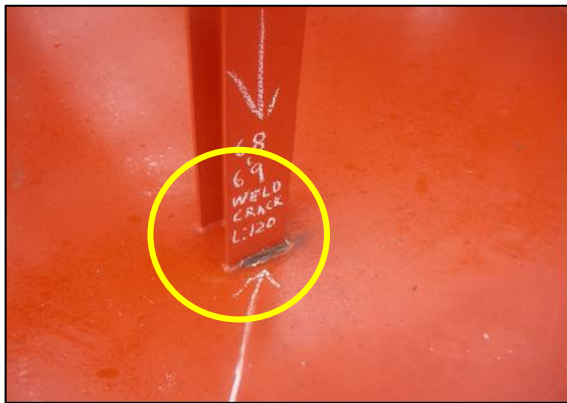
Location:	Main deck cargo area (0,4L)
Category:	Design
Type of Defect:	Cracking of the upper deck plating at the support connection to the deck plating
Corrective Action:	Soft brackets to be fitted on either side of the supports and these to be in alignment with the underdeck structure i.e. the brackets to be fitted to reduce the stress concentration where the pipe support on the top side of the deck crosses the longitudinal on the underside of the deck
Recommendation:	Supports should always be in alignment with underdeck structure and if possible the supports to be of a flexible design. The solution shown is one option and so far has worked. As a general comment: pipe support arrangements should be flexible and this should include the correct securing of pipes to the supports to allow the flexible couplings to work

Crack i.w.o fillet welding i.w.o pipe support connection to upper deck.

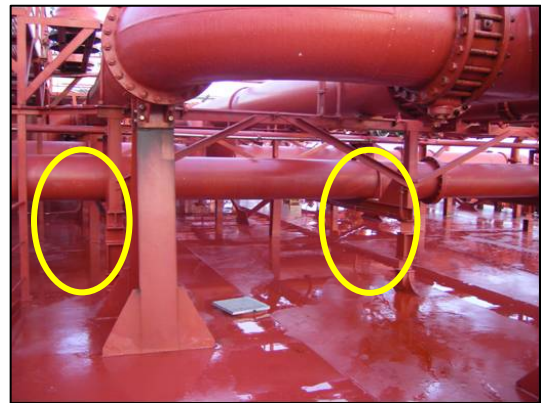
Many typical outfit item connections to upper deck – one of which is modified pipe support.

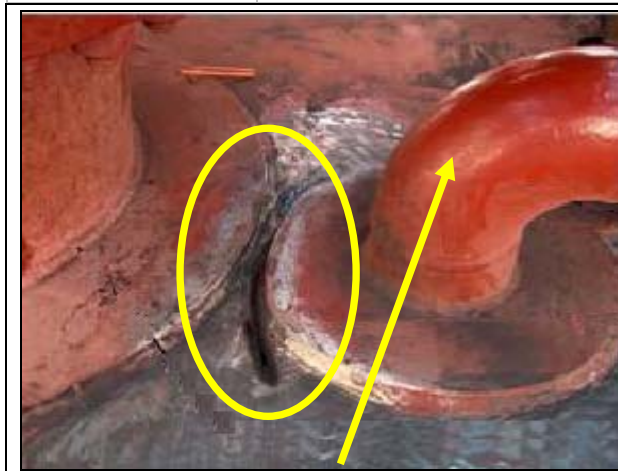
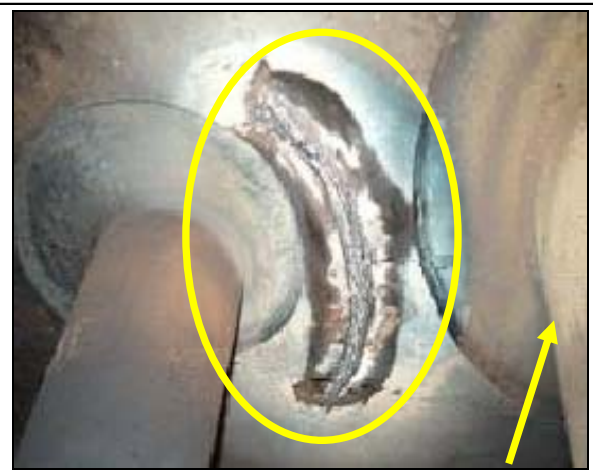
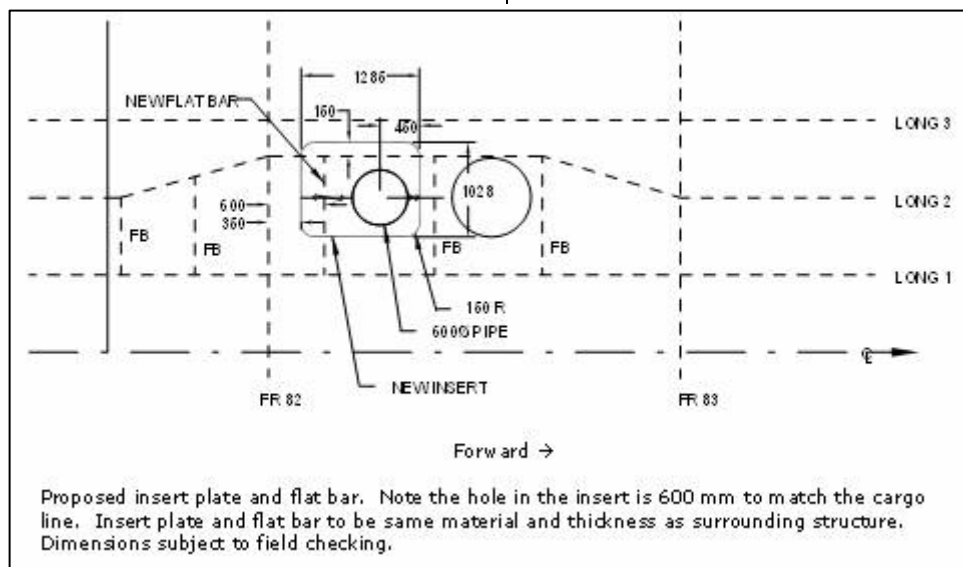
10 MARPOL line deck crack

Location:	Main deck cargo area (0,4L)
Category:	Design
Type of Defect:	Cracking on MARPOL line deck penetration
Cause:	Most likely the result of deck penetrations placed closely, together with pipe movement. There are two large (855 mm diameter for 600 mm pipe) penetrations in line with each other, with a small (315 mm diameter for 150 mm pipe) penetration in close proximity
Corrective Action:	<p>Considered long term repair possibilities include:</p> <ul style="list-style-type: none"> Relocate the MARPOL line penetration through the upper deck aft by 1-2 meters Insert the upper deck with similar thickness and grade of plating Add a transverse stiffener approx. 600 mm aft of the center of the #3 drop line, spanning the upper deck longitudinals at 840 and 1680 mm off centerline
Recommendation:	Allow sufficient space between penetrations. Doublers should be avoided, especially when the deck is made of Higher Tensile Steel

Marpol line, 150mm

Cargo line 600mm

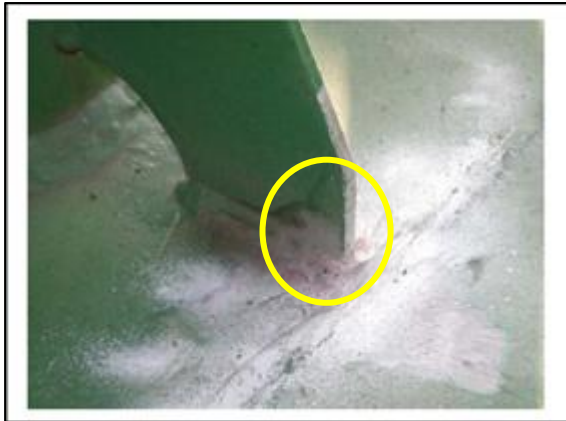
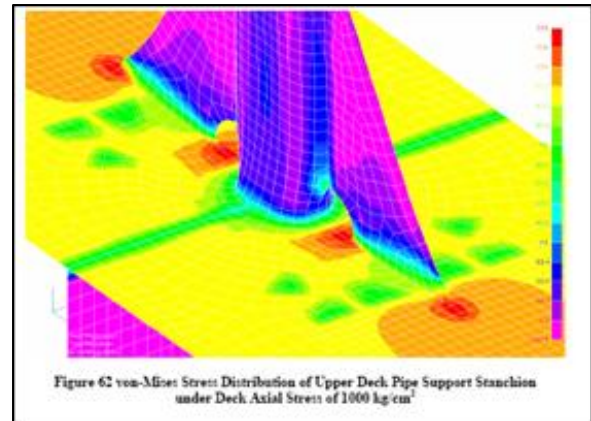
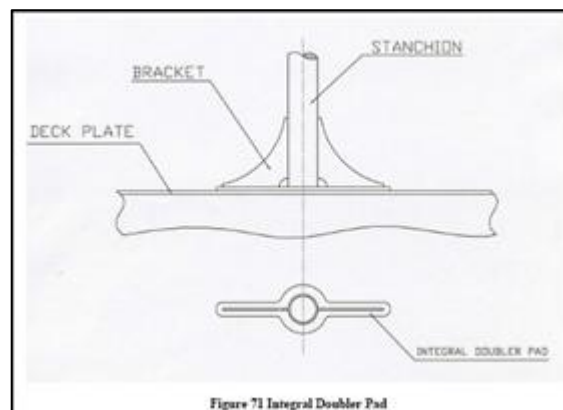
11 Pipe support

Location:	Main deck cargo area (0,4L)
Category:	Design / Construction & Installation
Type of Defect:	Fracture
Cause:	Excessive stress at the bracket toes. The design of the pipe supports was fairly well developed. The cargo pipes were fitted with expansion joints spaced approximately 20 meters. Furthermore, the support stanchions were fitted with brackets in the longitudinal direction and both the stanchions and brackets were aligned with underdeck longitudinals. The cargo pipes were attached using U-bolts, intended to permit deflection of the pipes relative to the hull. The depth of bracket toes on this vessel ranged from 35-80 mm. It is unclear whether all U-bolts were installed with sufficient clearance to permit longitudinal deflection. The problem was most severe near the Midship area where the relative displacement between the hull and cargo pipes is most extreme
Corrective Action:	For the vessels in operation the brackets were modified to provide a gradual radius and a toe of 10-15 mm. The brackets were also fitted with doublers to further reduce the stress concentration in the deck

Recommendation:	Expansion couplings to be provided where necessary. Care should be taken to ensure the "u" bolts are fitted to allow one end of each pipe length to be flexible. The doubler should only be fitted below the tubular pipe support, not below the new brackets. The support structure should preferably be made with open sections making alignment with under deck structure easier. Align with underdeck structure and fit well rounded brackets with soft toes, aligned with longitudinals below, with maximum toe height 10-15mm at connection of support to deck. If necessary additional under deck supports to be made to align with brackets

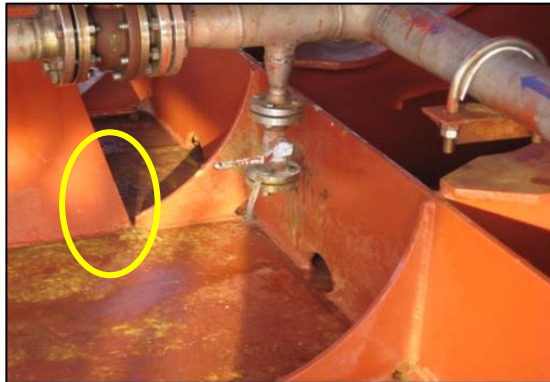
Location:	Main deck cargo area (0,4L)
Category:	Design / Construction & Installation
Type of Defect:	Upper deck plating cracks at the toes of miscellaneous brackets on the upper deck
Cause:	Excessive toe height. Bracket toes need only be a sufficient height to facilitate the bracket return welding
Corrective Action:	The upper deck to be inspected and if paint disturbance is noted in way of bracket toes etc any attached scale to be removed and the deck plating NDT tested. If deck plate cracks are found this will require local inserts. The shape of brackets with excessive toe “nose” heights should be altered to reduce the height of the bracket “nose”
Recommendation:	Bracket toe height to be as small as possible (10 – 15 mm). Connecting the bracket and the pump foundation by a common stiffener type bracket should be considered when as closely fitted as in this case. Bracket on the pump foundation should also be considered

Deck machinery coaming bracket erroneously trimmed hence creating excessive toe height. Crack in deck plate resulted

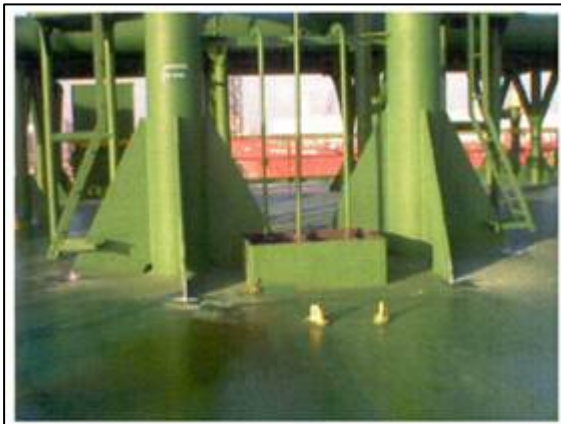
Location:	Main deck cargo area (0,4L)
Category:	Construction & Installation
Type of Defect:	Fracture
Cause:	Misalignment
Corrective Action:	For this particular vessel the brackets were close enough to additional above deck structure that they were fitted with a bracket above deck that linked to the adjacent riser
Recommendation:	Align with the underdeck structure

Figure 34 Deck Cracks IWO Bracket Toes of Vent Riser Pipe Support

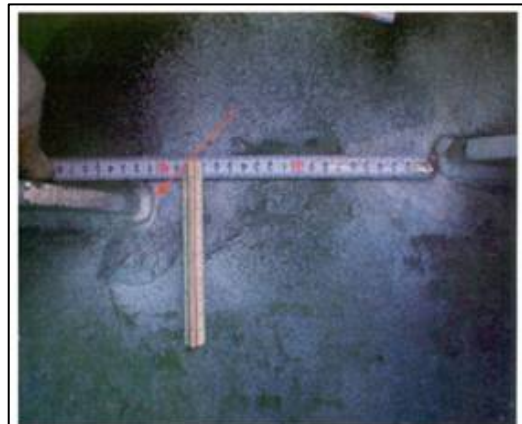
Figure 35 Misalignment Brackets of Vent Riser Pipe Support

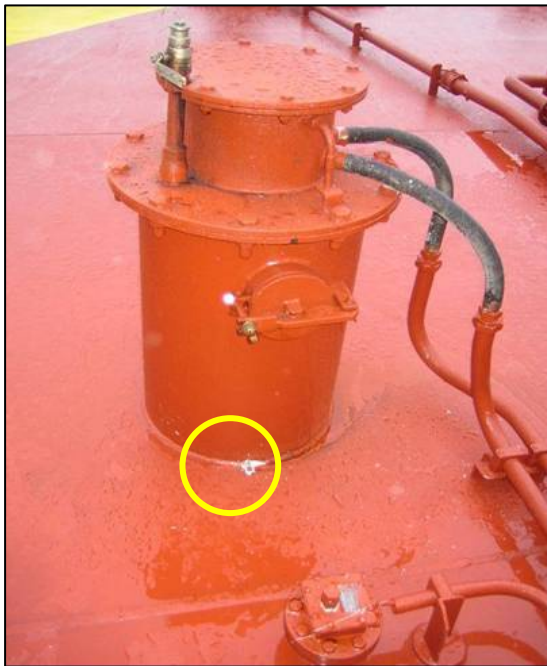
Location:	Main deck cargo area (0,4L)
Category:	Design / Construction & Installation
Type of Defect:	Cracking of the upper deck plating at the edges of the deck openings
Corrective Action:	Penetration extended through deck plating or ensure welding is well clear of deck opening. Ensure that possible cracks are removed by the grinding; in case of larger cracks, insert to be fitted
Recommendation:	Wherever possible the fittings should penetrate through the deck plating and the penetration piece full penetration welded to the deck above and under the deck. If the fitting stops at the deck level the deck opening plate edges to be well clear of the fitting to facilitate good full penetration welding detail. Such openings to be machine cut and smooth i.e. no notches

Radar contents gauge pedestal. Note paint disturbance at pedestal connection to the upper deck.

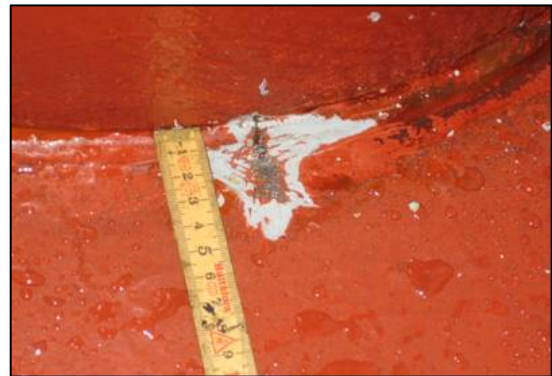
Close-up showing crack in deck plating

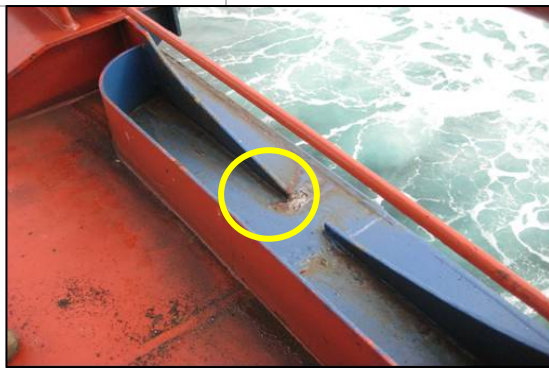
Location:	Main deck cargo area (0,4L)
Category:	Design / Construction & Installation
Type of Defect:	Cracking of the upper deck plating in way of the ends of expansion gaps in the gutter bar or in way of expansion swedges or knuckles
Cause:	Toe nose too high
Corrective Action:	Crop and renewal of deck plating. If there are expansions arrangements along the length of the gutter (P&S) the deck plating at the toes of the gaps in the gutter bar or in way of swedges / knuckles to be inspected and dealt with as necessary
Recommendation:	There are numerous expansion arrangements for ship side gutter bars i.e. gaps, knuckles, swedges etc. They should generally be avoided, and extension of sheer strake 300mm above the upper deck is the most preferred option. Mooring fairleads and other outfit items connected to the upper edge of ship side gutter bars in general results in gutter bar cracks. Such cracks if left unattended will eventually propagate downwards and into the deck plating. If ship side gutter bars are fitted these should be free of any connections and the upper edge and treated the same as the upper edge of the sheer strake, including 3mm radius corners

Paint disturbance noted in way of gutter bar taper toe

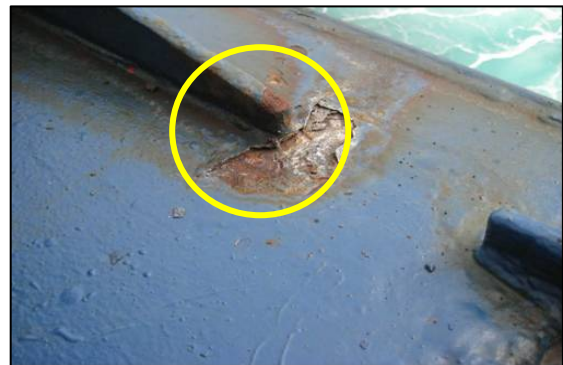
Upper deck plate crack in way of gutter bar taper toe

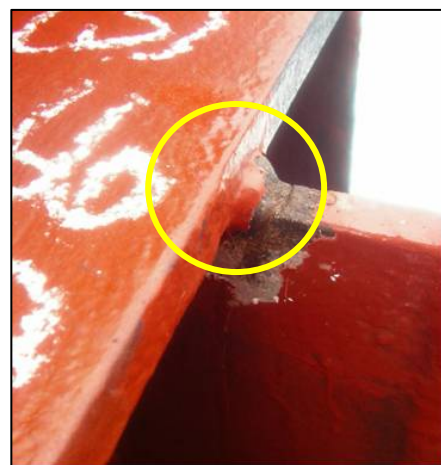
Gutter bar cracked in way of connection to mooring fairlead.

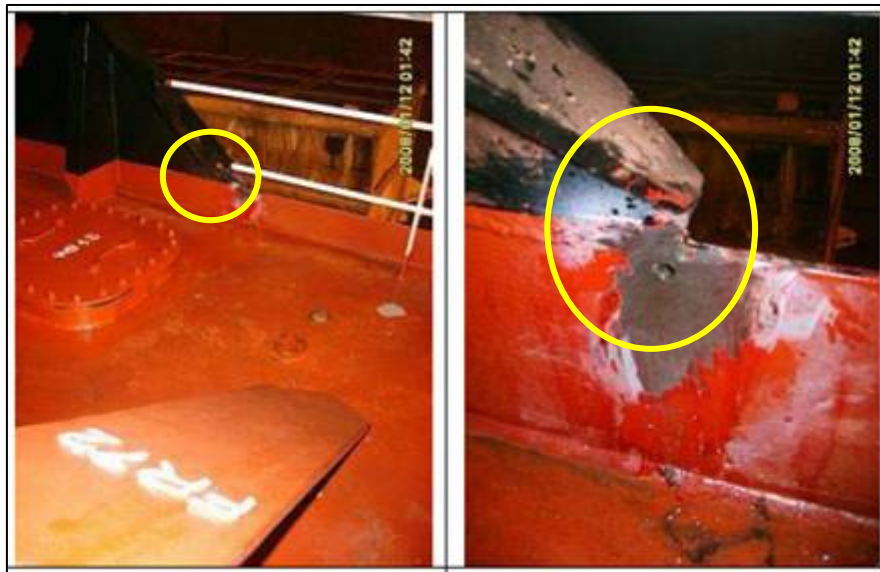
Location:	Main deck cargo area (0,4L), manifold
Category:	Design
Type of Defect:	Fracture
Cause:	Flexible hose resting outfitting support consists of a structure with a plate welded directly on the sheer strake/gutter bar. Outfitting support plate end is tapered with a bracket. Fatigue crack developed at the end of the bracket through the sheer strake. The straight edge bracket with edge face flat has resulted in increased stress concentration at the connection to the ship side gutter bar. Also excessive toe height
Corrective Action:	Repair solution applied was to increase bracket size. Further improvement could be to soften the bracket design, making it well rounded. The toe/bracket should be full pen welded over 200-500 mm and the toe ground flush with the sheer strake/gutter bar. Also the flange should be reduced, one sided and well tapered
Recommendation:	Generally this kind of design must be avoided. At the design stage prefer piping type resting support not connected to sheer strake. If the bracket is required due to the arrangement the bracket is to be elliptical in shape, and utilize higher strength steel, full penetration welding of bracket to the gutter bar and minimum toe height. The size and thickness of the bracket to be such that no edge stiffener is required

Crack developed through the sheerstrake at the manifold resting support.

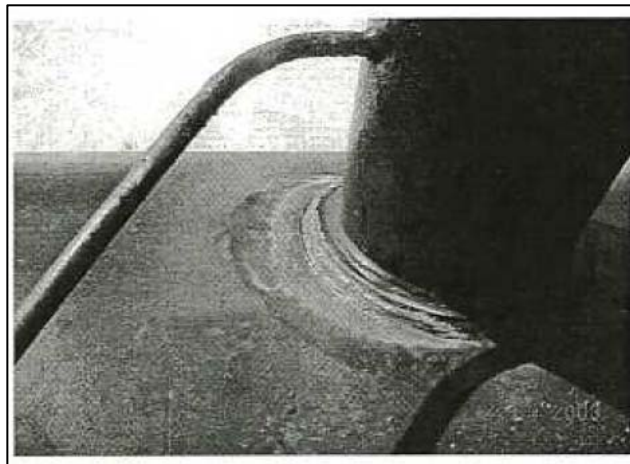
Location:	Main deck cargo area (0,4L), manifold
Category:	Design
Type of Defect:	A crack developed on upper deck (gunwale plate) around the fillet welding of doubling plate for the connection to stanchion
Cause:	Slight undercut was found at the cracked area and this area has high stress by longitudinal moment
Recommendation:	The fillet welding should be grinded smoothly to eliminate the possible undercuts and reduce stress concentration. Additional soft bracket fitted in line with under deck structure should also be considered. Such bracket should be fitted without doubler. Alternatively the hose rail should be considered cut in several lengths, this will make it more flexible and hence reduce the likelihood of deck cracks where the hose rail supports connect to the upper deck

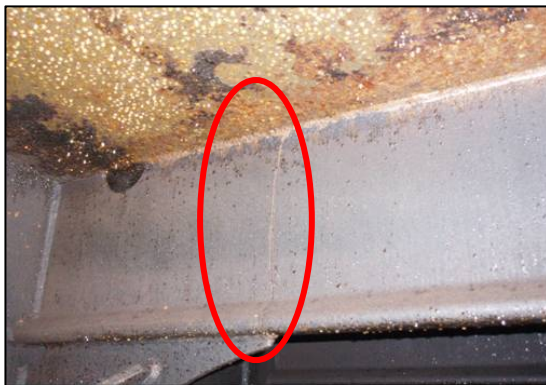
18 Local underdeck structure in way of deck crane pedestal (a)

Location:	Main deck cargo area (0,4L)
Category:	Design / Construction & Installation
Type of Defect:	Fracture
Cause:	The local underdeck structure fitted in way of hose handling deck crane pedestal(s) is usually but not always local longitudinal girders fitted between two underdeck transverse web frames. A bracket arrangement is normally provided at the ends of these partial girders. If the bracket shape is not correct or the bracket toe heights are excessive cracks in the underdeck longitudinals are likely and such cracks may propagate into the upper deck plating
Corrective Action:	This underdeck structure should be specifically inspected during routine tank inspections and any defects found to be dealt with as necessary, with a view to integrating the increased local structure more gradually into the normal underdeck structure, hence reducing the stress concentration at the ends of the partial girders. This could take the form of fitting new brackets or modifying the toe design of existing brackets

Crack in way of local underdeck girder end bracket toe

Recommendation:	Locate the deck cranes in way of longitudinal / transverse bulkhead intersections, pass the deck crane pedestal through the deck, and integrate the pedestal into the bulkhead structure

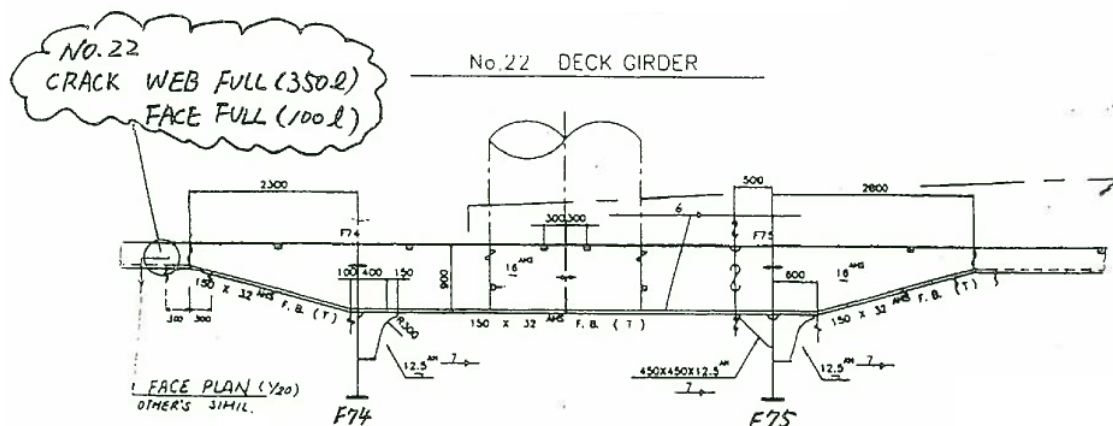
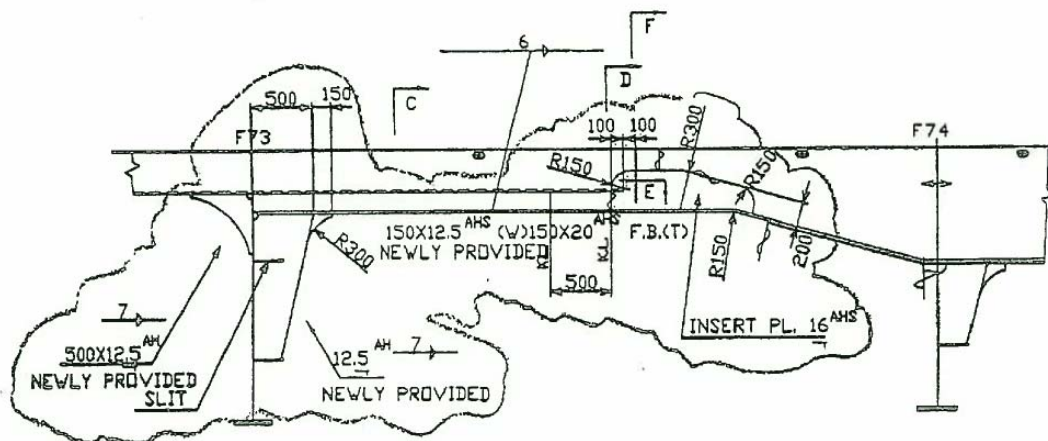
AFTER REINFORCEMENT

Location:	Main deck cargo area (0,4L)
Category:	Design
Type of Defect:	Fracture of the deck structure under hose handling crane including local reinforcements. Fractures at the end of partial girders propagating into underdeck longitudinals and deck plating
Cause:	Stress concentration. The cracks are caused by longitudinal hull girder bending stresses and stress concentrations due to the change of design
Corrective Action:	The welding connections of both of web plate and face plate between the partial deck girders and ordinary deck longitudinals were arranged in the same line. The welding connections of web plate and face plate were re arranged 300mm apart and the reduction of the scantling between the partial girders and the ordinary deck longitudinals was made smoother than the original design by increasing the scantling of ordinary deck longitudinals adjacent to the partial girders in order to make the transference of stress from the partial girders to the ordinary longitudinals smoother

Recommendation:	Locate the deck cranes in way of longitudinal / transverse bulkhead intersections, pass the deck crane pedestal through the deck, and integrate the pedestal into the bulkhead structure. Ensure smooth transitions with small stress concentrations in the connections between the longitudinals and the girders

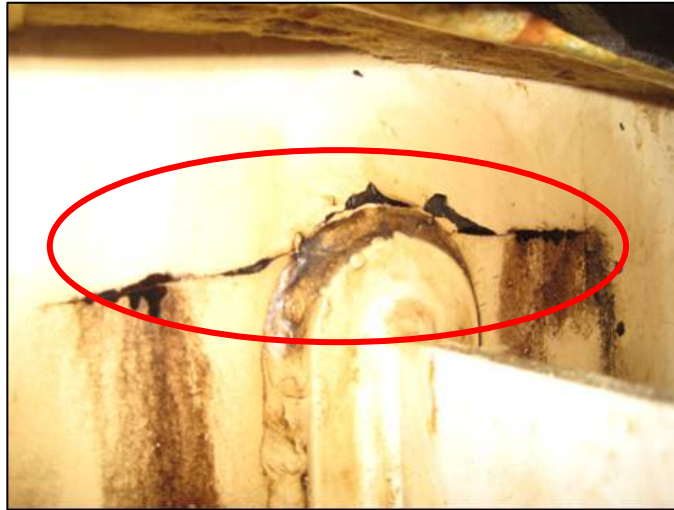
20 Ladder connection to oil tank

Location:	Engine room oil tank
Category:	Design
Type of Defect:	Crack in engine room oil tank bulkhead
Cause:	Vibration
Recommendation:	The ladder lug should be located in way of internal stiffening structure. A bolted connection between the lug and ladder would be preferable

**Crack in way of ladder lug doubler – connected to unsupported plate of oil tank.
Vibration induced crack**

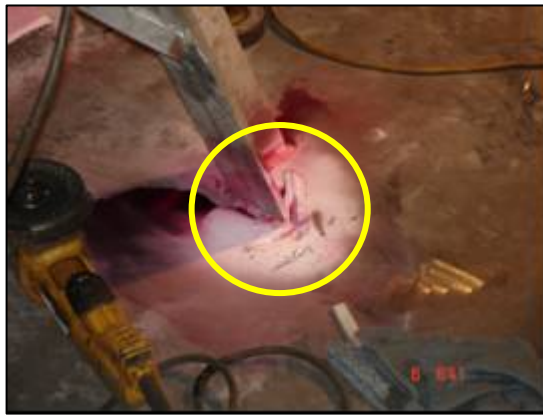
Location:	Cargo area, tank bottom
Category:	Design / Construction & Installation
Type of Defect:	Crack develop at the ladder connection to tank bottom
Cause:	No support
Recommendation:	Ladder should be welded on a doubling plate with backing structure below deck if the preferred bolted structure is not used

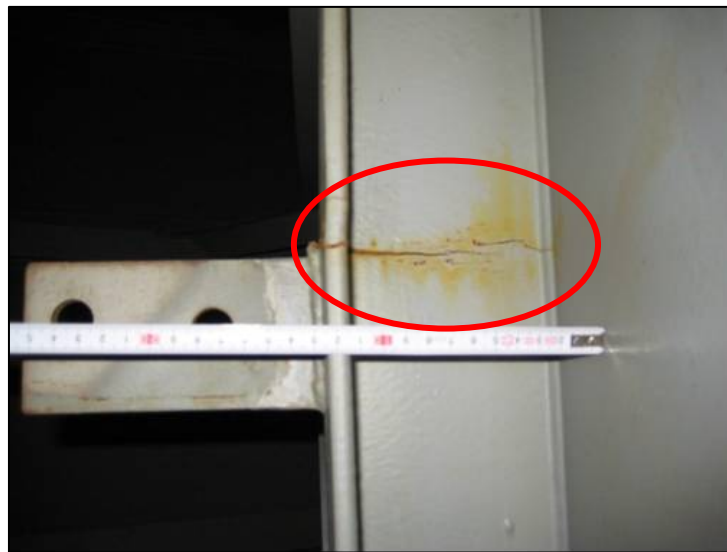
22 Staging lug left from newbuilding stage

Location:	Fresh water tank in engine room
Category:	Design / Construction & Installation
Type of Defect:	Crack in way of the fresh water tank stiffener that propagated into the bulkhead plating resulting in a leak
Cause:	Vibration induced crack
Recommendation:	Such lugs should have a “softer” shape and although not structural the welding condition should be improved by a smooth and correct profile. Removing the lug should also be considered, especially at locations where excessive vibration is expected

Non structural staging lug in fresh water tank. Abrupt connection and poor return weld detail resulted in the crack shown – vibration induced crack

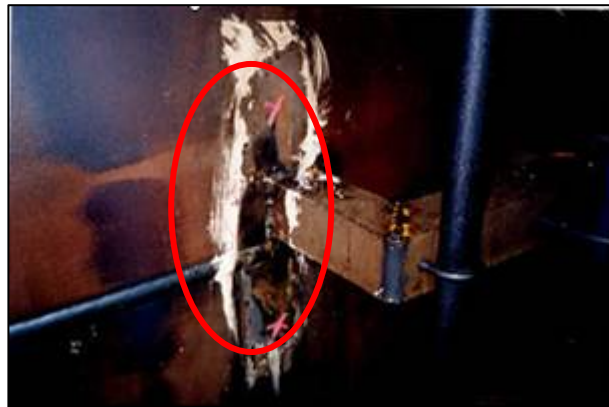
Location:	Cargo area (inside tank)
Category:	Design
Type of Defect:	The transverse BHD had a crack around fillet welding to pipe support.
Cause:	Doubling plate had not been provided at the connection. The cause of damage is vibration
Recommendation:	A doubling plate should be provided and number of supports increased. Stiffeners to be considered, especially at locations where excessive vibration is expected

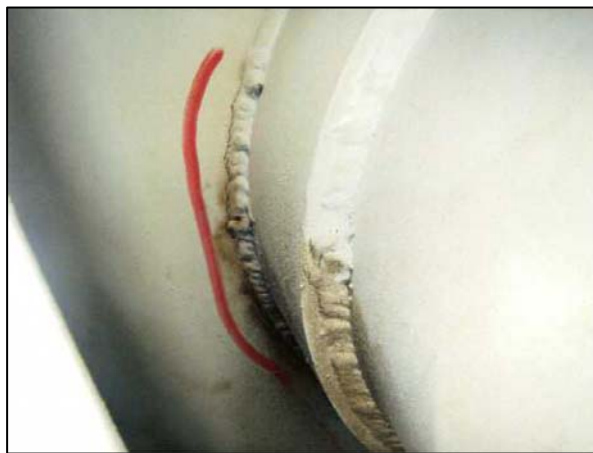
25 Pipe penetration at transverse bulkhead

Location:	Cargo area (aft)
Category:	Design
Type of Defect:	Crack developed along with fillet welding of pipe penetration at a bulkhead.
Cause:	Vibration
Corrective Action:	To avoid vibration damages, additional stiffener on BHD plates and additional pipe supports were recommended. Making pipe flexible (couplings)
Recommendation:	Routine management of the pipe supporting “u” bolts and flexible couplings should be carried out i.e. one end fixed and one end flexible. “u” bolts not to be over tightened

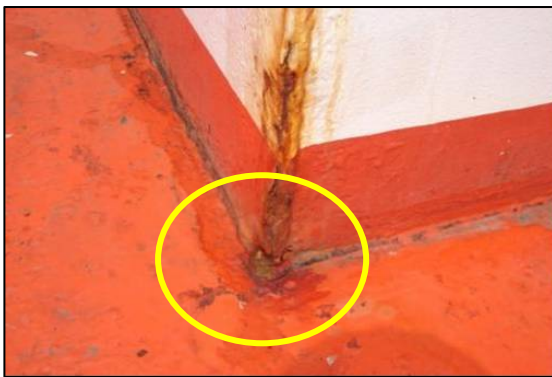
26 Lower corners of deckhouses on the upper deck

Location:	Main deck cargo area (0,4L)
Category:	Design
Type of Defect:	Cracking in way of the fillet welds at the corners of the deckhouse where the deckhouse connects to the upper deck and such cracks propagating into the upper deck plating
Corrective Action:	The corner fillet weld to be gouged out and the location MPI tested. The fillet weld at the corners to be re-welded or if cracks are found in the upper deck plating the deck to be inserted the deck. Brackets fitted at the corners
Recommendation:	Deck house sides should be aligned with under deck structures and brackets to be fitted at the corners of deckhouses / accommodation blocks etc.

Deckhouse corner at connection to upper deck. Note crack in way of fillet welding and local scale

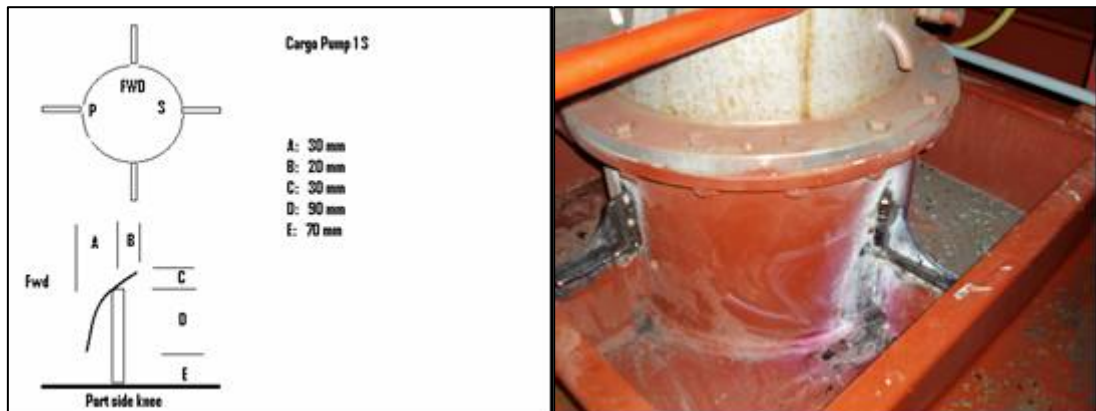
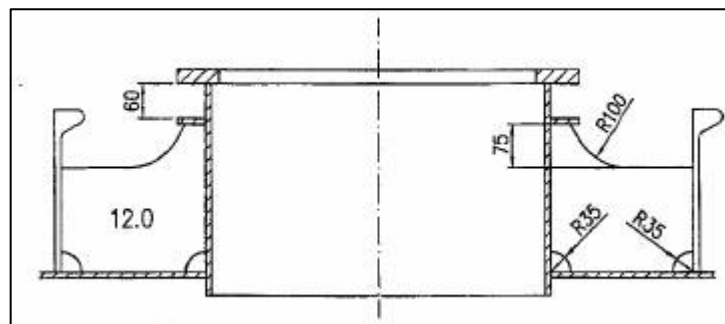
Location:	Cargo area
Category:	Design
Type of Defect:	Fracture
Cause:	Stiffener fitted on submerged pump trunk created hard point (high distance between stiffener toe and trunk flange). Cracks developed through the trunk due to vibration of the trunk and the pump
Recommendation:	Stiffener to be fitted with a soft toe bracket with bracket toe connected to trunk flange
