Not Repeating the Past - A Case Study of Fatigue Fracture in Midship Cargo Tanks

Ryan Salamati
ABS, Hamburg Germany

Dr. Michael B. Kennedy
Hellespont Ship Management GmbH & Co. KG, Hamburg Germany

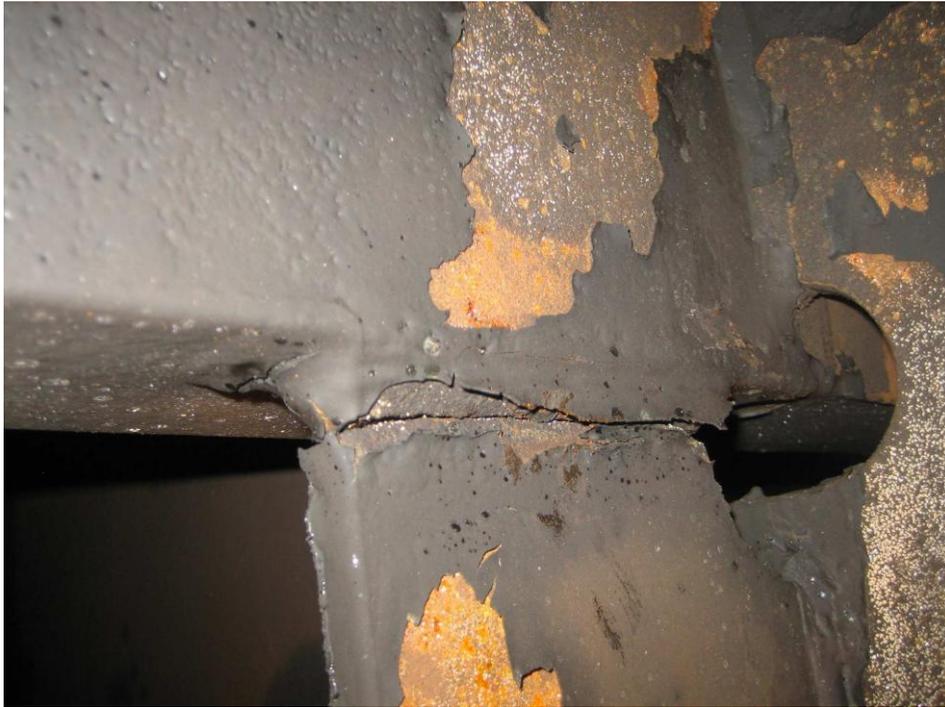
The port side rafting identified a fracture on the top side connecting weld of the flat bar vertical stiffener in way of the under deck longitudinal. This finding prompted the surveyors to expand the scope of close-up surveys while rafting in midship port and starboard cargo tanks.

Fig.1 Discovery - The Fracture When Cleaned
20 identical cracks were found in 4Port and 21 were found in 4Stbd.

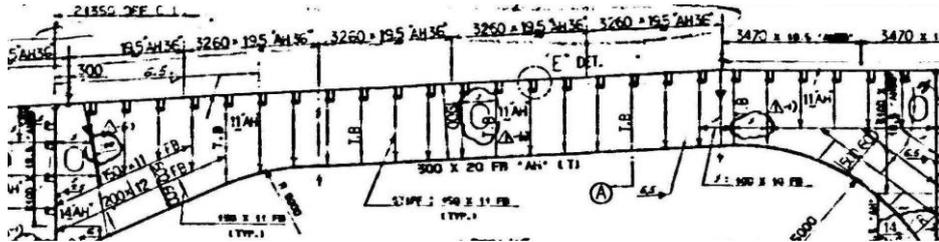
Fig.3 Longitudinal on the Web

The following sections of the midship drawings (figures 2, 3, and 4) show the structure where the fracture was found. It is in "Detail E" which shows how the stiffeners pass through slots in the web frame.

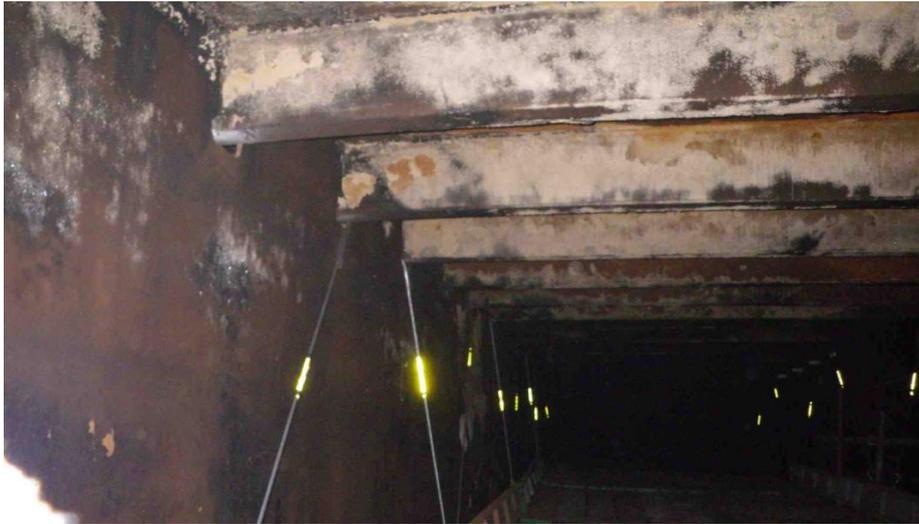
Fig.5 Opposite Side of Web - Staging Wire Shown

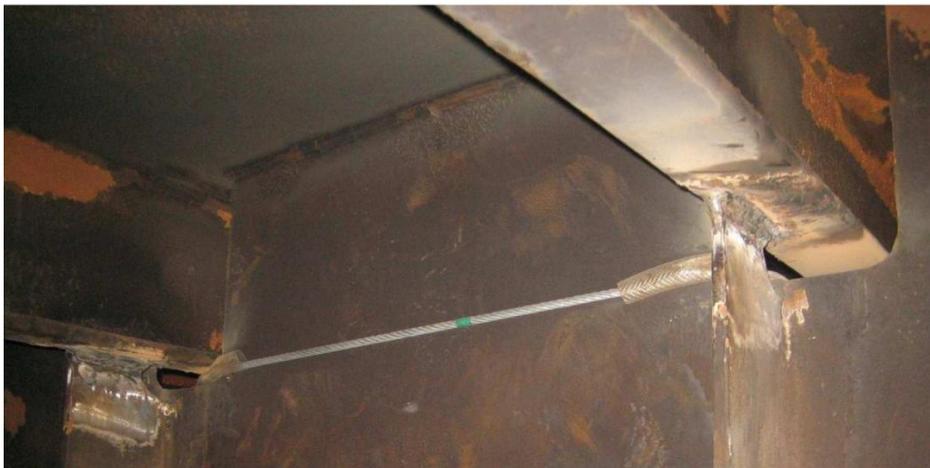
Fig.6 Vertical Stiffeners Connecting Longitudinals to Web (after weld repair)

Web frame No. 78, weld gouged out and built up/re-welded, on top side weld of the flat bar vertical

stiffener in way of the under deck longitudinal at No. 23 and 24.

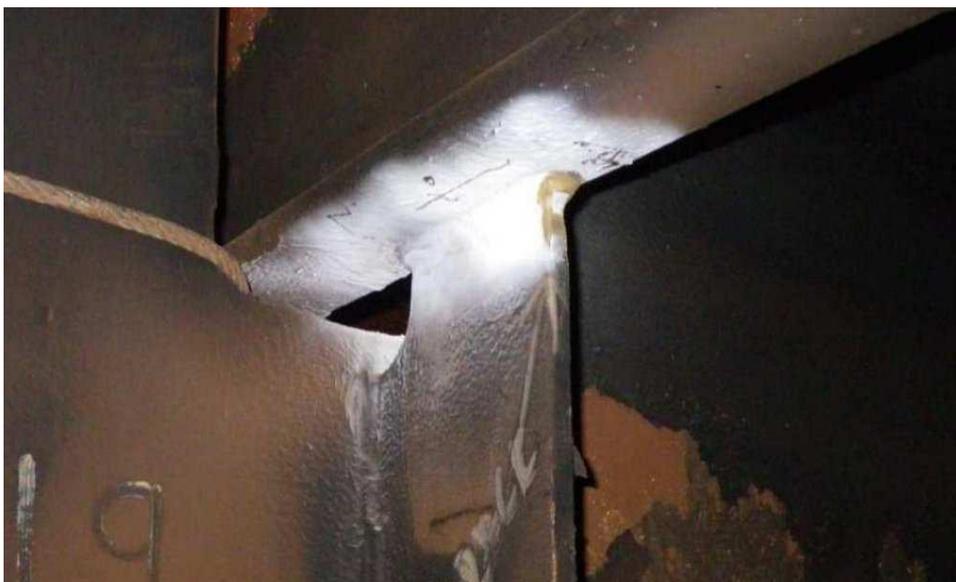
Fig.7 A Suspect Connection - The Weld

The vertical stiffener was made of mild steel and it was fillet welded to the deck longitudinal. The required fillet weld and the leg length are unchanged between CSR and pre-CSR. The type of connection in the original design is poor ("hard"). CSR should help to eliminate the stress concentration via fatigue consideration of the connection type.

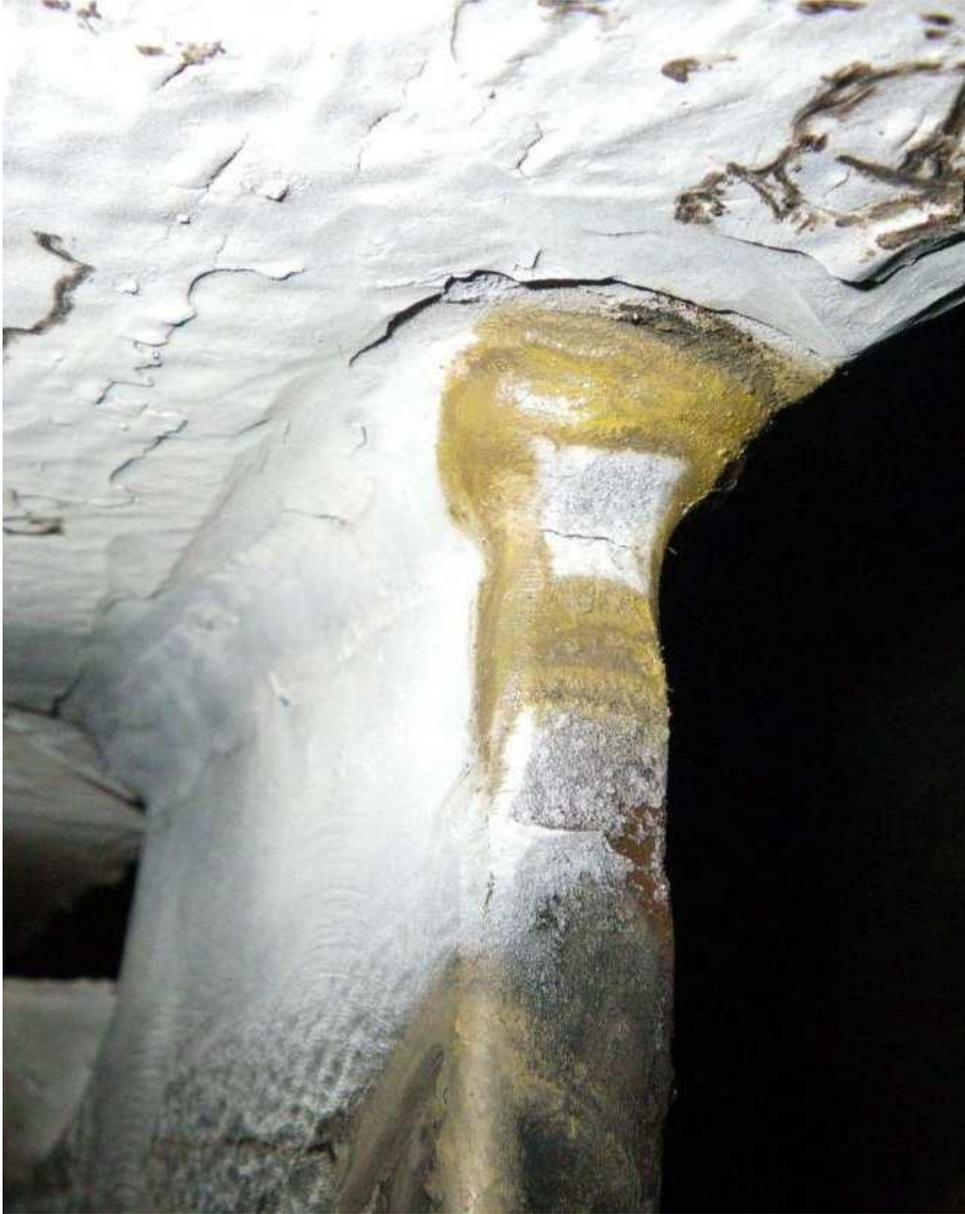
Fig.8 The Fracture - MPI Crack in the Weld Parallel to Deck

4 Port and 4 Stbd are the tanks located near midships where the hull girder bending moment stresses are at their maximums. It is also the location where the sea forces cause the largest wave-induced hull girder bending moment dynamic stresses to cycle. MPI examination showed the same type of crack in all the above mentioned locations.

A contributing factor could be the extensive use of high tensile steel in the midship section. Either AH32 or AH36 (no DH) steel was used in midship section. Deck longitudinal stiffeners were constructed using AH36 steel. Corrosion wastage was well within acceptable class limits. The ABS Rules at the time did not give full credit for the high tensile strength steel, as a Q factor of 0.78 and 0.72 for H32 and H36 respectively was applied to the hull girder and deck beam required section modulus. However this approach did not explicitly consider or compensate for fatigue "wear" from greater plate deflection amplitude because of the thinner steel. Note that the vertical stiffener was not high tensile although it was fillet welded to the high tensile deck longitudinal.

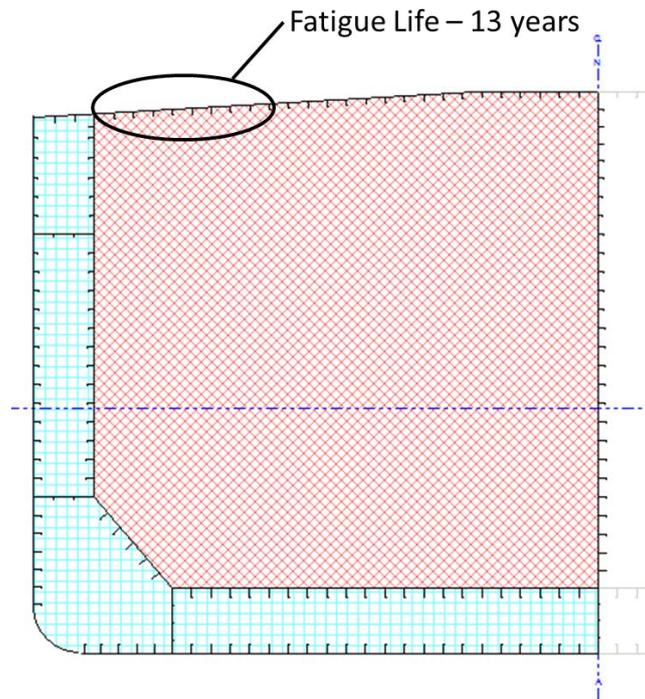
A fatigue analysis was carried out to assess the damaged deck longitudinals in accordance with the CSR criteria. As shown in Figure 9 the fatigue life of the damaged stiffeners was predicted to be 13 years, well below the 25 year minimum requirement.

Fig.9 CSR Fatigue Results
