**EXPERIENCE WITH DOUBLE HULL TANKERS  
AN OWNER'S VIEWPOINT**

**BERGESEN D.Y. ASA**

**TANKER STRUCTURE CO-OPERATIVE FORUM**

**TOKYO, OCTOBER 2000**

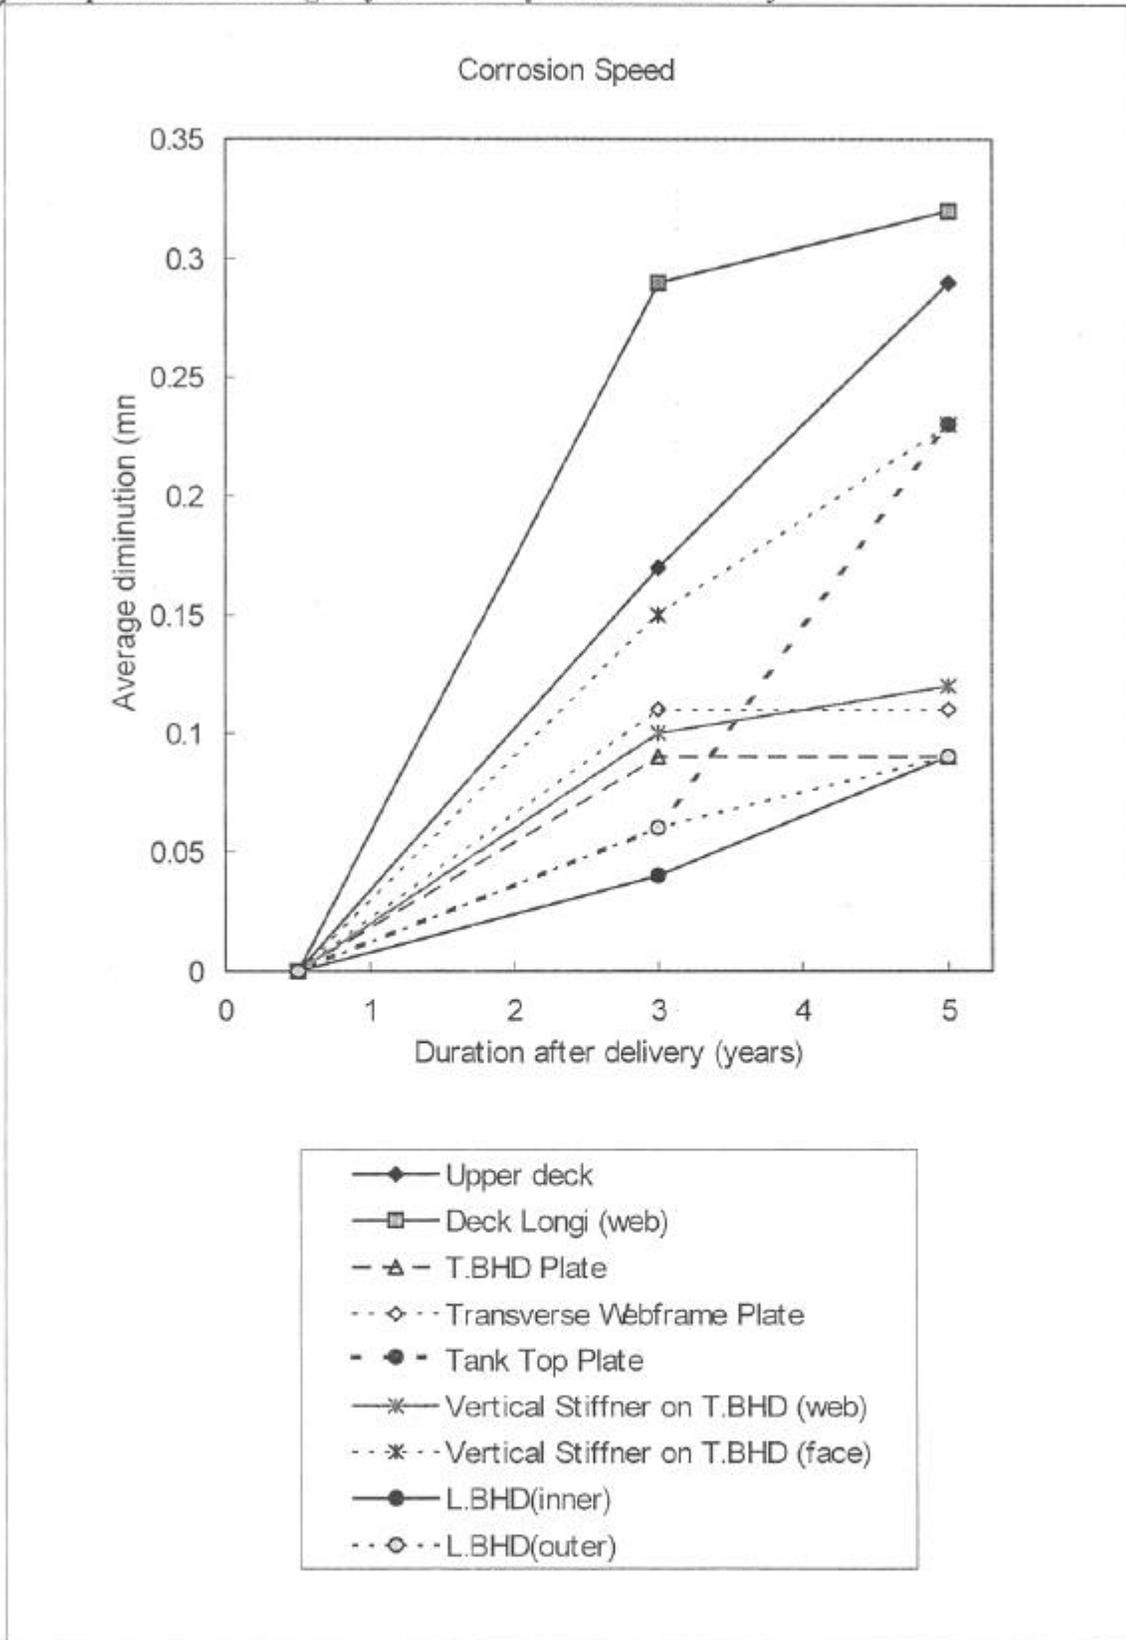
Fig.9. Comparison of wastage 3 years and 5 years after delivery

Photos were taken from the inspections above and are shown on photo no. 1 to no. 18. Table 1 gives a summary of the plate thickness diminution for each cargo tank. Table 2 gives the comparison of thickness diminution between 3 years and 5 years after delivery. The results of the measurements have been shown in Fig. 9. It is worth noticing that the shop-primer used in the cargo tanks for one vessel only delayed the corrosion on the inner bottom by two years. On this vessel the deepest pits were 4-5 mm whilst on the vessels without any primer the pits were up to 7-8 mm deep.

## Comparison of thickness diminution between 3 years and 5 years after delivery.

Table. 2 Comparison of Annual Diminution between 3 years and 5 years after delivery.

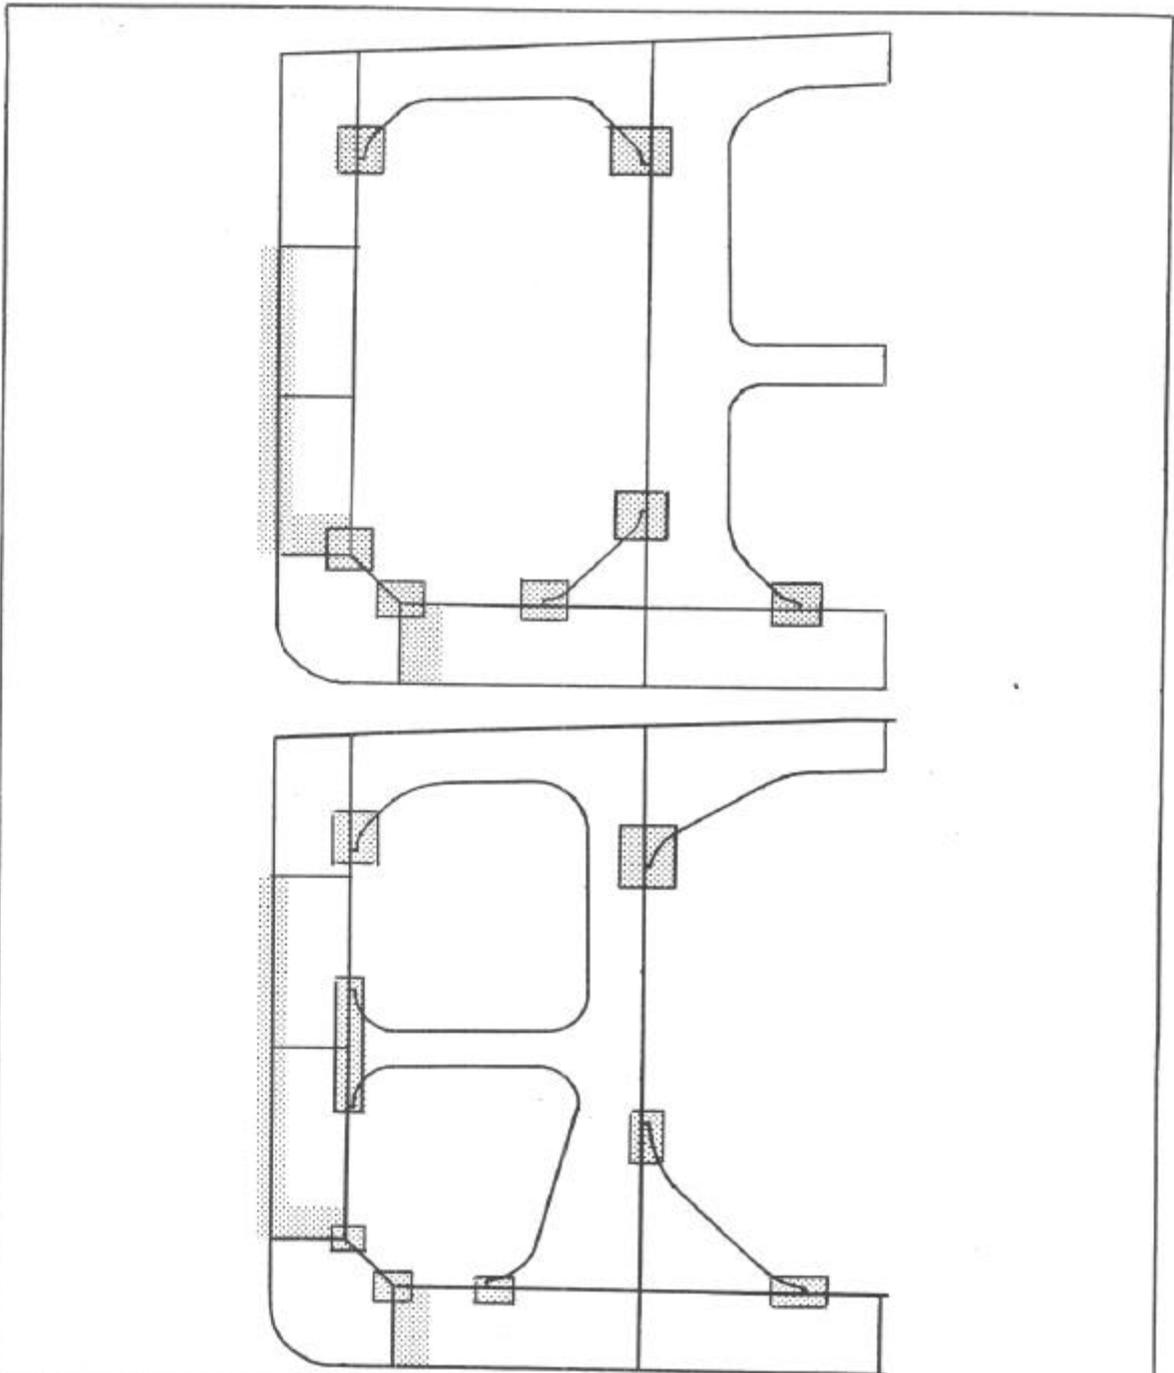
| <b>3.6</b> | SUBJECT: AREAS SUSCEPTIBLE TO STRESS CONCENTRATION AND MISALIGNMENT ON MIDSHIP SECTION OF DOUBLE HULL TANKERS WITH LONGITUDINAL BULKHEADS | <b>3.6</b> |

The so-called “critical areas” are shown by the marked squares in the corners of the vital points on figure 3.6. In the following I would like to compare the different figures in the TSCF

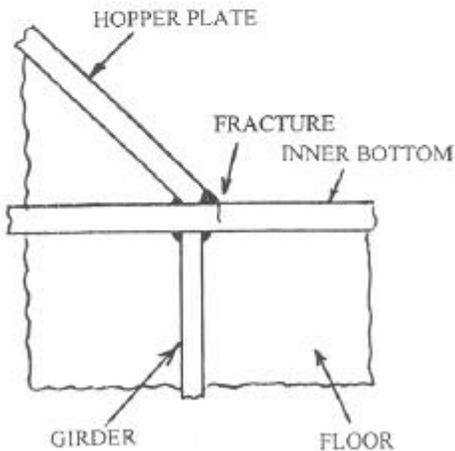
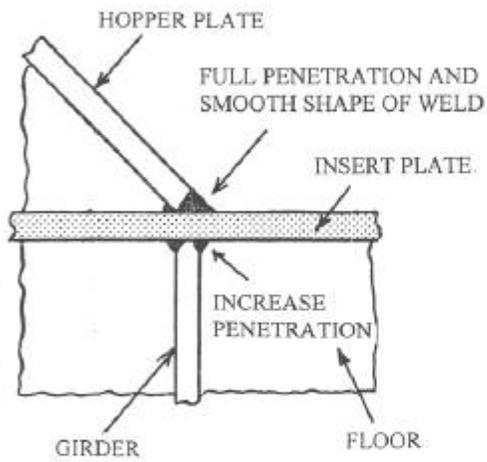
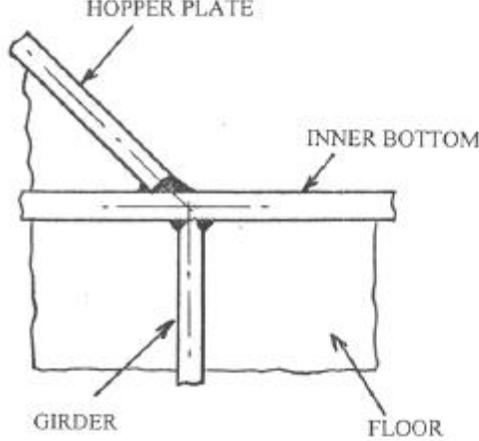
| 1 | SUBJECT: CATALOGUE OF STRUCTURAL DETAILS | 1 |

A school example where high stresses will cause cracks is the juncture of hopper plate to the inner bottom plate as shown in Fig. 1. The cracks shown in the bottom plating and in the floor below will not occur if proper attention is paid to those details as shown on the sketches taken from our VLCCs. Both increased plate thicknesses as well as avoiding the scallops are of importance. This is shown in Fig. 4 of the Manual.

1. Stress concentration at juncture of hopper plate to inner bottom.
2. Insufficient welding connection.
3. Misalignment between hopper plate, inner bottom and girder.

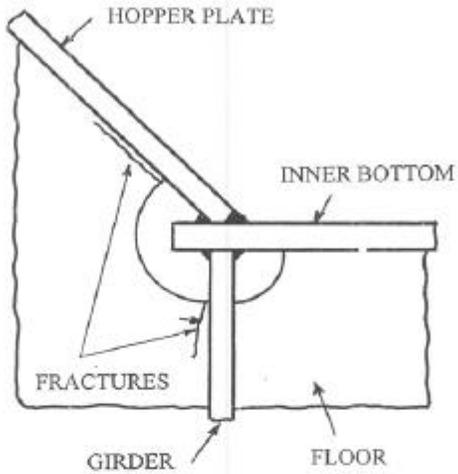
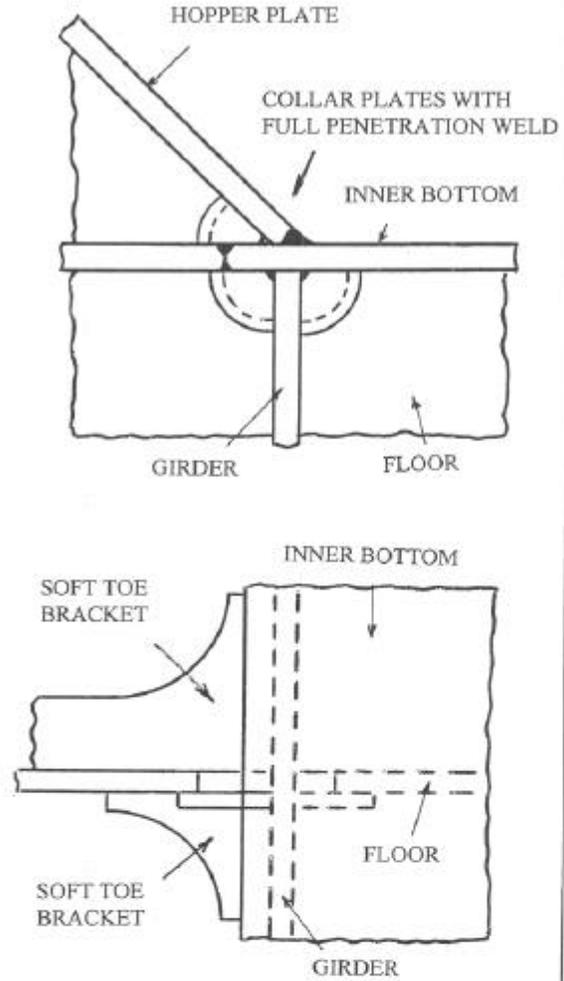
LOCATION : INNER BOTTOM PLATE  
 EXAMPLE : FRACTURE AT CONNECTION OF BILGE  
 NO 1 : HOPPER PLATE AND INNER BOTTOM

1. Stress concentration at the knuckle

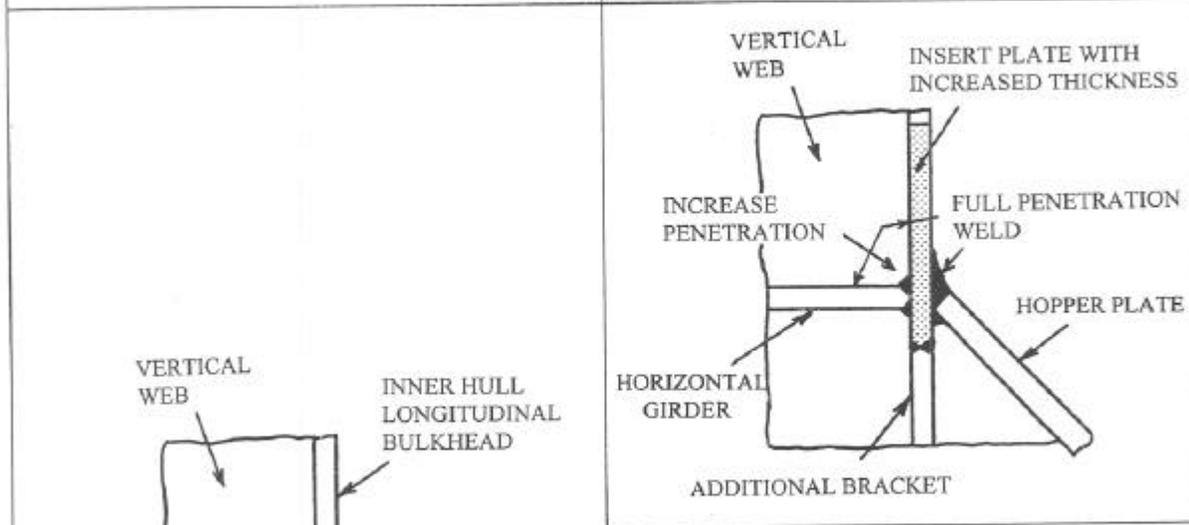
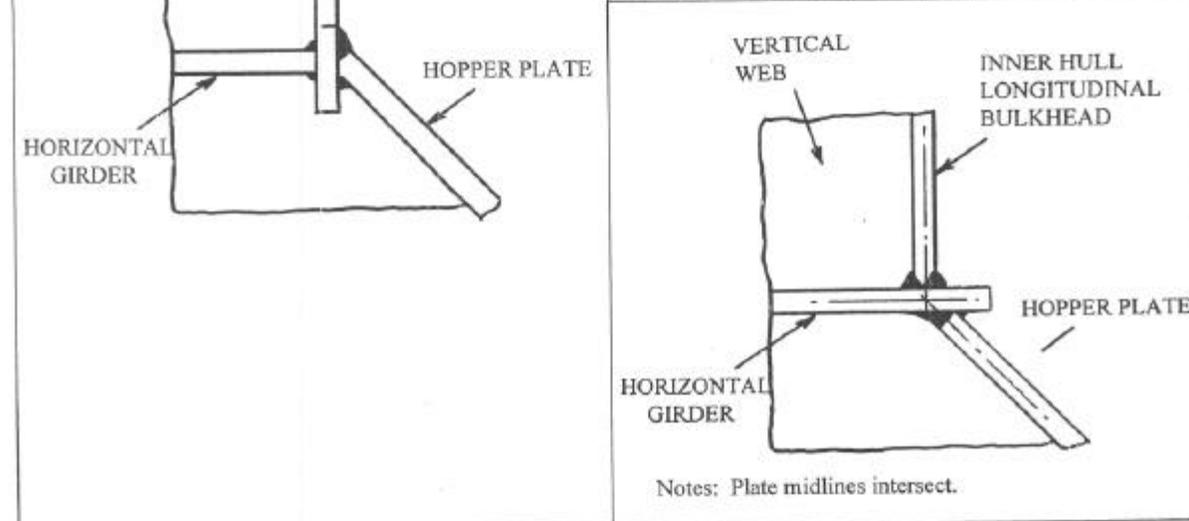
| FIGURE<br>9 | TANKER STRUCTURE CO-OPERATIVE FORUM | FIGURE<br>9 |

Similar defects may be found in the inner hull longitudinal bulkhead where this is connected to the hopper plate. Fig. 9 from the Guidance Manual shows two types in the proposed repair and also a new construction. We have used both types in our newbuildings as previously shown. You may note that the additional bracket which is fitted underneath the inner longitudinal bulkhead can only be done if the hopper plate is not too much inclined. Examples from our two vessels can be shown. It should also be noted that the longitudinals on the inner part of the hopper plate should be fitted with lugs in way of the transverse girder.

1. Stress concentration at junction of hopper plate to outside longitudinal bulkhead.
2. Insufficient welding connection and/or incorrect shape of the weld toe.
3. Misalignment between hopper plate, outside longitudinal bulkhead and side stringer.
