# Fatigue Analysis and Condition Assessment of FPSO Structures

## Abstract

## 4 Repair of Fatigue cracks in side shell longitudinals of an FSO offshore Vietnam

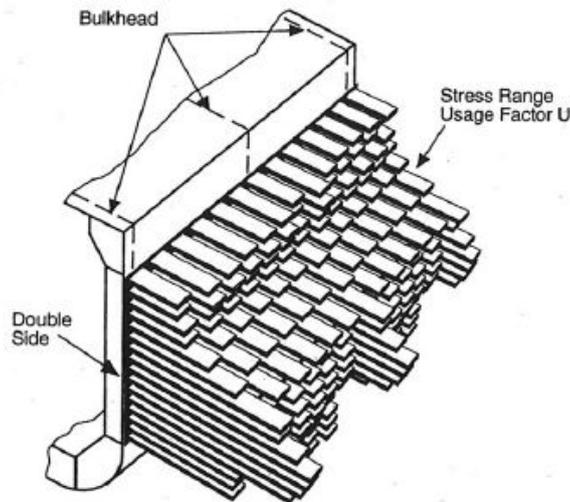
Fig. 5: Usage factors of intersections between side longitudinals and transverses

Fig. 5 shows the distribution of stress range usage factors  $U$  obtained for all intersections in the side area of two adjacent cargo tanks. Peak values can be observed at the bulkheads as well as below the sillwater line. Causative effects are relative deflections of webs and local pressure fluctuation, respectively. This is in agreement with the fatigue failures recorded by Yoneya (Yoneya, 1993). Based on the results, modifications can be defined in certain areas which reduce the local notch effects, for instance, by arranging brackets with soft toes at all critical points (see Sect. 0).

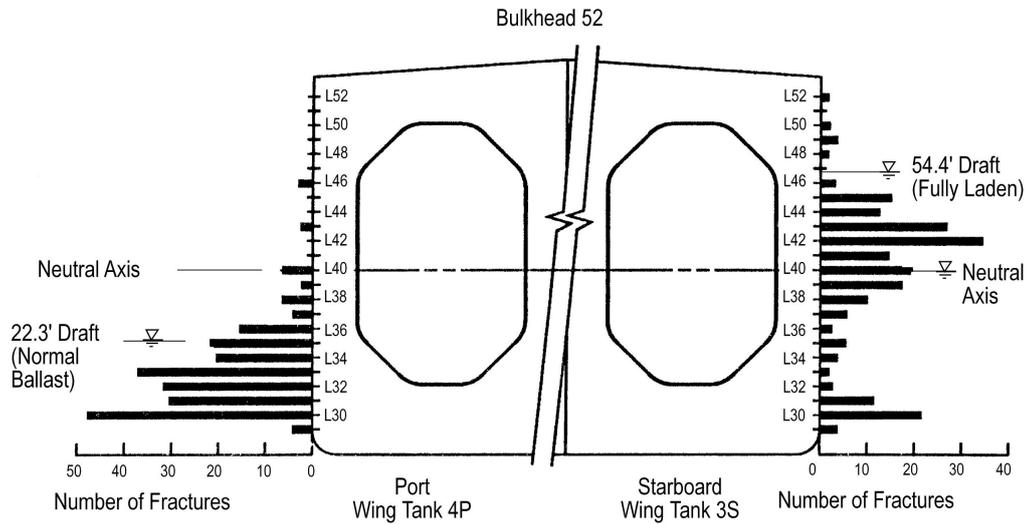
Fig. 8: Vertical distribution of side shell longitudinal fractures of the Atigum Pass Tankers

The effect of high fluctuating pressures close to or below the waterline has been investigated by Witmer (Witmer, 1994). Fig. 8 impressively shows the damages observed on tankers operating from Alaska to US west coast. Wave direction was mainly from one side, resulting in damages on the starboard side below the fully loaded line and on the opposite ship side below the ballast waterline. This damage scheme was verified by recalculation, using spectral analysis.

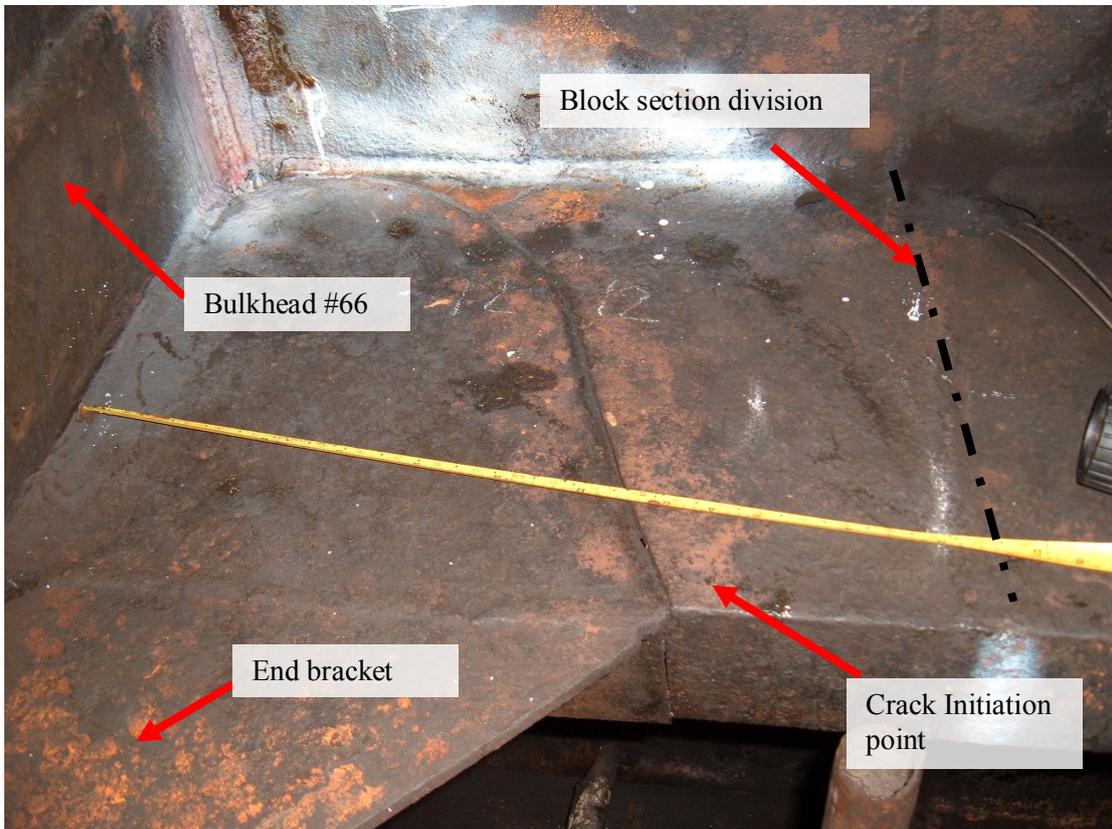
Fig. 10: Longitudinal frame, fully ruptured

During the inspection from outside, in close vicinity of a tank bulkhead located approximately at mid ship a vertical crack about 300 mm long in the side shell was reported. The crack was crossing a longitudinal at about half height of the hull.

During the internal inspection it was observed that the L-shape longitudinal frame was fully ruptured. The crack has obviously started at a bracket attached to the frame at an end connection

with a bulkhead. The photograph Fig. 10 and the drawing shown in The damage pattern is in excellent accordance to calculation results presented in Sect. 0.

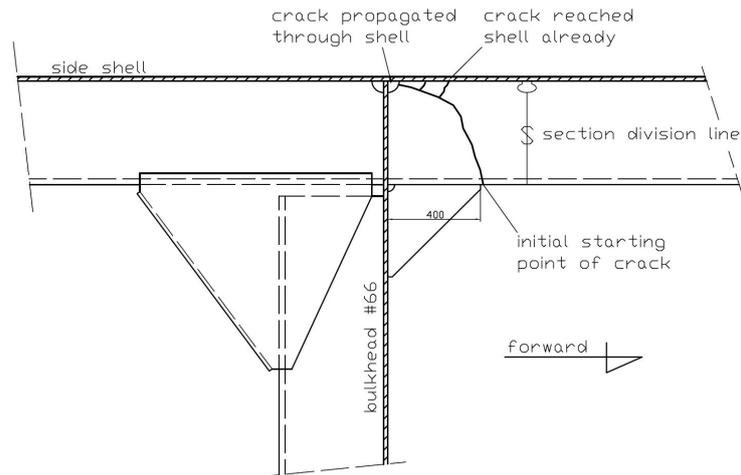
Fig. 11: Original details of the longitudinal framing system in way of the tank bulkheads

Fig. 11 give an impression of the damage and of the structural design

Further internal inspection showed that about 75% of the frames had cracks of different lengths, most of them visible to the naked eye. The cracks were all similar, starting at the end bracket where the frame is connected to the transverse tank bulkhead.

The longest cracks were found at about half height of the hull. This is a very clear indication that the dominating loads for the fatigue cracks are local wave loads rather than global hull girder bending loads.

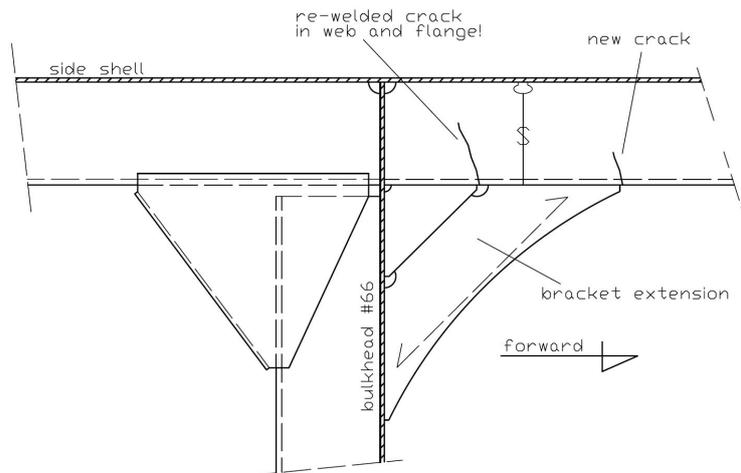
Fig. 12: Intermediate unsuccessful repair of unknown date

The inspection also showed that several repairs have been tried in the past with insufficient success. At some locations the cracks have been re-welded and an extension of the bracket has been installed previously. Although the shape of the extension of the extension was somehow rounded, but this did not provide a sufficiently soft transition to the frame. Consequently the crack re-occurred at the end of the bracket extension. The damage pattern is in excellent accordance to calculation results presented in Sect. 0.

It is interesting to note that at the overlapped bracket at the opposite side of the bulkhead no cracks have been found. The welding around the bracket edge of an overlapped bracket obviously creates a smooth detail that improved the fatigue strength. This is also reflected in GL Rules and in IIW recommendations given by Hobbacher (Hobbacher, 2007), where overlapped bracket arrangements have a higher detail category than butt weld connected brackets.
