Shipyard Experience in Structural Design of Double Hull Tankers -Past, Present and Future-

Satoshi Yamamoto

Universal Shipbuilding Corporation, Japan, yamamoto-satoshi@u-zosen.co.jp

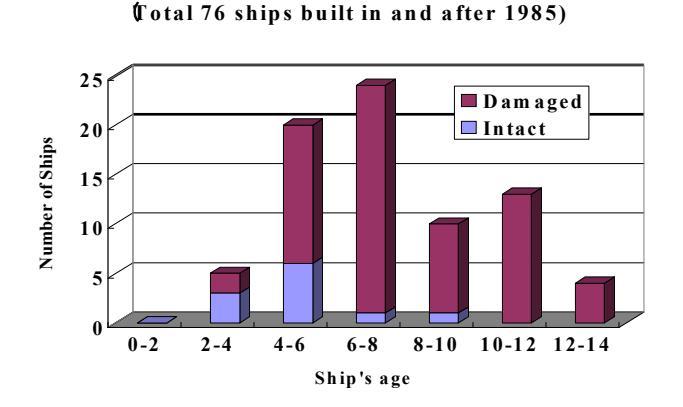
Fig. 1 Service experience of 2nd generation S/H VLCCs

Service experience of the second generation VLCCs was well summarized in ClassNK(1998). According to the report, a lot of structural damage occurred at a very early stage after their delivery, as shown in Fig. 1.

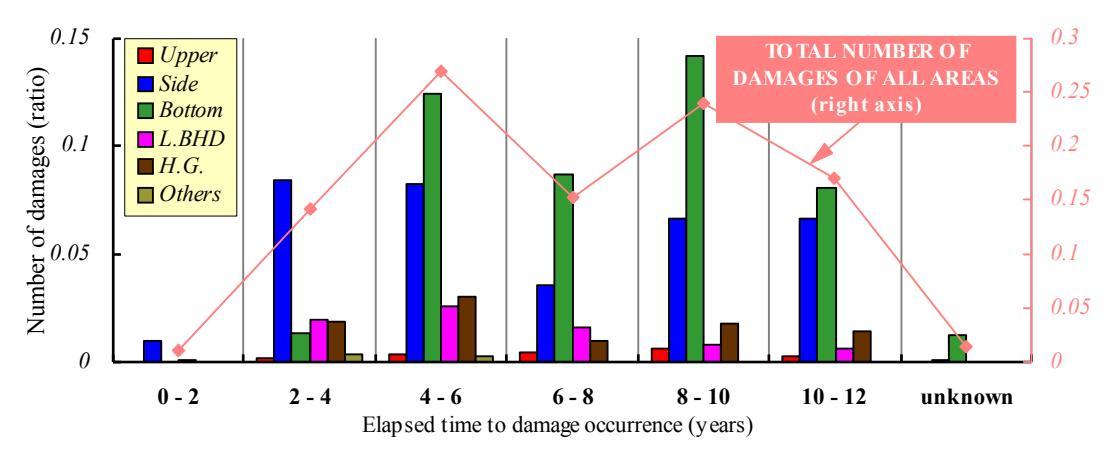
Fig. 2 Frequency distribution of damage based on elapsed time to damage occurrence of S/H VLCCs, ClassNK(1998)

ClassNK(1998) reviewed the structural damage in each ship's age. The results are shown in Fig. 2. In the figure, the solid line shows the total amount of damage for each area (ratio to the cumulative total number of damage). The line has two peaks at ship's ages of 4-6 and 8-10 years old. Since the ages correspond to 1^{st} and 2^{nd} Special Survey, the structural damage was probably found during the special survey.

Fig. 2 shows that almost all structural damage occurred in side and bottom areas. The structural damage of side area began to occur at an earlier stage than any other areas. Two years later, structural damage of bottom area began to occur.

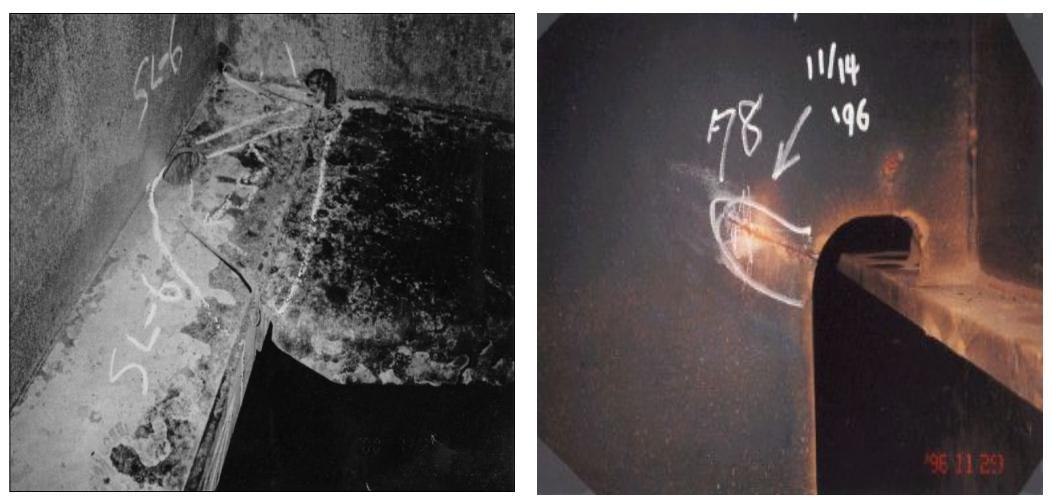
Fig. 3 Photos of fatigue cracks

The type of the structural damage in side area is mainly fatigue crack which occurs at connections of side longitudinals and web stiffeners fitted on transverse webs or transverse bulkheads. On the other hand, the type of the structural damage in bottom area is mainly fatigue crack which occurs around slot openings for bottom longitudinals.

Photos of fatigue cracks occurred in second generation VLCCs are shown in Fig. 3. Left hand photo shows the fatigue crack occurred at the connection between side longitudinal and web stiffener. Right hand photo shows the fatigue crack occurred around slot opening of bottom transverse.

The structural damage in side area can be categorized into two patterns. One is a fatigue crack propagating along welded joint of side longitudinal and web stiffener. The other is a fatigue crack occurring at toe of web stiffener and propagating into side longitudinal. The latter one is

very serious damage since the crack probably penetrates side shell plating. As a result, it makes oil spills and can lead to environmental pollution.

The cause of the former crack is lack of connection area of side longitudinal and transverse web. The connection area is the total area of a lug connection area of side longitudinal and transverse web and a connection area of side longitudinal and web stiffener.

In the second generation VLCCs, depth of side longitudinal was reduced. And thickness of transverse web was also reduced. Thus the lug connection area was reduced in comparison with that of the first generation VLCCs by using HT steel design. As a result, stress in the connection area of side longitudinal and web stiffener increased, which caused the fatigue crack at the connection. Taking this into account, many classification societies established their rules requiring an adequate total connection area.

As for the latter crack, main cause is an increase in working stress in side longitudinal. The working stress was increased due to the following causes. The first is scantling reduction of side longitudinal by using HT steel. The second is a reduction of rigidity of transverse web, which increases a relative deflection between transverse web and transverse bulkhead. The increase in relative deflection increases stresses in side longitudinal. The last is configuration of side longitudinal. Asymmetrical shape was used to side longitudinals of the first generation VLCCs. This asymmetrical shape increases working stress in side longitudinal. In the second generation VLCCs, however, the shape of side longitudinal had not been reconsidered.

- > Required scantling of longitudinal taken into account fatigue strength
- Relative deflection to be taken into account in fatigue assessment
- > Difference in shape of longitudinal to be taken into account in fatigue assessment

> To provide adequate size of collar plate to slot opening

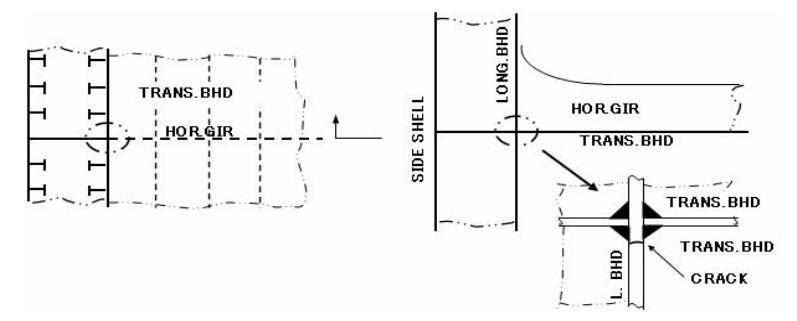
Fig. 6 Sketch of damage occurred at connection of L.BHD and T.BHD

Several years ago, however, new kinds of structural damage were reported. Fatigue damage was found at connections between longitudinal bulkhead and transverse bulkhead of several double hull VLCCs having struts in center cargo tanks, which had never been observed before. A sketch of the damage is shown in Fig. 6. Such kind of damage has not been found out in wing strut type VLCCs until now.

In case of center strut type VLCCs, the stresses occurring at the intersection of longitudinal bulkhead and transverse bulkhead are very high in comparison with those of wing strut type VLCCs. In case of wing strut type VLCCs, the double side structure exposed to dynamic sea loads is supported by wing struts connected to vertical webs on inner longitudinal bulkhead. Thus the stresses at the location concerned are lower than those of center strut type VLCCs.

Since the frequency of occurrence of the damage is very little, initial defect during construction stage, such as misalignment between transverse bulkhead and transverse web in double hull, would probably be one of the causes.

In the present design, therefore, backing brackets are provided at the position to prevent the damage.

- > To provide back brackets at the intersection of L. BHD and T. BHD
- To keep alignment between T. BHD and T. Web in double hull

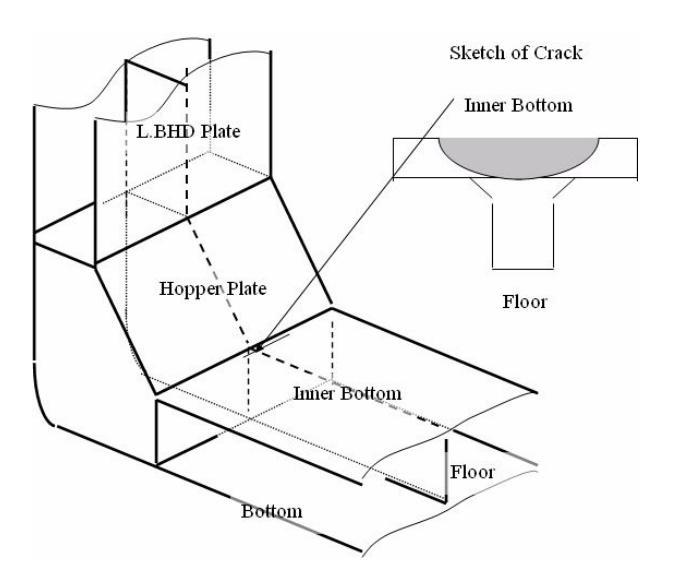
Fig. 7 Sketch of damage occurred at lower hopper knuckle

The other type of damage was reported by SR245(2002). The damage occurred at lower hopper knuckle of a few double hull VLCCs. A sketch of the damage is shown in Fig. 7. The damaged lower hopper knuckle is of welded type. And grinding at toe of weld bead had not been carried out.

- > Toe of weld bead of lower hopper knuckle to be ground smooth
- > Centerline alignment among inner bottom, hopper plate and side girder to be kept

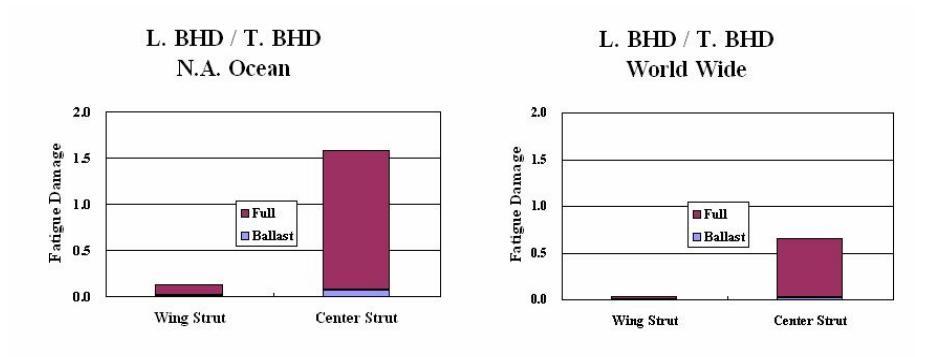
Fig. 8 Comparison in fatigue damage factor between Wing Strut and Center Strut

A result of fatigue strength assessment is shown in Fig. 8. Fatigue damage factor of wing strut type VLCC is very little in comparison with that of center strut type VLCC. Under heavy weather conditions, such as the North Atlantic Ocean, fatigue damage factor of center strut type VLCC exceeds the criterion of 1.0.

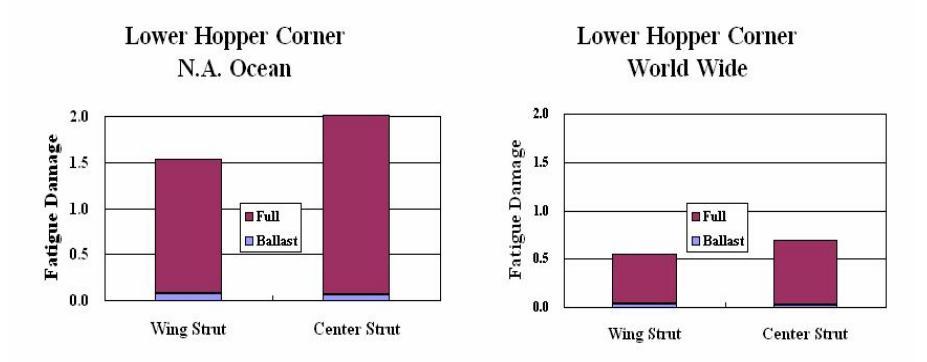
Fig. 9 Comparison in fatigue damage factor between Wing Strut and Center Strut

Figure 9 shows the result of fatigue strength assessment on lower hopper corner. Although the fatigue damage factor of lower hopper corner is less than 1.0 under world wide operation, under heavy weather conditions, such as the North Atlantic Ocean, the fatigue damage factor exceeds 1.0. Taking into account grinding effect, the fatigue damage factor can be reduced to less than 1.0.
