Tanker Structure Co-operative Forum

Information Paper on Cargo Tank Corrugated Bulkhead Damages of Double Hull Tankers

Reference	Revision N°	Revision Date
IP 002/2011	Rev 0	2011.10.13

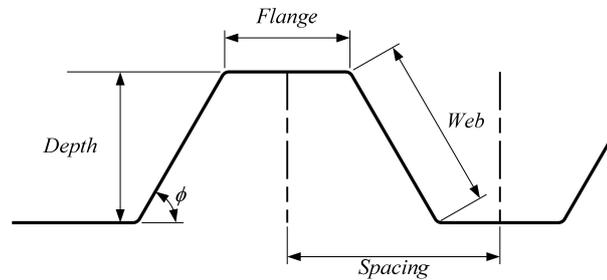
Terminology used throughout the paper for parts of the corrugation is defined in Figure 1.

Figure 1 Corrugation terminology

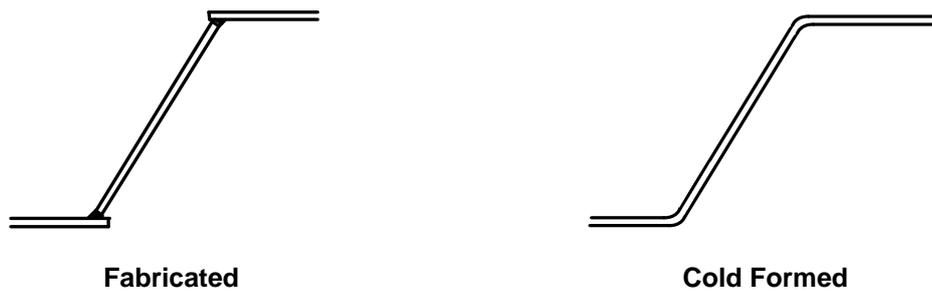
Corrugations can either be fabricated or cold formed (Figure 2). Fabricated corrugations are produced by welding web and flanges together. Cold-formed corrugations are produced from a single sheet of material and pressed into the corrugation shape by mechanical means.

Figure 2 Types of corrugation

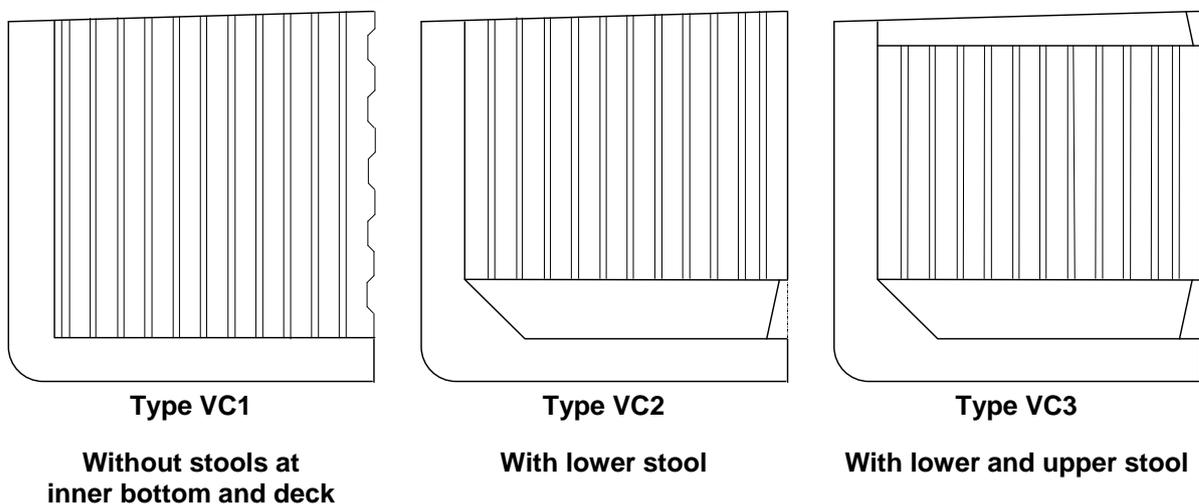
Vertically corrugated bulkheads take three basic forms as illustrated in Figure 3. Each configuration presents various challenges in ensuring continuity of strength and load transfer to surrounding structures.

Figure 3 Configurations of vertically corrugated bulkheads

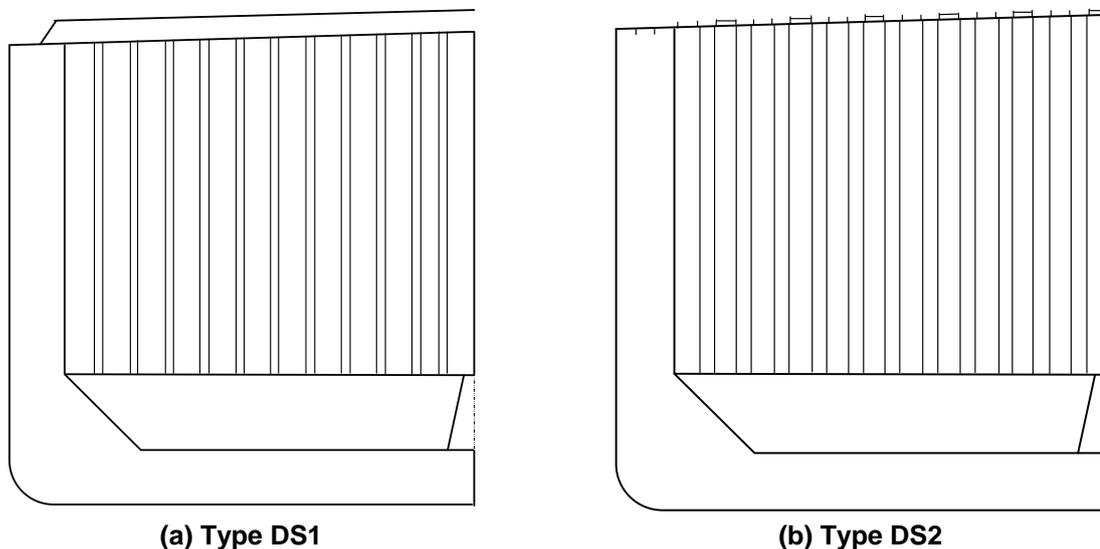
Figure 5 Types of support for upper end of corrugation on types VC1 and VC2

In Type DS1 shown in Figure 5 a, substantial above deck structure is provided consisting of girders or transverses to provide a relatively rigid support for the upper end of the corrugation. On some of these designs, additional partial girder structure is incorporated to form a grillage structure in way of the bulkhead, with the aim to reduce relative deflection, between adjacent deck transverses, see Figure 6.

Type DS2 consists of only very limited above deck structure as shown in Figure 5 b. This provides a relatively flexible support, thereby attracting less load (and therefore local stress) to the upper end of the corrugation but bigger deflection in rotation.

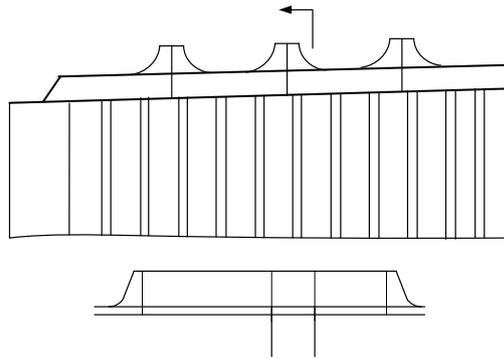
Figure 6 Schematic view of typical partial girder arrangement

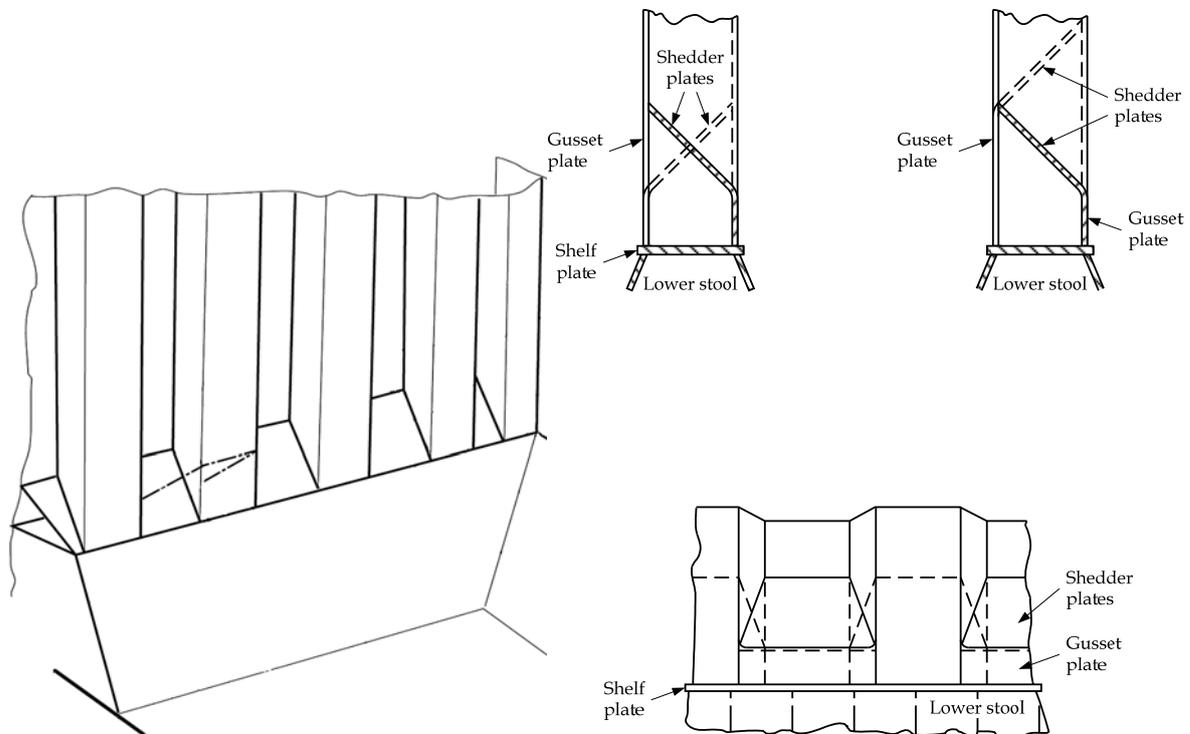
The support structure for the lower end of the corrugation (shown in Figure 7) is provided by means of a fabricated stool which is a box type structure. This may be of rectangular or non-rectangular cross section depending on the height of stool. The lower stool consists of shelf plate, side plates and internal web plates providing primary support for the stool boundaries. The shelf plate provides a foundation for the corrugation and facilitates load transfer from the corrugation web to the structure below through shear and also from the corrugation flanges to the stool side plates through transmission of out of plane stress.

Figure 7 Lower bulkhead stool terminology

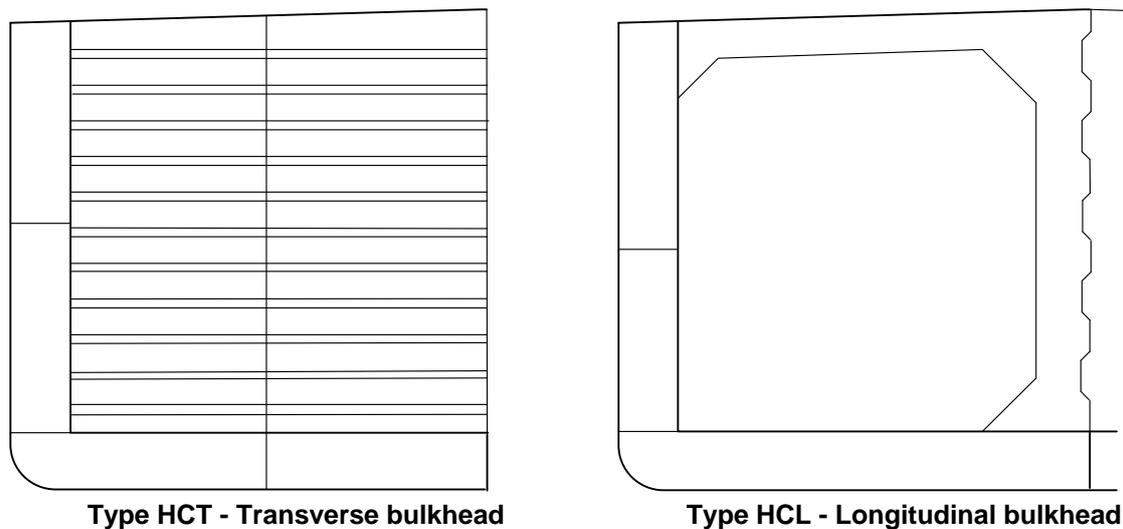
Horizontally corrugated bulkheads take two basic forms as illustrated in Figure 8.

Figure 8 Configurations of horizontally corrugated bulkheads

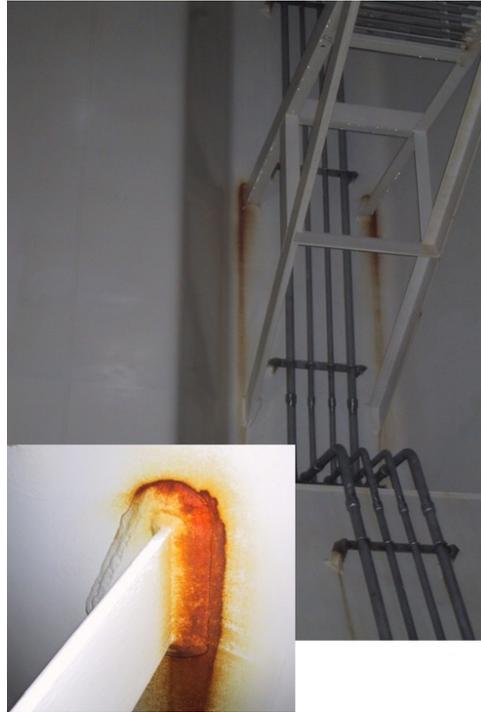
The surface of corrugations is almost free from surface stiffening which means that the incidence of grooving is reduced compared to stiffened structures where regular patterns of drainage can develop. However where brackets or outfit items such as access ladders or pipework are attached to bulkheads, accelerated corrosion can occur in way of coating breakdown at the attachment points.

Figure 9 Accelerated corrosion in way of attachment points
