## **Tanker Structure Co-operative Forum**

### **Comparison of TSCF and PSPC Ballast Tank Coating Guidance - Owners Experiences and Best Practice**

# TSCF and PSPC Comparison

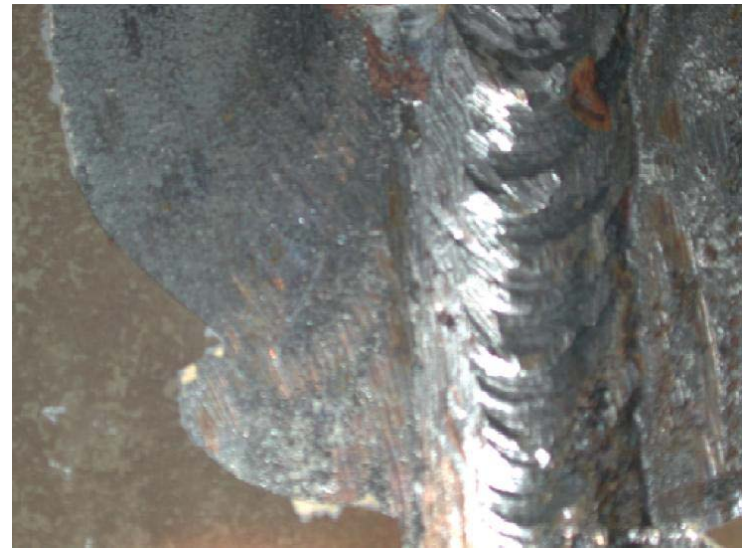
*St3 power-tooled surface finish*

- Surface treatment of block joints represents the most significant gap between TSCF and PSPC, and the most significant issue for ship owners.
- The PSPC guidelines for surface treatment of block joints fall significantly below the TSCF15 guidelines:
  - *TSCF10 – St3 for block joints*
  - *TSCF15 – Sa2.5 for block joints*
  - *TSCF 25 – Sa2.5 for block joints*
  - *PSPC – St3 for block joints*

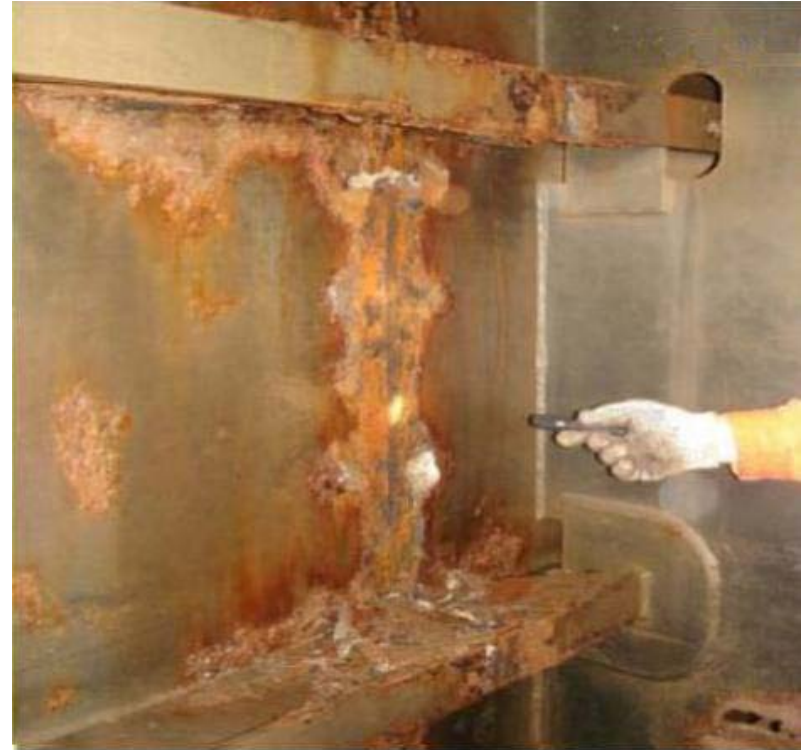
*Power-tooled block joint after 5 years service*

- Power tooling of block joints is inadequate and leads to poor coating adhesion. Owners have experienced many failures of coatings on power-tooled block joints.
- Coating performance tests are carried out on Sa2.5 surfaces, but not St3 surfaces, and so are not optimized for St3 surfaces.
- For best practice, Sa2.5 surface treatment should be applied to all block joints (with vacuum-blasting) or paints should be additionally tested for adhesion on St3 surfaces.

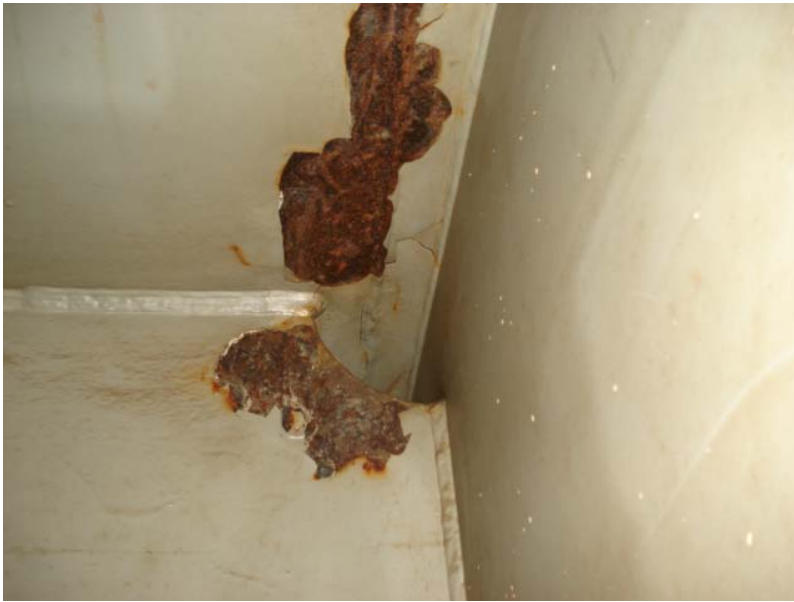
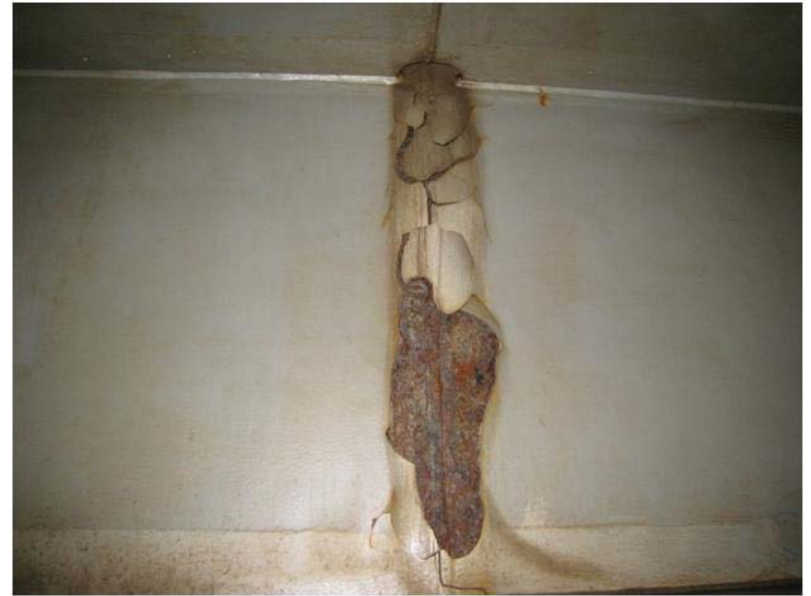
*Examples of poor coating adhesion on  
power-tooled block joints*

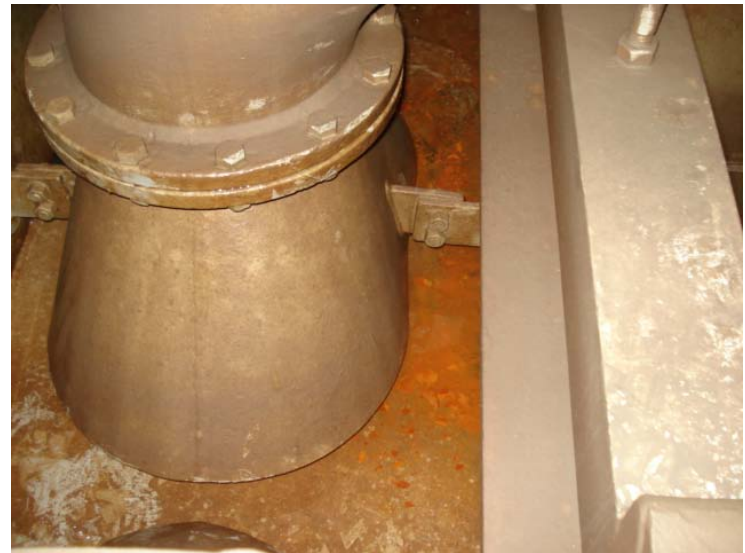
*General corrosion*

- TSCF guidelines specifies that areas under bell-mouths should have extra protection by reinforced coating or coating of increased thickness.
- PSPC offers no guidance on additional protection under bellmouths and no glass flake paints have been given PSPC approval.
- Lack of extra protection under bellmouths on PSPC tanks leads to faster coating breakdown.
- For best practice, additional protection under bellmouths should be covered by PSPC.

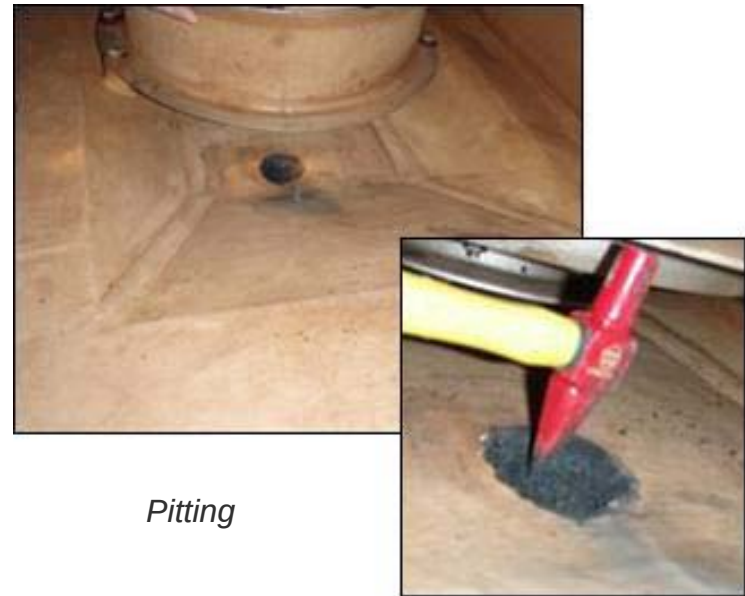
*Pitting*

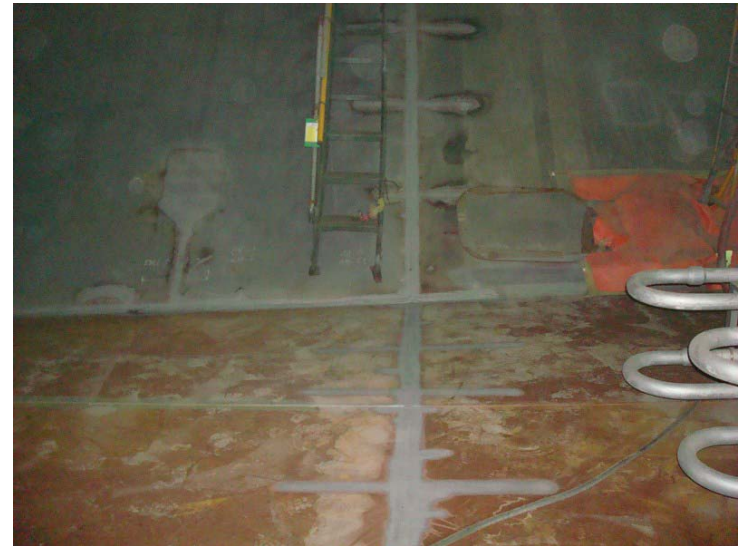
*Example of poor BHP performance*

- TSCF guidelines suggest the use of block holding primers is acceptable for TSCF10 and TSCF15 standards, but not for TSCF25.
- PSPC offers no guidance on block holding primers.
- From owners' experiences, quality varies between yards, but block holding primers are more likely to fail when blocks are constructed in other yards and transported to the assembly yard by sea.
- Best practice would be for full painting to be carried out directly after blasting instead of using block holding primers.

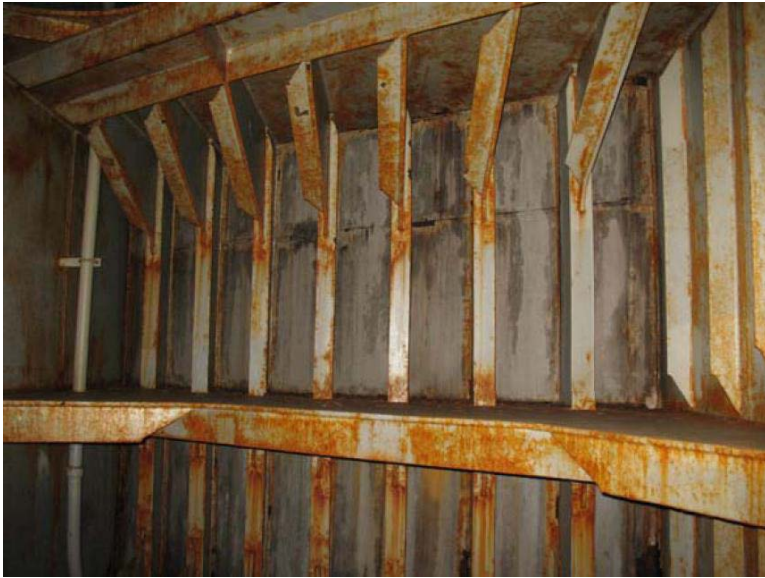
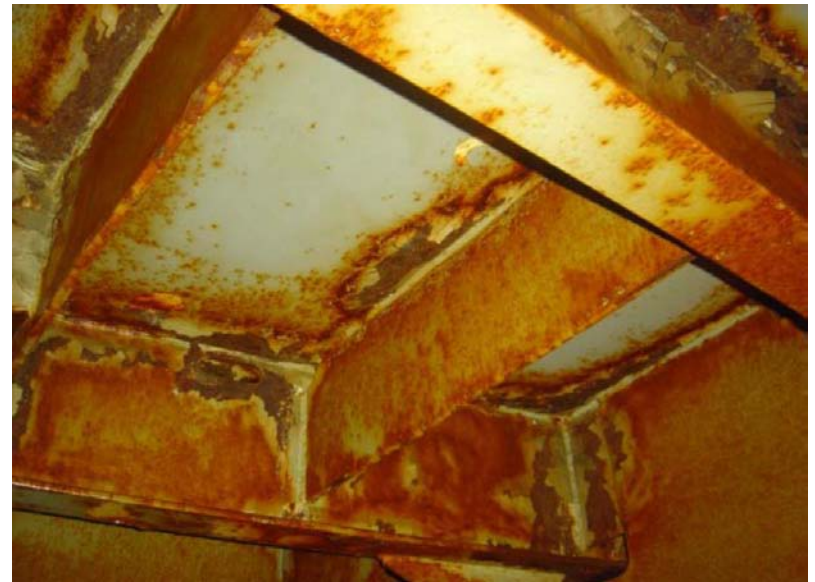
*Large-scale failure of coatings –  
indicative of a lack of environmental  
controls during painting/curing or paint  
transportation/storage.*

- Paints can be damaged by poor environmental controls during transport to and storage at the shipyard which can lead to large-scale coating problems.
- Quality Control procedures need to be maintained during transport and storage.
- For best practice, fingerprinting of paints should be mandated:
  - Use infrared spectral analysis to check paint chemistry (density, ash, volume solids and mass content of binder, pigments and non-volatile matter) (e.g. ASTM D7588)
  - Comparison of applied paint with spectrum of tested/approved paint.
  - Ensures quality of applied paint is the same as approved paint.

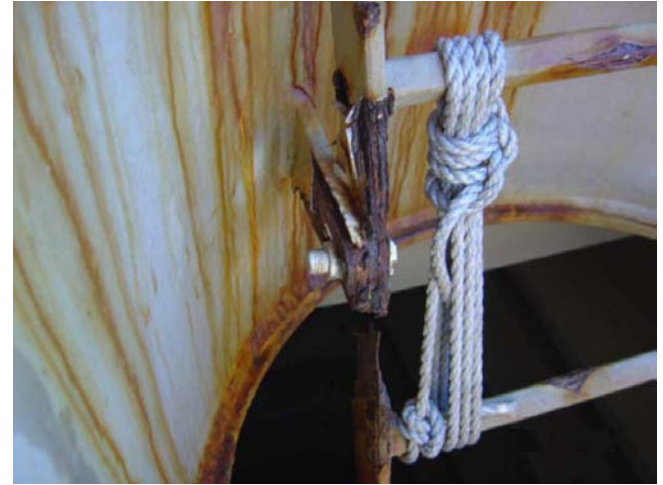
*Corrosion on PMA can be life-threatening*

- TSCF specifies coating of all outfit/non-integral items should be same standard as the tank, including galvanized or corrosion-resistant alloy items.
- PSCC recommends coating for non-integral PMA items, but does not comment on specialized surfaces (galvanized, CRA, etc.). MSC Circular 1279 should be applied.
- Owners' experience of best practice, from a safety perspective, is not to compromise on coating PMA items and specialized surfaces.

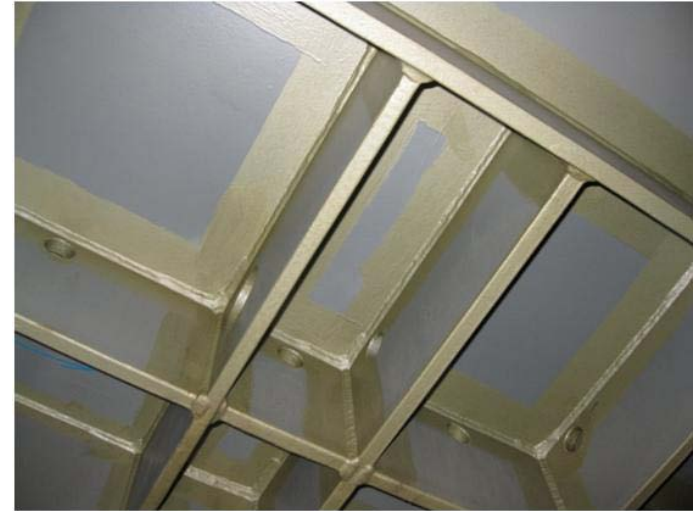
*Example of good stripe coating*

- Further work is needed to resolve order of coating and method of application.
- Owners' experience of best practice is that the first coat should always be a full coat, followed by a stripe coat. Stripe coat should be a different colour.
- Second stripe coat should be applied to all welded seams unless the Buyer approves otherwise. NDFT needs to be assured in practice.

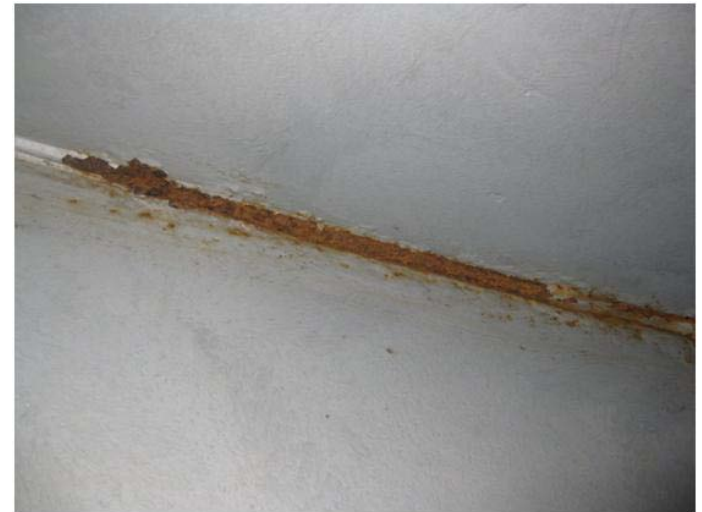
*Example of inadequate stripe coating leading to breakdown*

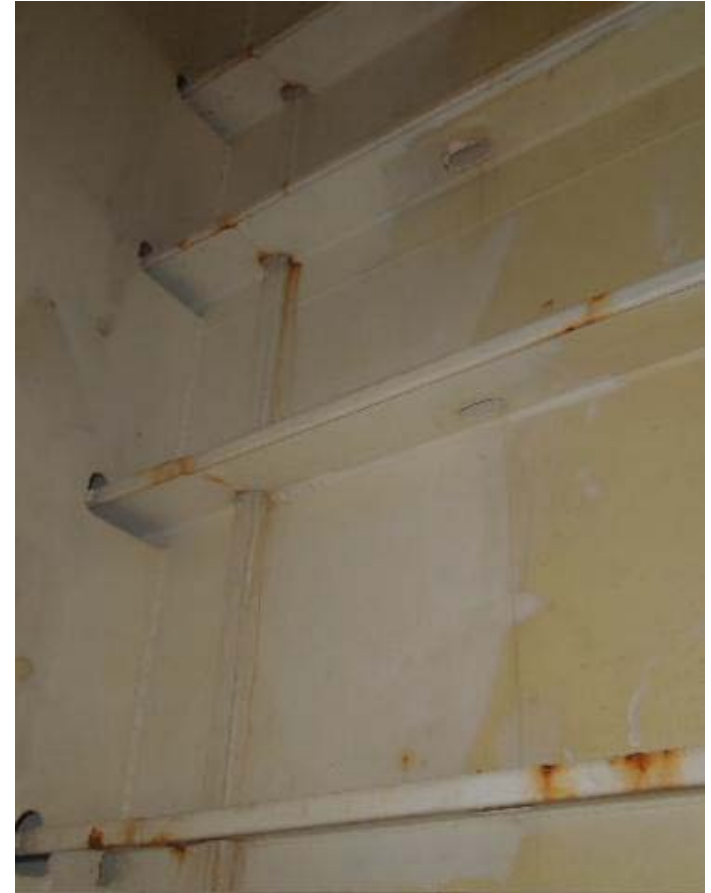
*Coating breakdown starting to occur due to inadequate stripe coating on 2 year old PSPC ship*

- TSCF specifies stripe coating to be carried out by brush only.
- PSPC does not specify how stripe coating is applied.
- Roller application for stripe coating is considered a lesser standard, with higher DFT and less penetration of substrate.
- IACS UI SC223 states - *“Roller to be used for scallops, rat holes, etc., only”*.
- Owners’ experience of best practice is that stripe coating is carried out using brushes for a better finish.

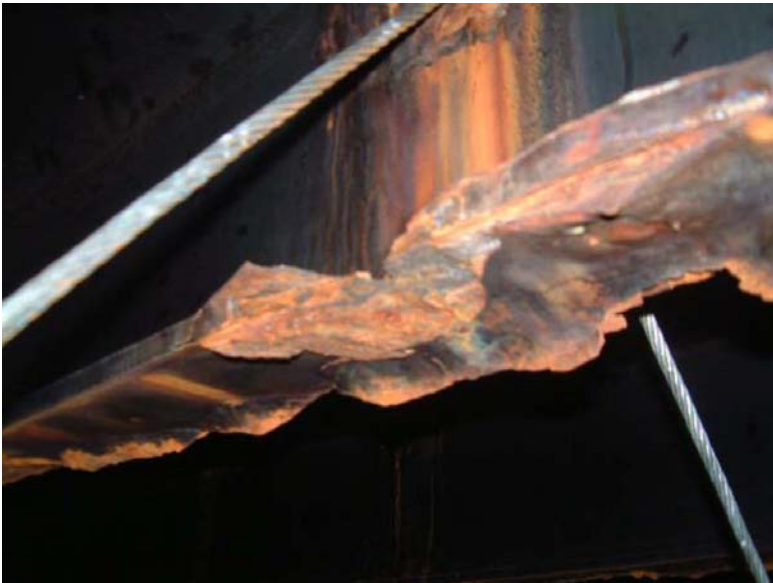
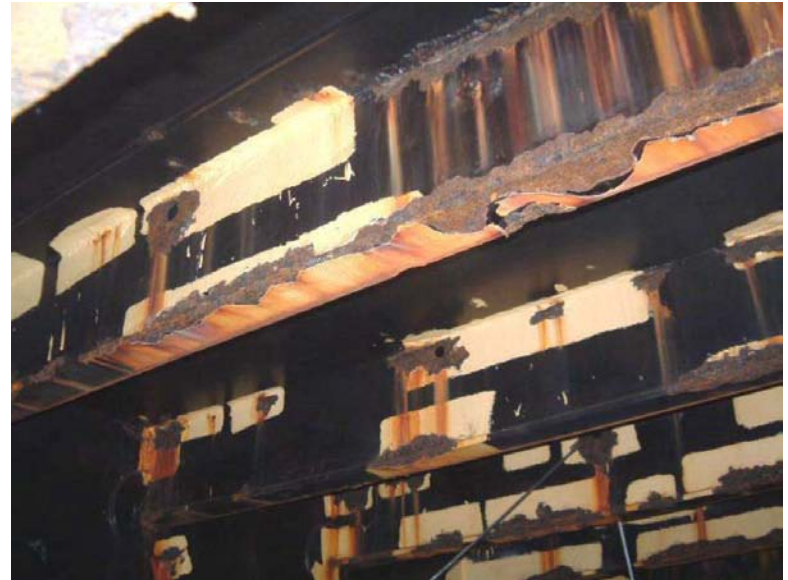
*Excessive edge breakdown due to no edge treatment and only one stripe coat*

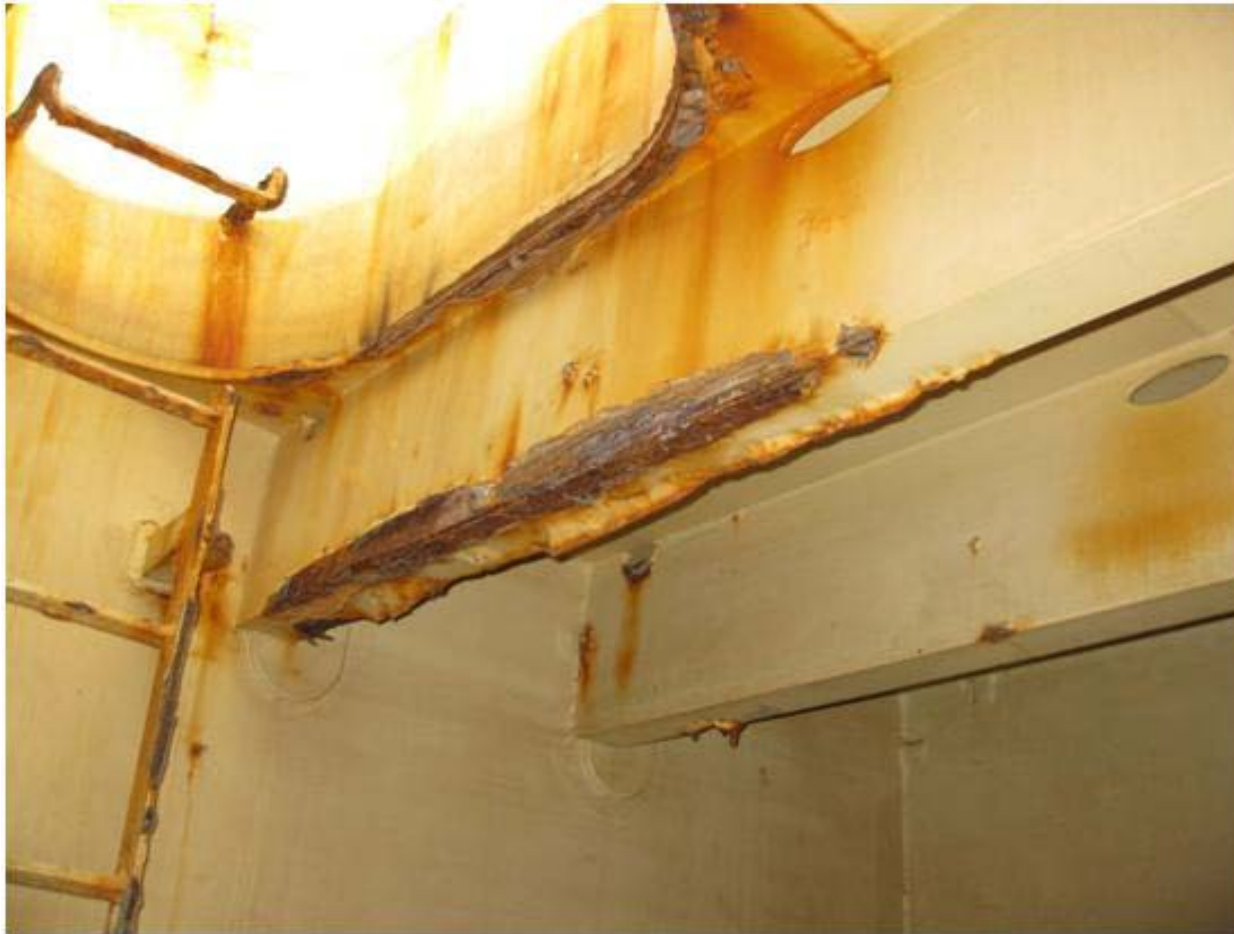
*10 year old ship with coating breakdown on access ladders, coaming and longitudinal edges due to insufficient stripe coating and poor treatment of non-integral fittings*

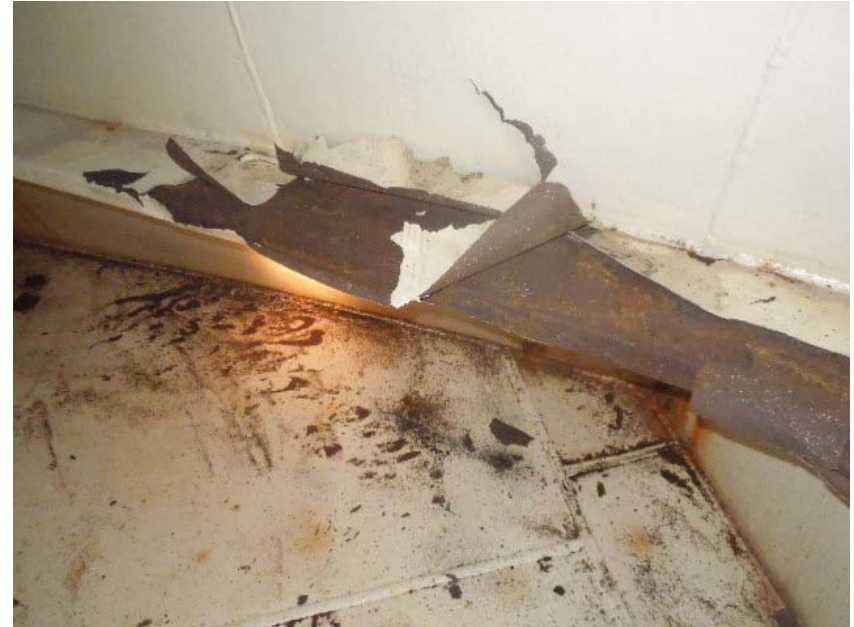
*Severe coating breakdown within 2 years of coating in accordance with PSPC.*

- Sa 2.5 (30-75 $\mu$ m) is a compromise surface finish and coating adhesion could be improved with higher profile values.
- The use of hydro-blasting for secondary preparation is not covered by PSPC. This would be a useful addition.

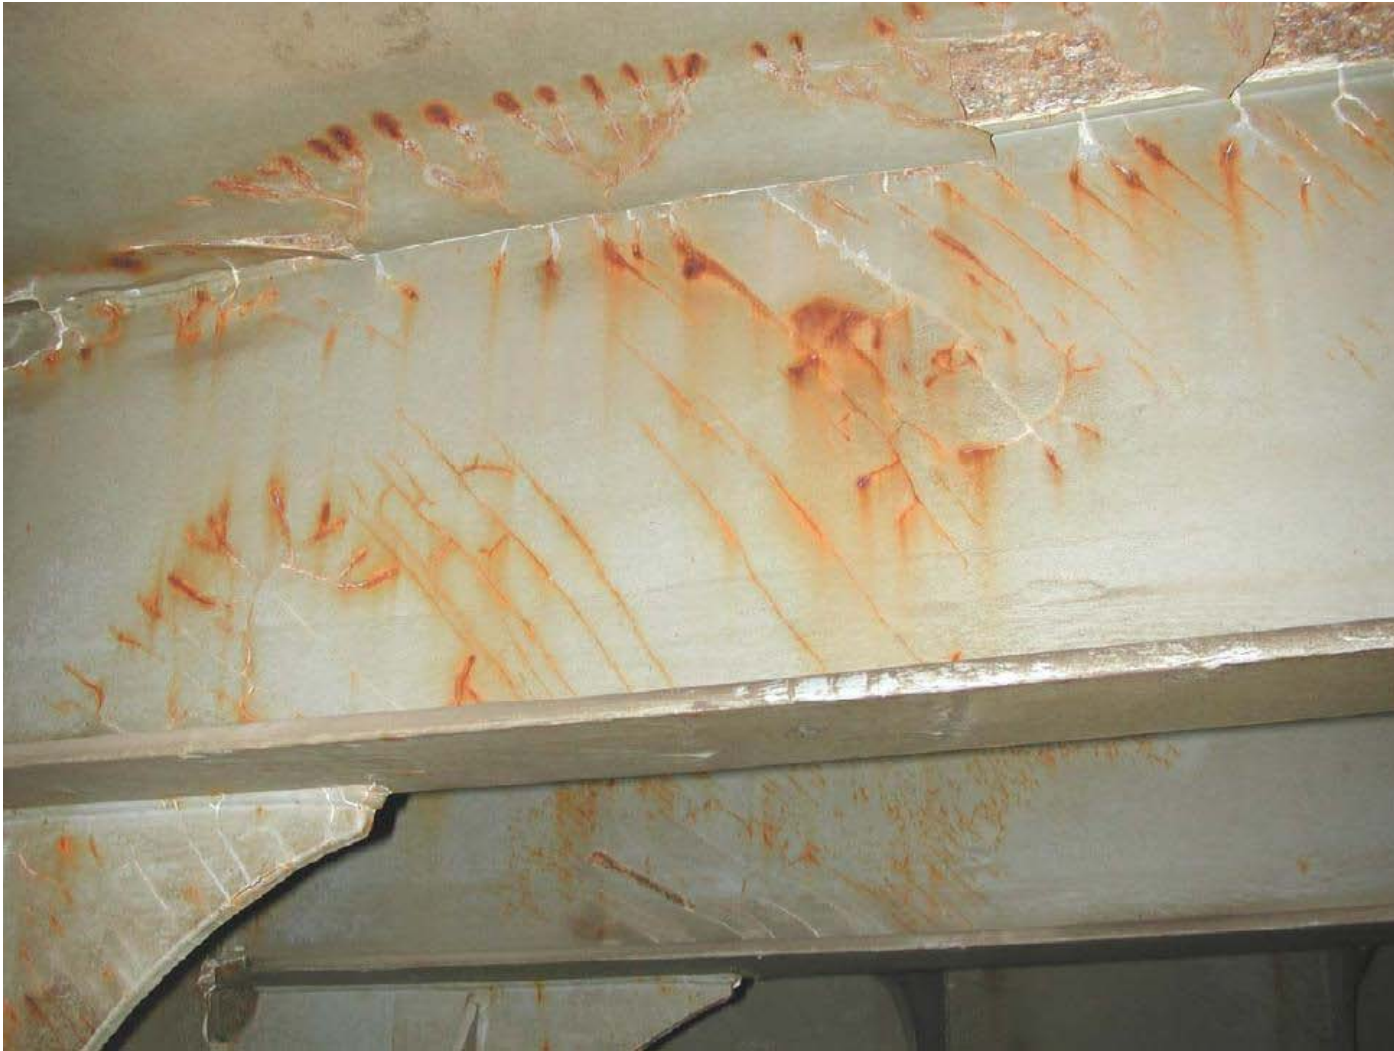
*Paint cracking in 5 year old ship – contributing factors were excessive DFT, short loading cycles and temperature gradient – effective selection of coating system is important.*

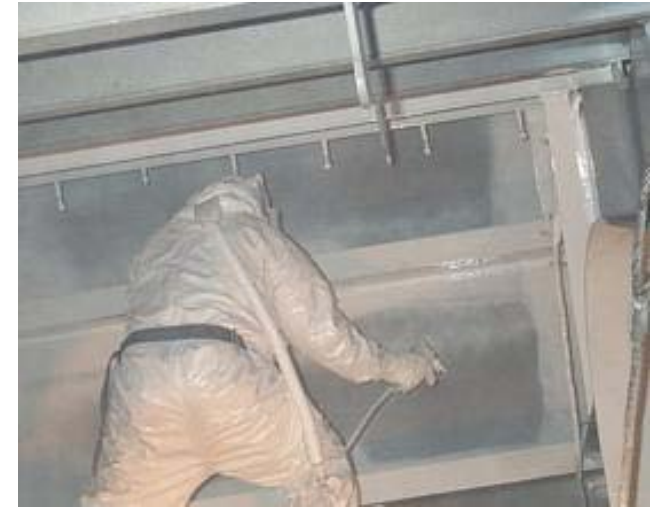
*Who is painting your ship?*

- Painter qualifications are a notable omission from both PSPC and TSCF guidelines.
- Painting is skilled work and requires training to produce consistent high quality coatings.
- Owners consider that painters should be trained and qualified in the same way that welders are.
- Owners consider that there should be Class involvement to ensure painters are properly trained and qualified.
