The Implementation Process Analysis and Improvement on PSPC in China Shipyards

TSCF 2013 Shipbuilders Meeting

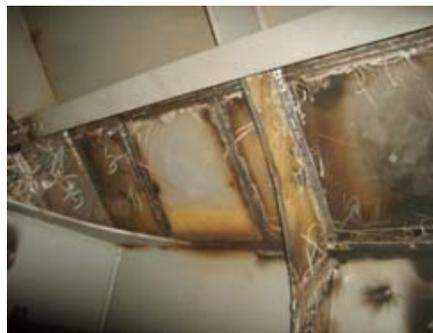
Fig.1 H1053 coating damage condition (after erection of the entire tank)

Took No.9 ballast tanks of the PSPC effective ship H1112 manufactured by the shipyard firstly as example, the paper analyzed the reason of the excessive coating damage through the water ballast tanks after erection.

The coating damage caused by the welding spatter scald. As workers have weaker protection awareness while welding and cutting, or the coating protection work is not in place, the welding slag will burn the surrounding coating, and formed large area of coating burn pitting.

If the protective measures of hull erection are not in place, the burning coating width on both sides of the butt weld will be greater than 200mm, and the excess portion will be included in the coating damaged area.

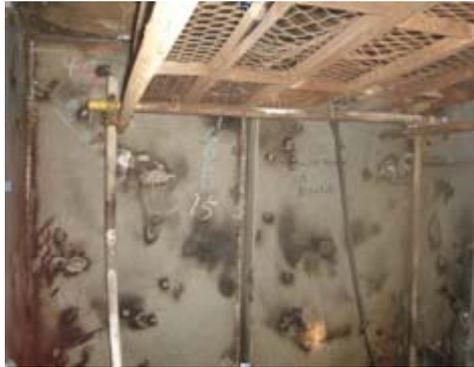
Fig.2 H1053 coating damage condition (man-made damage)

For some reasons, such as the low PSPC awareness of the workers, poor coating protective awareness during the construction process, building and removing the scaffold, random arc-making, the brutal application and poor "5S" clean, the man-made coating damage is created;

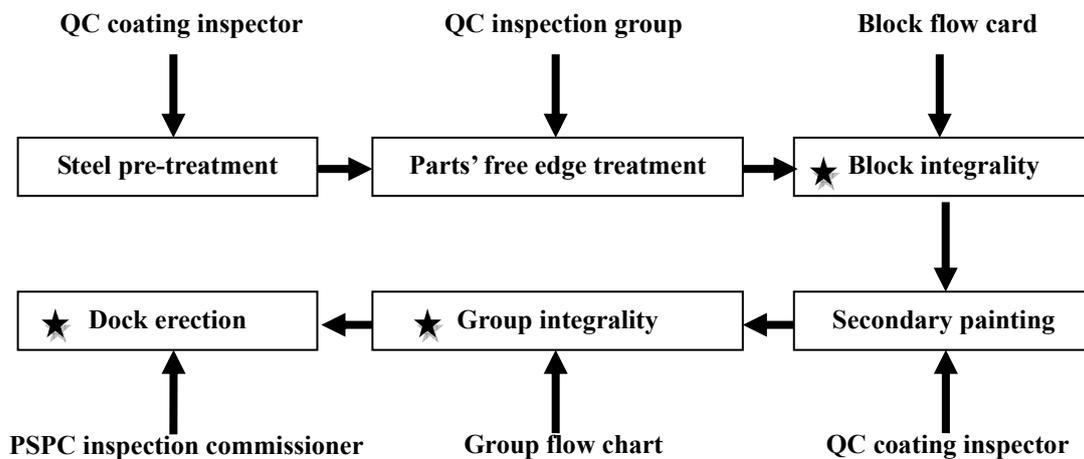
Fig.3 PSPC standard implementation control point chart
 (★ stand for key control points)

On the basis of analyzing the impact on the PSPC standard implementation in the main shipbuilding process, combined with the PSPC standard requirements, we decomposed the PSPC implementation difficulty to the main shipbuilding process, confirm the control points of the various aspects, and take the relevant control method at each control point, so as to ensure that the PSPC standard implementation is monitored throughout the whole process (PSPC standard implementation control points are as shown in Fig 3).

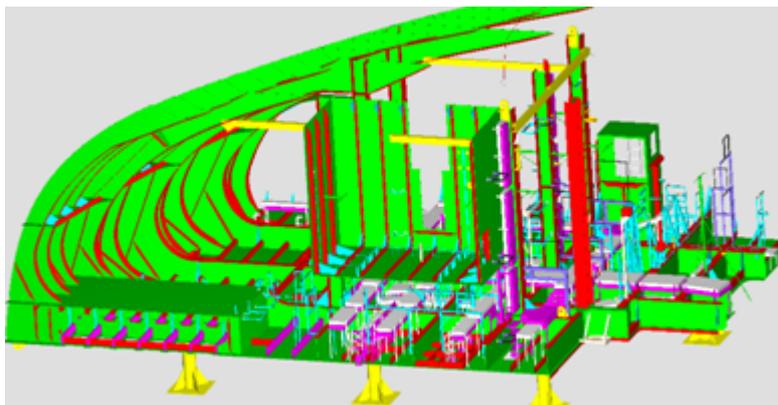
Fig4. The model of the typical engine tank block strengthening

In the precision control of the block construction, it is found that some blocks' structure strengthening is inadequate, which is prone to the deformation while lifting, shelving or sanding, so the engineering chamber, assembly department and precision management department are organized to take the optimization work of the block strengthening and supporting process. At present, the modeling of 206K BC block strengthening has been completed. For example, in fig 4 “the model of the typical engine tank block strengthening”, the slot steel supporting of the block section below can ensure the structural rigidity and reduce the deformation.

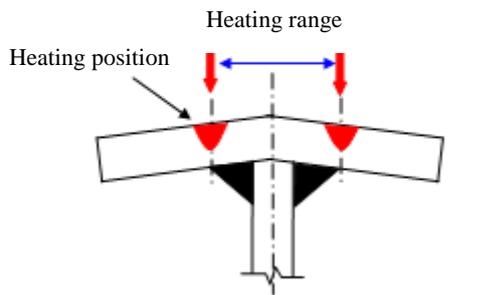
Heating shall not exceed 2/3 of steel thickness

Fig.5 Back burn position drawing

The purpose of block back burn is to eliminate the residual stress generated by welding, correct distortion, and prevent hull to be distortion. Heating working for part welding opposite surface aims to reduce paint damage at block group and erection stage. All the back heating should be done on the back of the welding with the flame after finishing small, medium and large assembly work, and the optimum heating temperature is 600 to 700 degrees. Its heating position is shown in Fig.5. According to the orientation of the butt bevel, the effect after the back burning is shown in Fig.6.

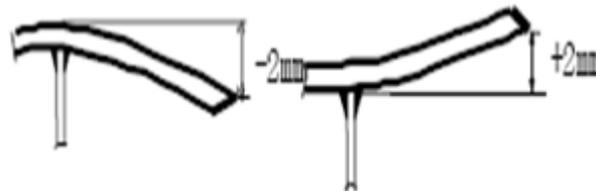
Fig.6 Effect drawing after back burn

Presently, the back burn of block butts acts as a block D precision into the block accuracy assessment. By viewing the on-site implementation situation, the fire work at group and erection stage has been significantly reduced.

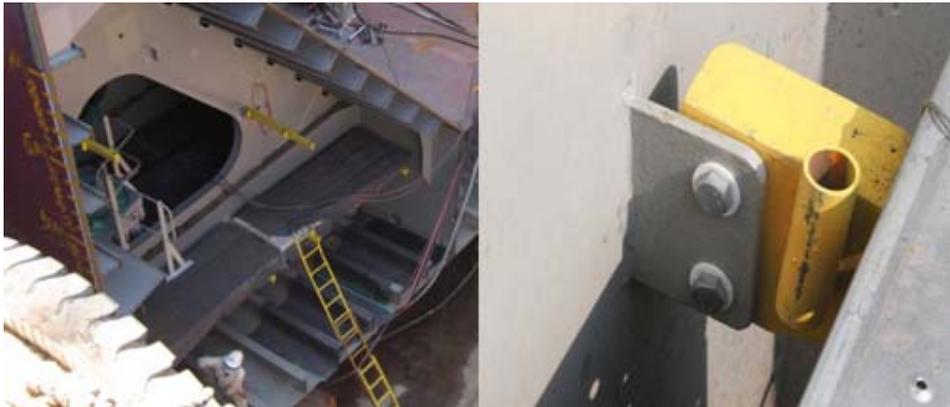
Fig.7 Erection effect drawing of water ballast tanks fabricated scaffold

To avoid scaffold and hull direct contact to damage water ballast tank coatings, the scaffold design amends the original welding erection form, and promotes the use of fabricated scaffold in water ballast tanks greatly. In the area of the ballast tanks erection seams and watertight board lay the scaffold pieces, and use the fabricated scaffolds, while the scaffold pieces will be remained in the hull as a permanent piece. In the fabricated scaffolding erection process, the protection measurements on the scaffold pieces are increased that all the contact areas with the scaffold pieces use the rubber pad for protection, which effectively ensures the integrity of the coating, as shown in Fig7.
