Corrosion-resistant Steels, NSGP™-1, -2 for Crude Oil Tankers and their Performance

Hidehiko Sato	NYK Line
Shunsuke Ogisu	NYK Line
Hiroyuki Fujioka	NYK Line
Minoru Ito	Nippon Steel & Sumitomo Metal Corporation
Naoki Oda	Nippon Steel & Sumitomo Metal Corporation,
Kazuyuki Kashima	Nippon Steel & Sumitomo Metal Corporation

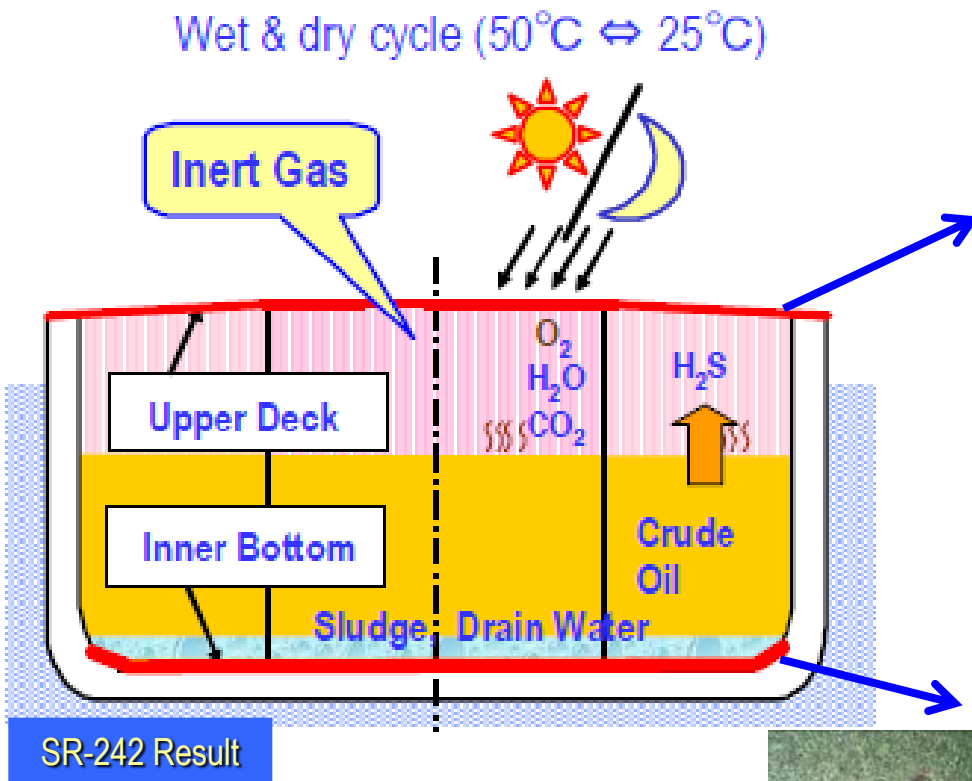
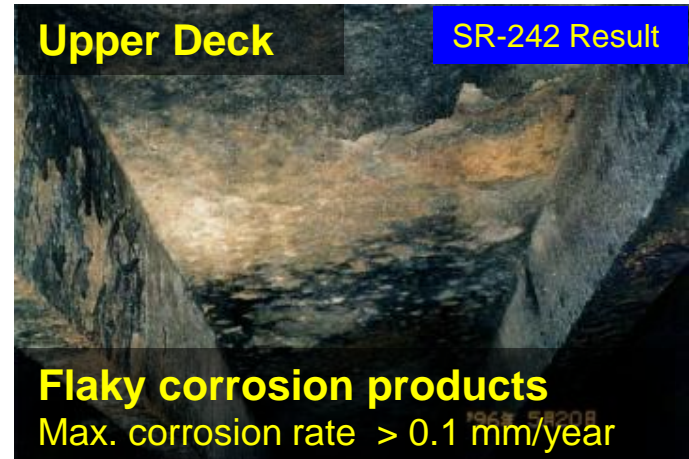
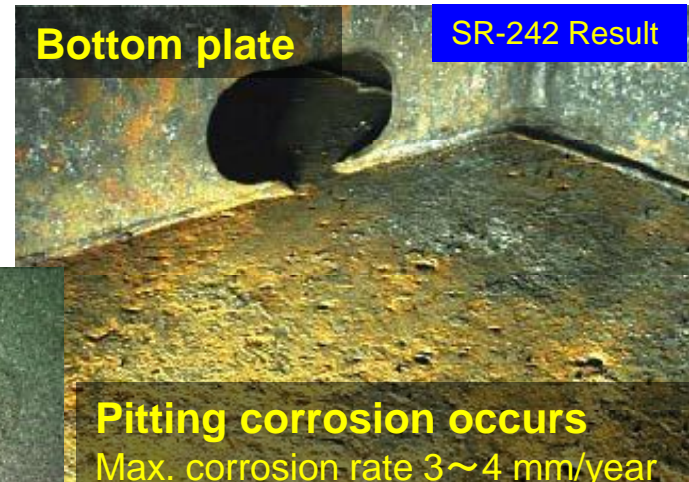
Environment and Corrosion in the COT

Environment : Not only crude oil, but also sludge, drain water (brine), and severe gases.
Corrosion: There are 2 types. 1) pitting corrosion (bottom), 2) general corrosion (upper deck)

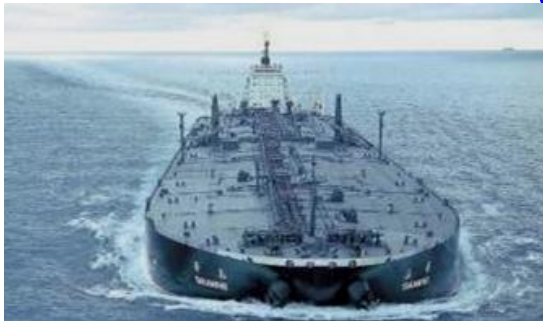
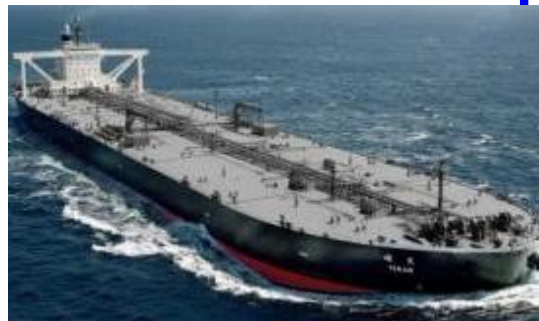
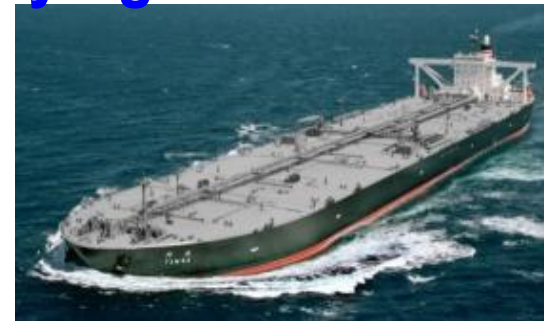
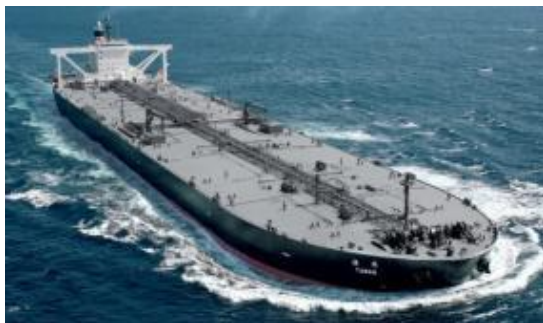
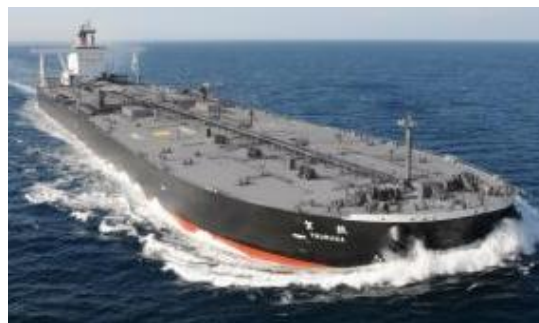
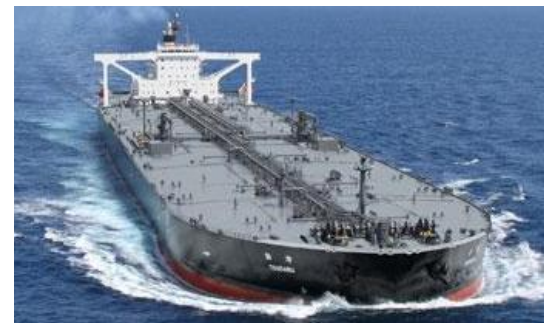
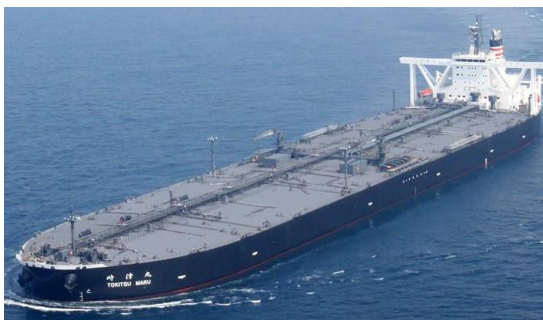
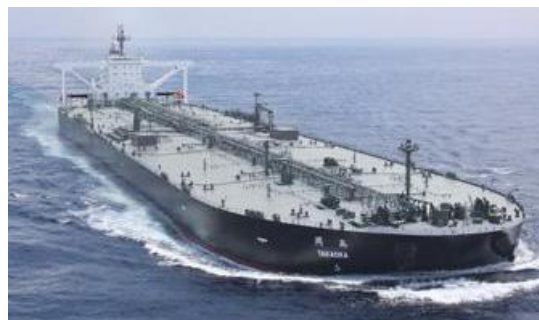
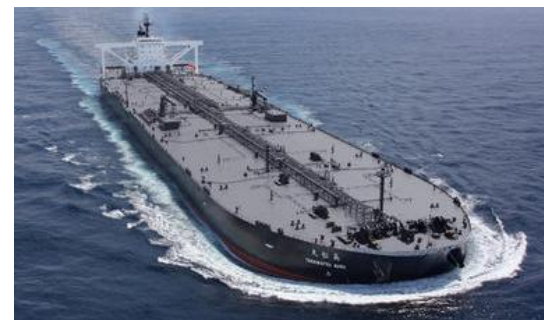
Onboard Investigations of VLCCs Applying NSGP™-1

(1) The first NSGP™-1 applied NYK's VLCC will be at the 5th inspection (Over 12 year Service Period)

(2) NSGP™-1 subsequently applied NYK's 8 VLCCs to all COTs and their service periods are ranged from 5 years to 8 years.

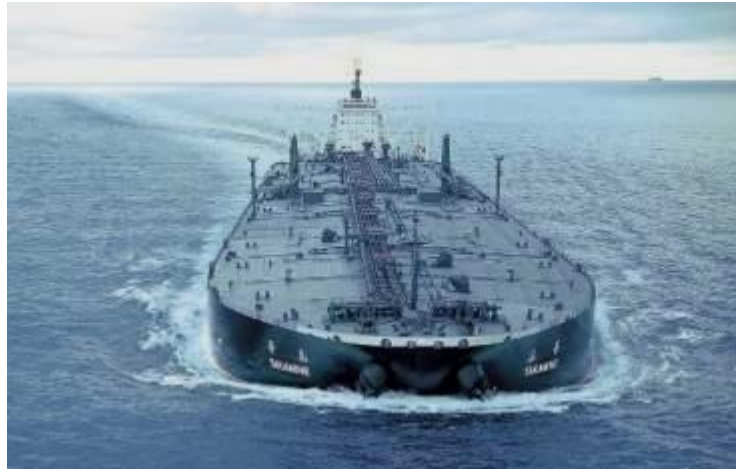
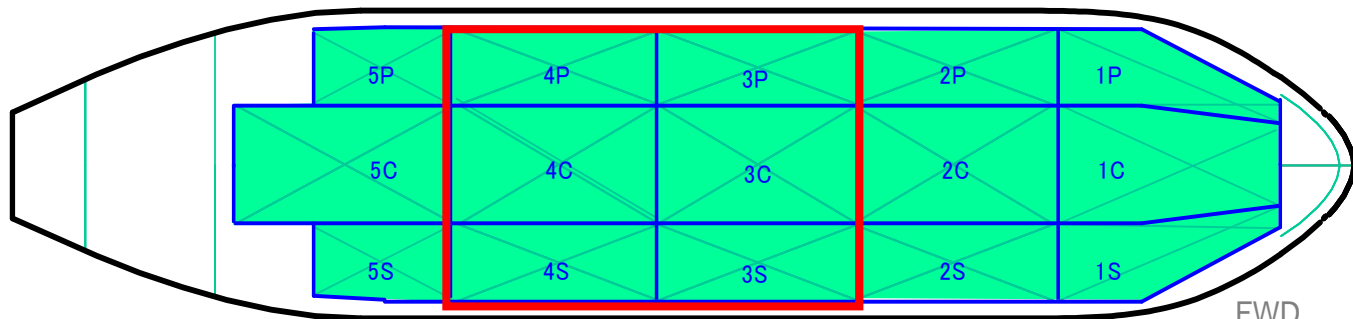
Onboard Evaluation Results of VLCC using NSGP™-1 at 10years

The CRS applied 6 tanks without protective coating: **Inspection area**

FWD

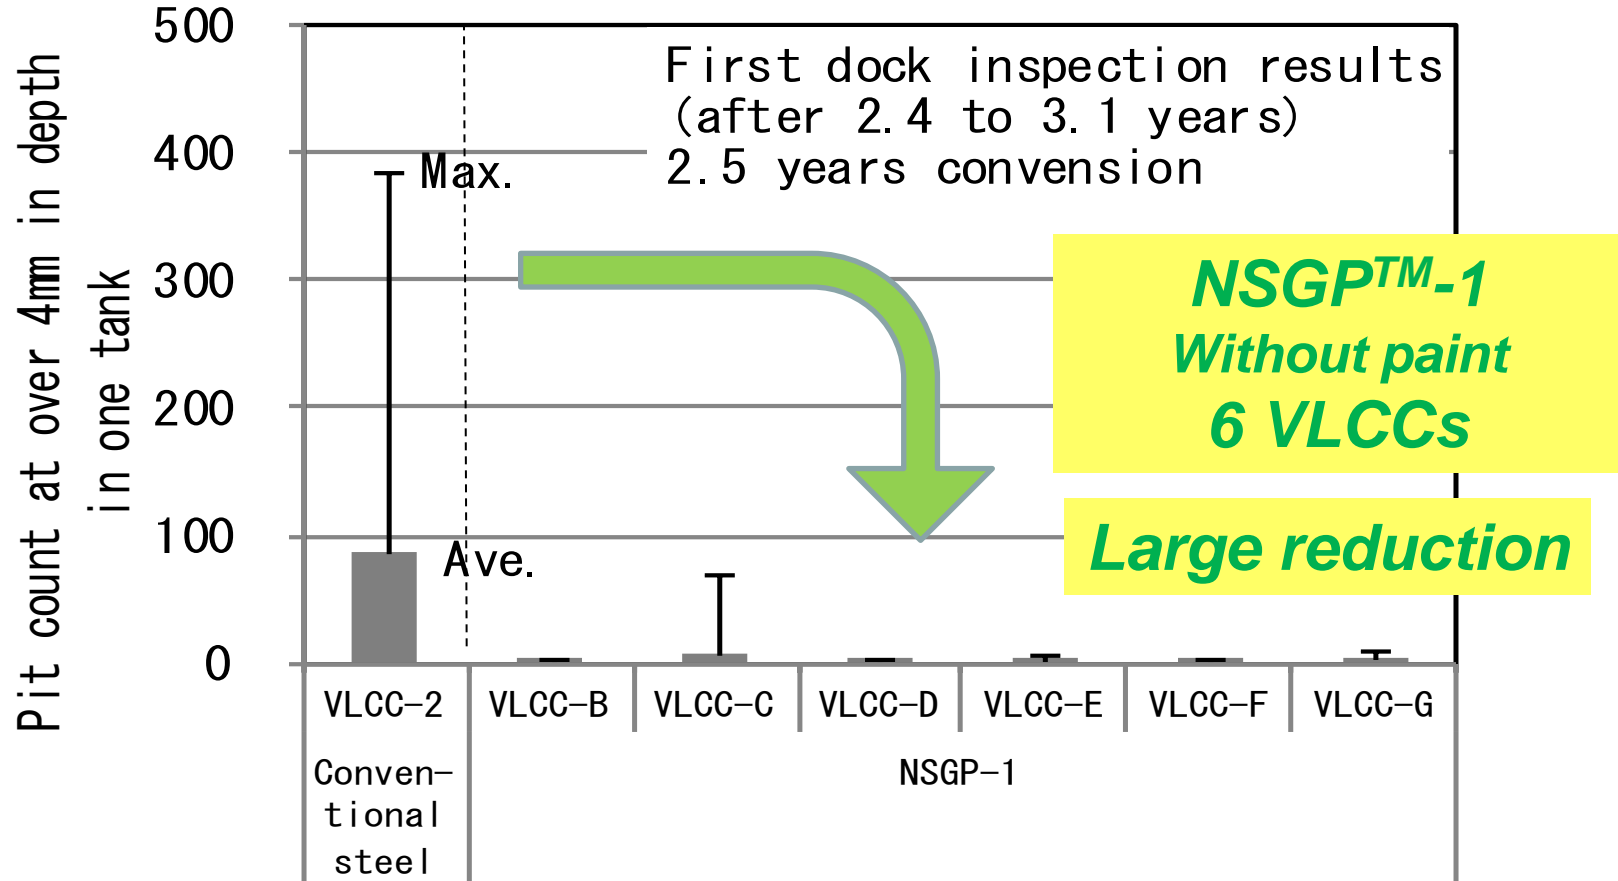
Fig. Observed pit count at over 4 mm in depth for conventional steel and NSGP™-1

NSGP™-1 Showed Good Pitting Corrosion Resistance in all 6 VLCCs

**Conventional steel
Without paint**

- Pit count of VLCCs applying the NSGP™-1 was much lower than that of VLCCs using conventional steel. **And structural countermeasure was found to be effective against pits.**
- Direct evidence for termination pit growth was observed.
- Approved for CRS from Class NK and ABS.

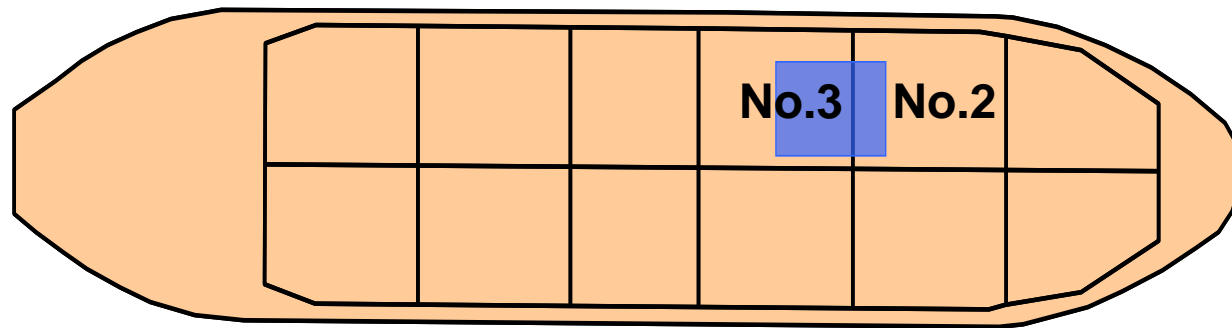
Upper deck

NSGP™-2 was applied to an Aframax tanker for No. 2 and 3 COT's upper deck plates.

Onboard investigation at 2.7, 5.0, 8.1 and 10 years

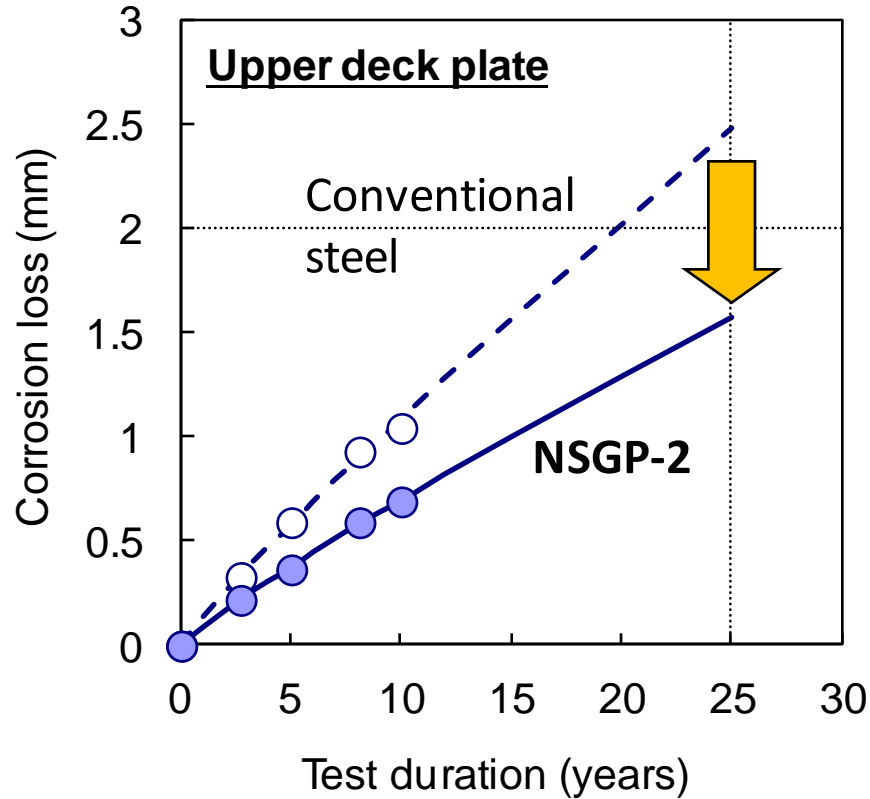
Fig. Results of the exposure test on the upper deck of an Aframax tanker

- Corrosion loss is less than 0.7 mm/10years.
- It is considered that the corrosion loss will not exceed 2 mm after 25 years.

- Corrosion loss for deck plate was 38% down to conventional steel (less than 2 mm / 25year) by onboard investigation.
- It is thought that the corrosion loss will not exceed 2 mm after 25 years.
- Approved for CRS from LR, Class NK and ABS.
