Table A.1 Overview of corrugated bulkhead damages

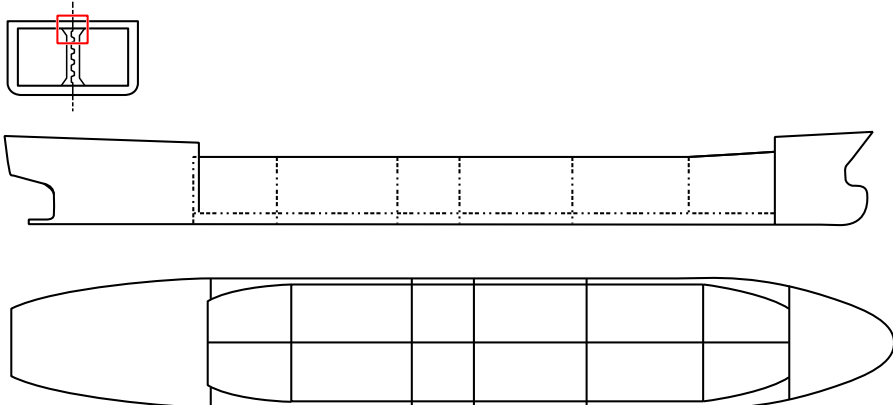
Case 1.1				
Ship-Type	Chemical Tanker		Capacity [dwt]	Abt. 17,000
Year of build	2000	Vessels age when damage found		7 years
Main dimensions	L	138 m	B	22 m
	T	-	D	11 m
Bulkhead	Horizontally corrugated		Longitudinal & transverse bulkhead	
Stool	None fitted			
Material	Stainless steel			
Overview of damage location	Longitudinal corrugated bulkheads (horizontal type) in way of mid cargo area.

Description of damage	Cracks developed at longitudinal corrugated bulkhead (horizontal type) following fillet welding connection to access trunk wall. The crack initiated at crossing section with vertical stiffener of trunk wall on center line.

<p>Cracks were gouged out and re-welded, and carling was additionally fitted along web plate of longitudinal corrugated bulkhead in access trunk.</p>
Probable cause of Damage	<p>Detail design</p>
Recommendation for design improvement	<p>In case of horizontally corrugated bulkheads, additional carlings to be fitted also along with web plate of bulkhead in order to reduce stress concentration caused by longitudinal moment. Any connection between the corrugation web and crossing stiffeners or other structure must be supported by brackets or carlings.</p>

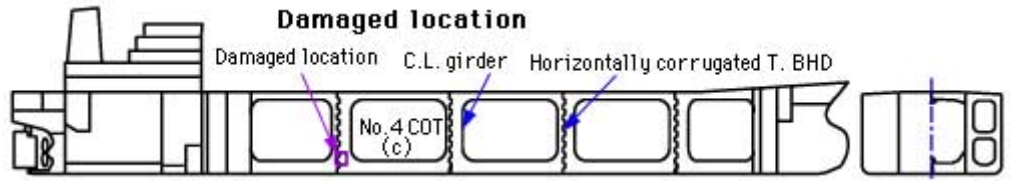
Case 1.2				
Ship-Type	Product Tanker		Capacity [dwt]	Abt. 30,000
Year of build	1990	Vessels age when damage found		11 years
Main dimensions	L	160 m	B	-
	T	-	D	-
Bulkhead	Horizontally corrugated		Transverse bulkhead	
Stool	None fitted			
Material	HT32			
Overview of Damage location	<p>Transverse corrugated bulkhead (horizontal type) in way of cargo tank area.</p>

Description of damage	<p>Crack developed on corrugated bulkhead. The crack was initiated from a toe end of tripping bracket to C.L. girder.</p>

Description of repair	<p>Cracked area of the bulkhead and the bracket were partly renewed. An additional small bracket was also fitted at toe end of the tripping bracket for reinforcement (reduce stress concentration).</p>

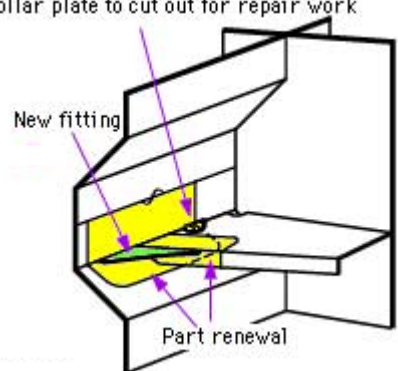
Probable cause of damage	Detail design			
Recommendation for design improvement	Soft end type bracket to be considered at such high stress area. Preferably the tripping brackets should be aligned with the inclined web of the corrugation.

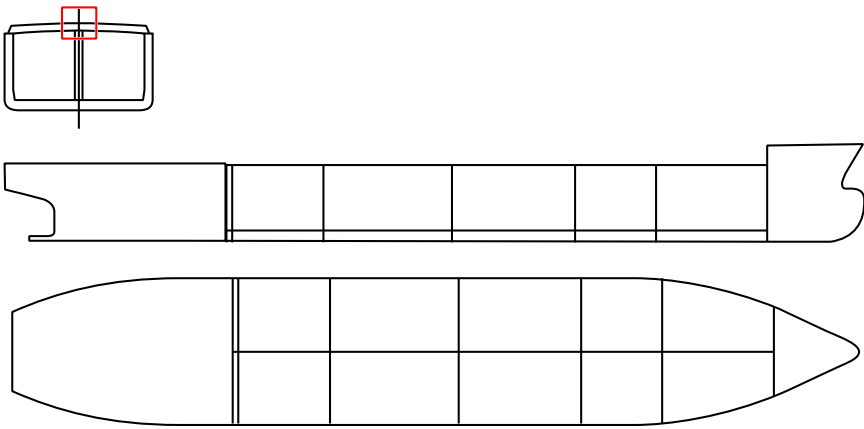
Case 1.3				
Ship-Type	Chemical Tanker		Capacity [dwt]	Abt. 9,000
Year of build	1998	Vessels age when damage found		9 years
Main dimensions	L	105 m	B	19 m
	T	-	D	10 m
Bulkhead	Vertically corrugated		Longitudinal bulkhead	
Stool	None fitted			
Material	Stainless steel			
Overview of damage location	Longitudinal corrugated bulkheads in way of crane post at mid cargo area.

Description of damage	Crack developed on longitudinal corrugated bulkhead connection to upper deck. The crack initiated from fillet welding at the corrugation corner under a crane post.

Description of repair	Cracks were gouged and re-welded by full penetration welding.			
Probable cause of damage	Detail design, insufficient welding			
Recommendation for design improvement	Sufficient reinforcement from upper deck side is preferable due to restriction for reinforcement from tank side. Full penetration welding should be generally preferred in way of supporting structures if the connection is exposed to high stresses.

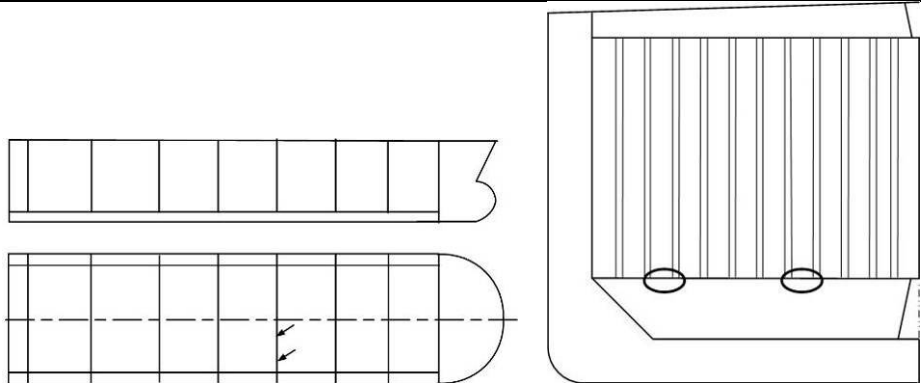
Description of damage	<p>Note Sloped Stool to shelf plate by full penetration welding</p>

<p>Two cracks approx. 50mm in welds between bottom stool shelf plate and sloping plate in way of corrugation corners</p>			
Description of repair	Affected welds gouged from both sides and rewelded. Additionally collar plates have been fitted to scallops in way.			
Probable cause of damage	Stress concentrations in-way of the corrugation corner due to lack of web support and scallops.			
Recommendation

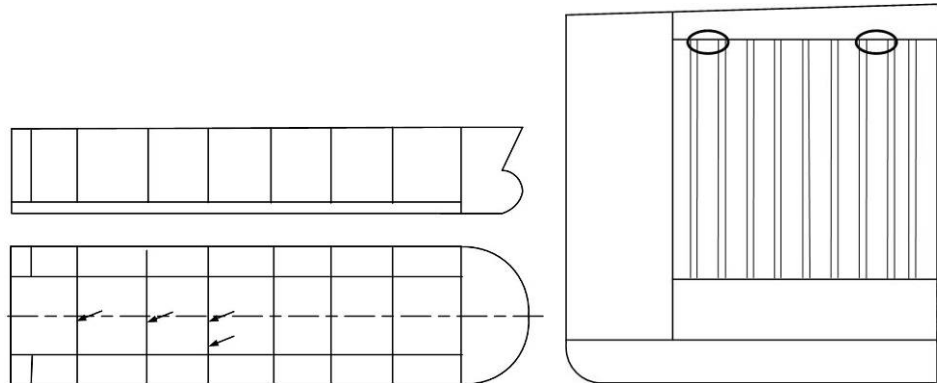
<p>Cracks in upper stool sloped plate near junction of upper stool sloped side plate and upper stool shelf plate.</p>			
Description of repair	<ol style="list-style-type: none">1) Upper stool shelf plating of void space cropped and part renewed with increased thickness2) Upper stool sloped side plating cropped and part renewed with increased thickness3) Longitudinal bracket at bottom of void space (11mm) connecting stool side stiffeners at bottom of void space modified4) Additional bracket fitted in line with corrugated bulkhead web underneath			
Probable cause of damage	Detail design

Recommendation for design improvement	Scallops/openings to be avoided in way of connection of sloped stool plate to shelf plate

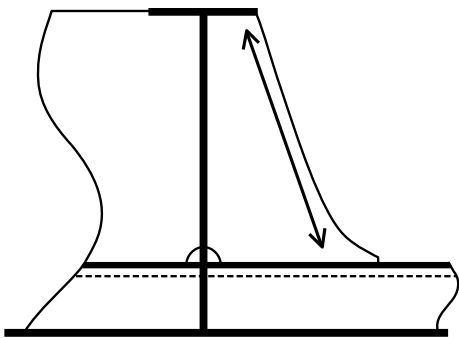
<p>Note: On above picture the deck longitudinal is cracked through to the deck plating. The majority of the other cracks found were less than 10 mm deep. On above picture a pipe support is landing adjacent to the bracket nose on the same deck longitudinal. This might have contributed to the problem at this position. However cracks are also appearing where there are no pipe supports.</p>
Description of repair	<p>Cracks in bracket toe welding and/or bulb:</p> <ul style="list-style-type: none"> • Determine extent of crack by dye penetration • Gouge out existing fillet welding 200 mm away from bracket toe. • Re-weld with full penetration. • Open crack in bulb by gouging and re-welding. • All welding to be ground smooth by means of pencil grinder (not disc grinder). <p>See also sketch below.</p>

Cracks in profile up to 50% of profile height:

- Determine extent of crack by dye penetration
- Stop drill crack at the crack tip by hole of diameter 50% higher than the profile thickness.
- Open crack in bulb by gouging and re-welding.
- Apply bracket as shown on above sketch of temporary repair
- All welding to be ground smooth by means of pencil grinder (not disc grinder).
- Drain holes within 200 mm from bracket nose to be closed by doubling plate.

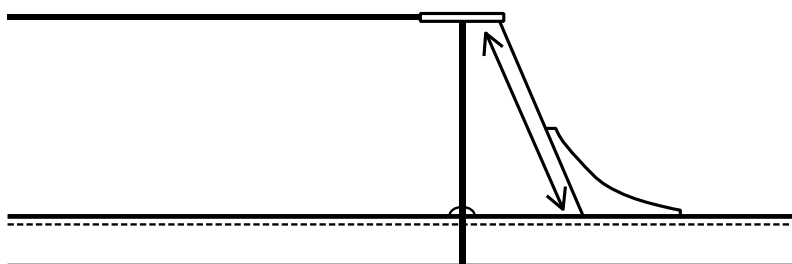
Cracks in profile deeper than 50% of profile height:

- Determine extent of crack by dye penetration
- Crop and renew cracked profile by insert. (Minimum distance from insert to any existing profile lightening hole shall be minimum 500 mm)
- Apply bracket as shown on below sketch.
- All welding to be ground smooth by means of pencil grinder (not disc grinder).
-

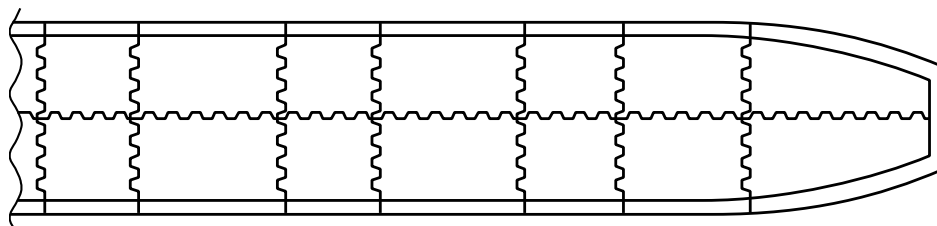
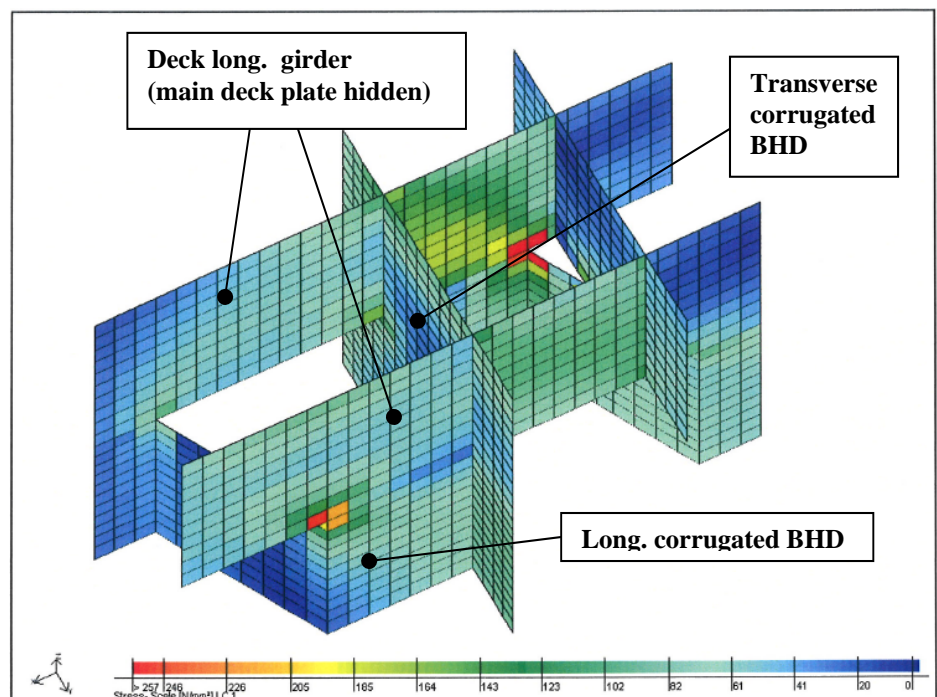
Drawing/Sketch of original structure

Description of damage	Cracks developed at corrugation corners in areas of intersection of longitudinal bulkheads and longitudinal deck girder.

Continuous support of the web plate of the corrugated bulkhead to be provided on upper deck.

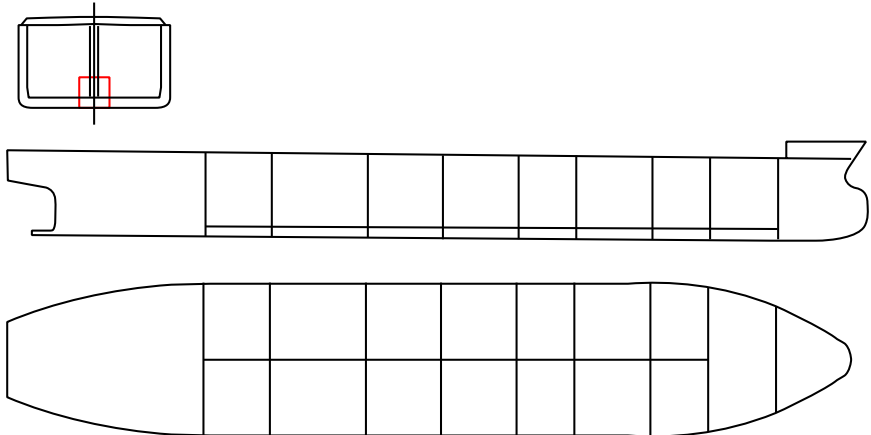
Case 1.9				
Ship-Type	Chemical Tanker		Capacity [dwt]	Abt. 11,000
Year of build	1998	Vessels age when damage found		5 years
Main dimensions	L	110 m	B	20 m
	T	-	D	11 m
Bulkhead	Vertically corrugated		Longitudinal bulkhead	
Stool	None fitted			
Material	Stainless steel			
Overview of damage location	Inner bottom longitudinals in line with face of longitudinal corrugated bulkheads in cargo areas.

Description of damage	Cracks developed at penetrations of the inner bottom longitudinals through floors.

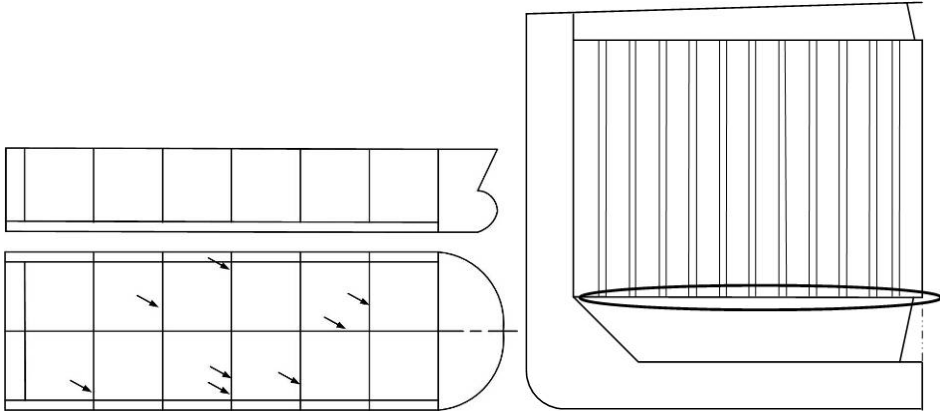
Description of damage	<p>Note: Welding of stool side to shelf plate by deep penetration</p> <p>Note: Partial backing structure for webs of corrugation is provided in some locations</p>

<p>Cracks at intersection of lower transverse bulkhead stool side plate connection to shelf plate in way of corners of corrugation flanges at locations where no backing structure for corrugation web</p>			
Description of repair	Backing brackets below web plate of corrugated bulkhead extended			
Probable cause of damage	Lack of Continuity			
Recommendation for design improvement	For corrugations of high tensile steel, backing brackets to be fitted below corrugation webs

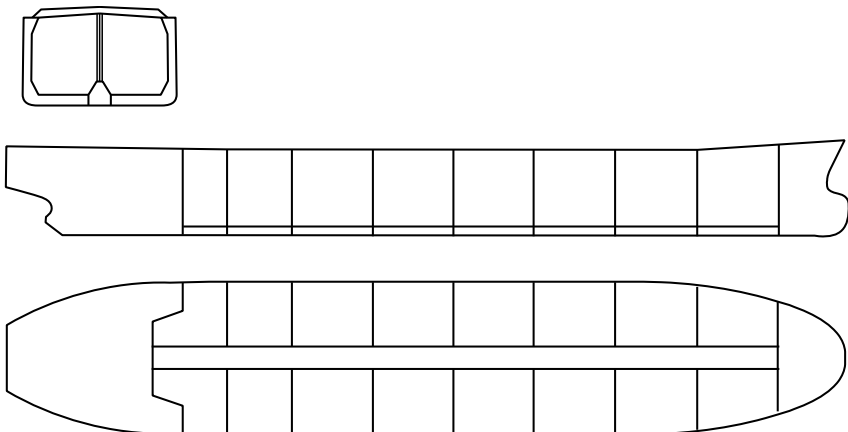
Description of damage	Cracks developed around transverse corrugated bulkhead connection to stool structure. Cracks were initiated mainly from corner area of corrugated bulkhead but also from stool slant plate connection to top plate just under the corner area.

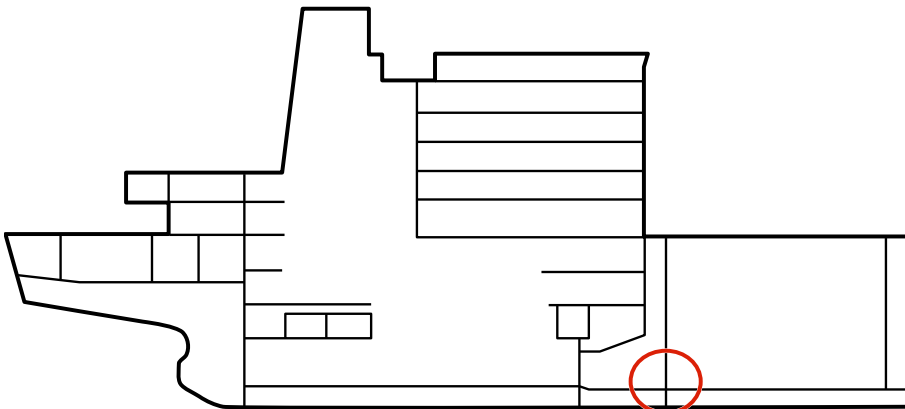
<p>Damage shown on sketch of original structure. Damage located in lower aft end termination of the longitudinal bulkhead.</p>

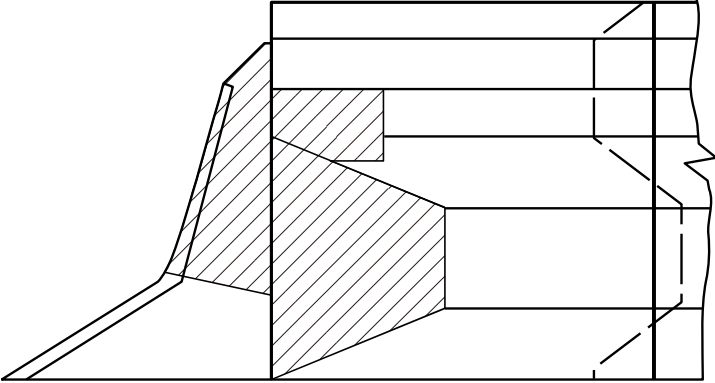
Case 1.12	
Description of repair

Probable cause of damage	<ul style="list-style-type: none"> • Detail design • Lack of continuity • Generally, the scarfing brackets are undersized.
Recommendation for design improvement	<ul style="list-style-type: none"> • See Sketch • For further improvement a bigger and softer bracket.

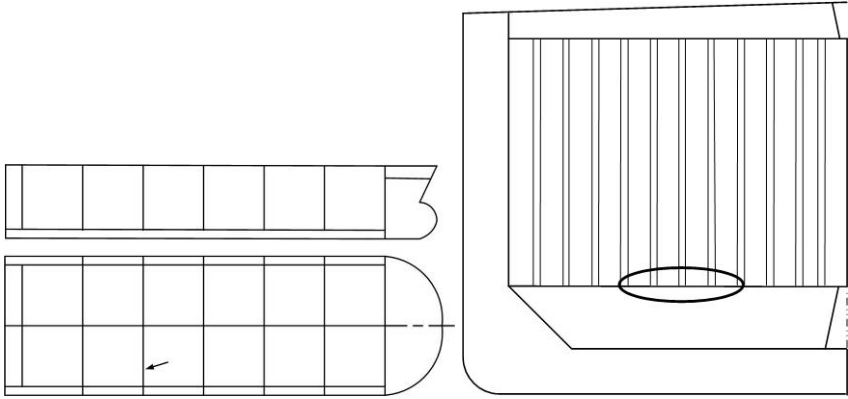
Description of damage	<p>Note Connection of sloped plating to shelf plate by penetration welding</p>

<p>Fillet welding between the shelf plate and sloped plating of lower stool cracked approx. 500 mm in the middle No.4 Cargo Tank (P) and No.4 Ballast Water Tank (P) and oil leaked into the bottom stool in No.4 B.W.T.(P). Cracks and paint cracks were found at the round end corners of transverse corrugated bulkhead inside of bottom stool in No.4 Cargo Oil Tank(P)/No.4 Ballast Water tank(P).</p>			
Description of repair	Brackets fitted side of bulkhead at frame 55,63,71 & 79 corrugation in way of shelf plate bottom connection and gauging out stool plate to self plate connection and welding back after examination with MPI. The above repair carried out at builder suggestion based on history of crack of sister vessel and on this vessel which found and gauged out during above repairs.

Probable cause of damage	Lack of continuity Insufficient throat thickness of fillet weld			
Recommendation for design improvement	Continuous support of corrugated bulkhead inside of bottom stool to be provided Full penetration welding

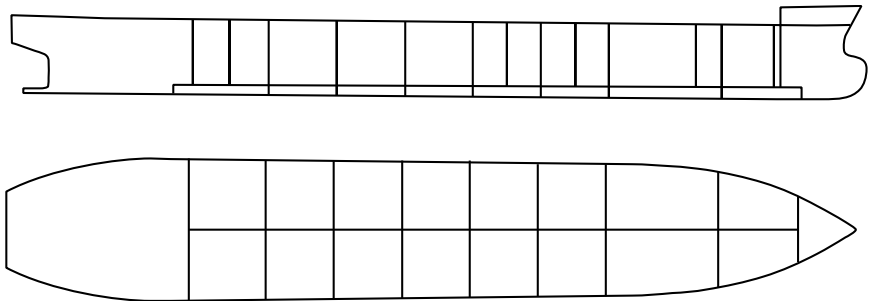
Case 1.14				
Ship-Type	Chemical Tanker		Capacity [dwt]	Abt. 20,000
Year of build	2002	Vessels age when damage found		5 years
Main dimensions	L	141 m	B	24 m
	T	-	D	12 m
Bulkhead	Vertically corrugated		Longitudinal bulkhead	
Stool	None fitted			
Material	Stainless steel			
Overview of damage location	Longitudinal corrugated bulkheads in entire cargo tank areas.

Description of damage	Cracks developed around corners of corrugated bulkhead connection to inner bottom plates.

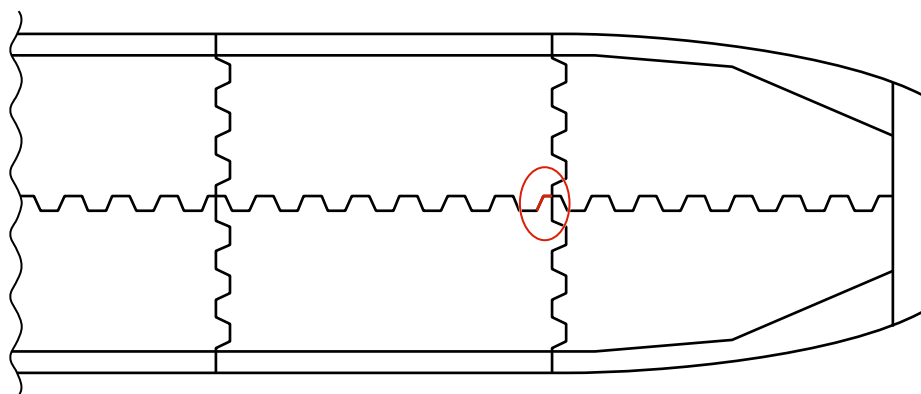
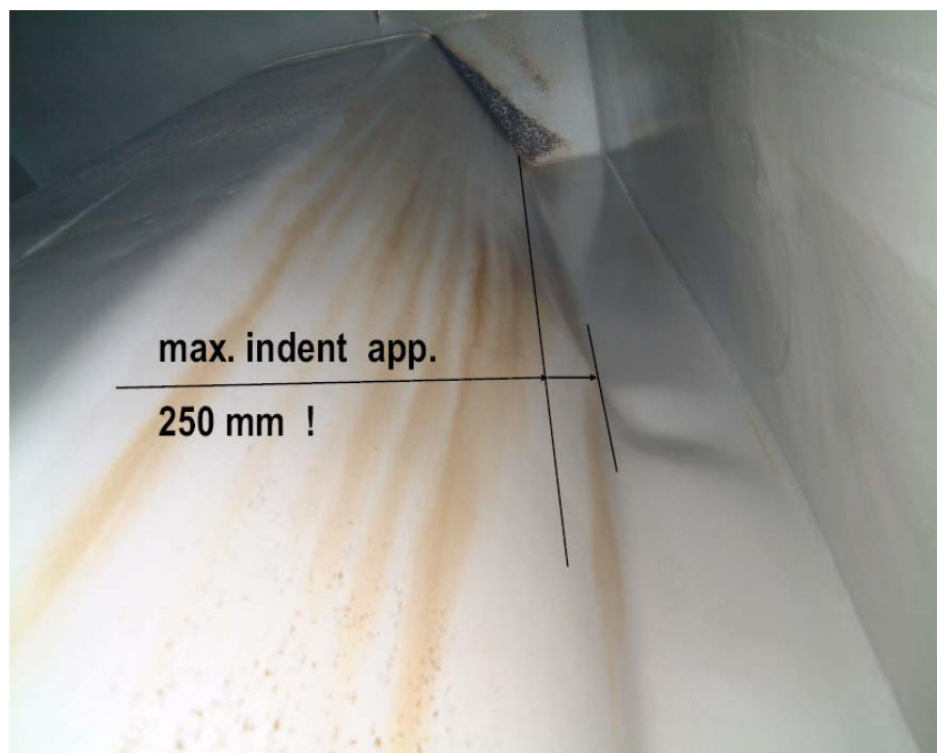
Drawing/Sketch of original structure

Description of damage	<ol style="list-style-type: none"> 1. Indent of longitudinal bulkhead occurred at half height of tank at frame 105. 2. Crack occurred between longitudinal bulkhead and main deck in way of corrugation corner below cutout in deck longitudinal at frame 105.
Description of repair	<ol style="list-style-type: none"> 1. Renewal of longitudinal bulkhead in way of frames 105-106. 2. Deck longitudinal was supported by HP200×11.5 in way of frames 105-106. Cutout in deck longitudinal was closed by insert.
Probable cause of damage	<ol style="list-style-type: none"> 1. Unknown 2. Poor detail design
Recommendation for design improvement	Discontinuities of supporting structure (e.g. cutouts in deck longitudinal girders) in way of corrugation corners are to be avoided.

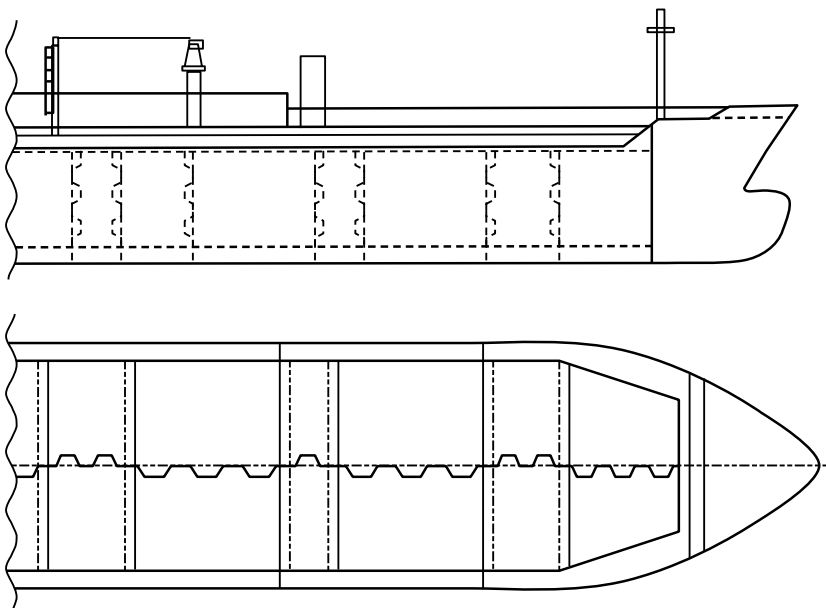
Cracks of 60mm to 250mm developed in longitudinal bulkhead at corrugation corners at frames 115 and 130 (connection to transverse bulkheads), and frame 119 (connection to tank top plate). One crack (250mm) developed in transverse bulkhead at corrugation corner at frame 130 (connection to longitudinal bulkheads).

Description of repair	All cracks were gouged and re-welded.
Probable cause of damage	Misalignment Insufficient throat thickness of fillet weld
Recommendation for design improvement	Full penetration welding.

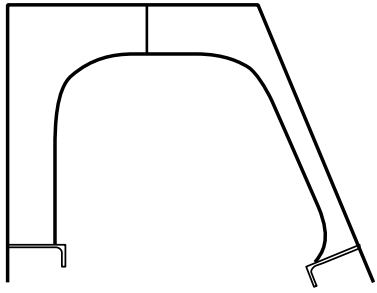
Case 1.18

</div> <p>Cracks were found in the welds connecting the corrugated bulkhead to the shelf plate and the shelf plate to the sloping plate. The cracks were found in way of the radius of the corrugated bulkhead and at the toe of the bracket within the stool (water ballast tank).</p>			
Description of repair	<ul style="list-style-type: none">Welds gouged out, replaced with full penetration welds and groundBrackets modified as below to remove the toe of the bracket within the stool from the shelf plate/sloping plate weld

Probable cause of damage	Poor detail design and lack of full penetration welding, creating hotspot at toe of stool bracket in way of highly stressed corrugated bulkhead radius.
Recommendation for design improvement	Brackets in stools, backing up corrugated bulkhead webs, should preferably be continuous and extend down the sloping plate. If in conflict with the normal brackets inside the stool, the brackets should be terminated close to the middle of the shelf plate.

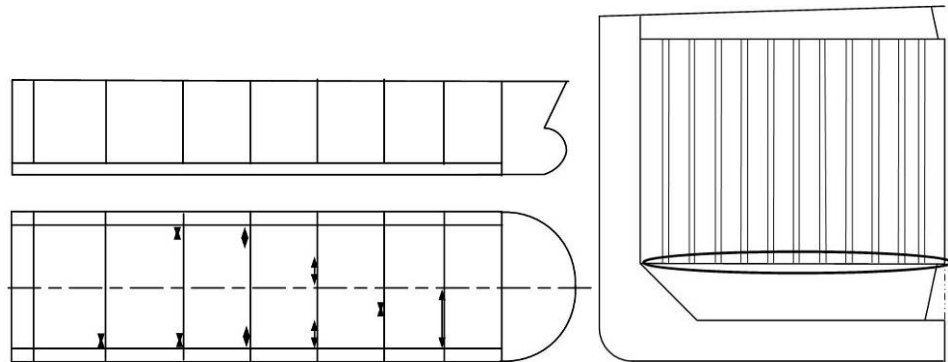
Case 1.19				
Ship-Type	Oil Product Tanker		Capacity [dwt]	Abt.36,000
Year of build	1992	Vessels age when damage found		15 years
Main dimensions	L	174 m	B	30 m
	T	12 m	D	17 m
Bulkhead	Vertically corrugated		Transverse bulkhead	
Stool	Lower and upper stool			
Material	Grade A			
Overview of damage location

<p>Magnetic Particle Inspection of forward and aft corrugated bulkhead weld seams at the connection with the lower stools revealed porosities and lack of penetration.</p>			
Description of repair	Above affected weld seams were gouged and full penetration welded. Existing scallops in way of the water ballast tank internals (stool spaces) were closed with welded collar plates.			
Probable cause of damage	Poor welding control.			
Recommendation for design improvement	Scallops/openings to be avoided in way of connection of sloped stool plate to shelf plate. Weld connection between bulkhead and stool to be full penetration and to be confirmed with ultrasonic testing.

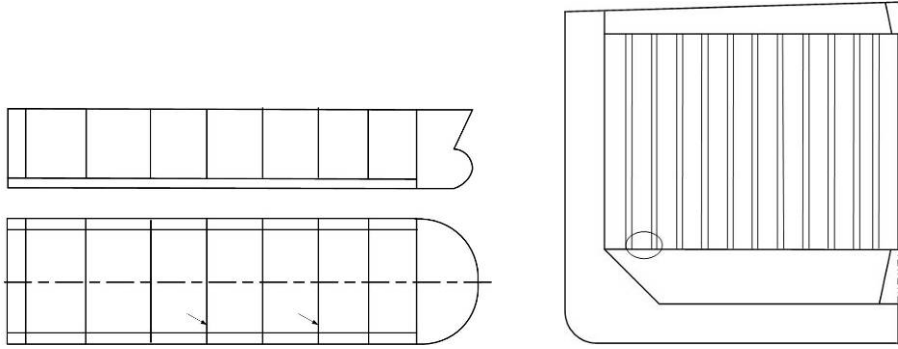
Case 1.20				
Ship-Type	Oil Product Tanker		Capacity [dwt]	Abt.36,000
Year of build	1992	Vessels age when damage found		5 years
Main dimensions	L	174 m	B	30 m
	T	12 m	D	17 m
Bulkhead	Vertically corrugated		Transverse bulkhead	
Stool	Lower and upper stool			
Material	Grade A			
Overview of damage location

<p>Note: Shedder plate to lower stool connected by full penetration welding</p> <p>Aft bulkhead of Cargo Oil tank numbers 2 and 4 cracked at connection of outermost corrugation shedder plate lower edge to lower shelf plate on starboard side.</p>			
Description of repair	Cracked areas of plating cropped and part renewed as found necessary. On completion repairs examined and found satisfactory, tested tight.			
Probable cause of damage	Poor welding control, poor alignment between shedder plate and stool sloping plate.			
Recommendation for design improvement	Ensure weld between shedder plate and shelf plate is full penetration through ultrasonic testing. Ensure good alignment between shedder plate lower edge and stool sloping plating.

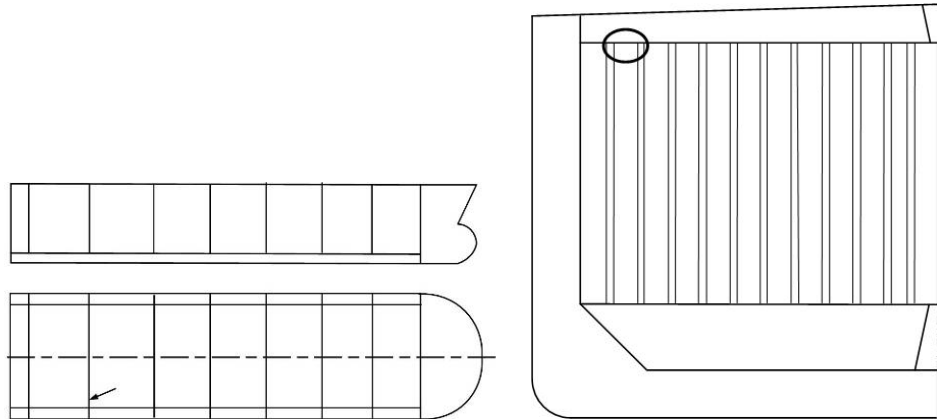
Case 1.21				
Ship-Type	Oil Product Tanker		Capacity [dwt]	72,000
Year of build	2004	Vessels age when damage found		11 years
Main dimensions	L	219 m	B	32 m
	T	14 m	D	20 m
Bulkhead	Vertically corrugated		Transverse bulkhead	
Stool	Lower and upper stool			
Material	Grade A			
Overview of damage location

<p>Welding cracked at intersection of upper transverse bulkhead stool side plate connection to shelf plate.</p>			
Description of repair	Weld gouged and re-welded.			
Probable cause of damage	Welding defects			
Recommendation for design improvement	None

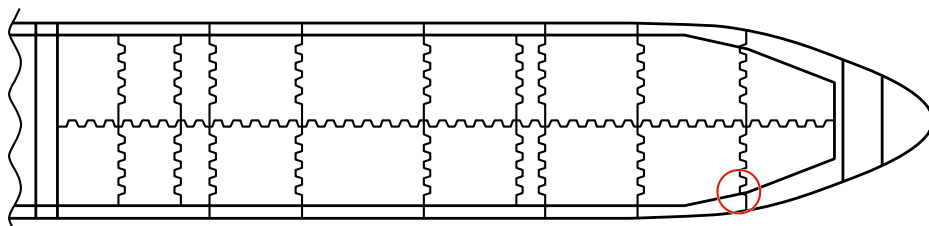
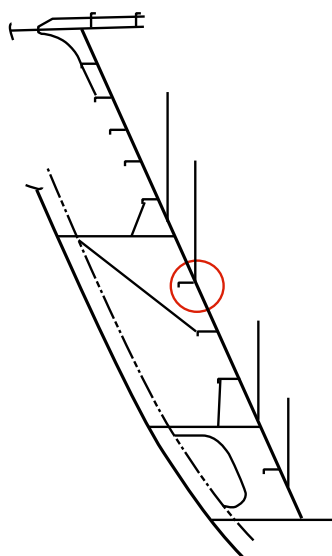
Case 1.22				
Ship-Type	Chemical Tanker		Capacity [dwt]	Abt.6,000
Year of build	1996	Vessels age when damage found		5 years
Main dimensions	L	95 m	B	16.5m
	T	6 m	D	8 m
Bulkhead	Vertically corrugated		Transverse bulkhead	
	Height from tank top to deck		6.6 m	
Stool	None fitted			
Material	Duplex stainless steel			
Overview of damage location

<p>Cargo Tank No 1 STBD</p> <ul style="list-style-type: none"> trans. corrugated BHD Fr.123 550 aft off Fr.123 Sloped Plate Cargo Tank No 2 STBD <p>Crack of approx. 70mm developed in transverse corrugated bulkhead 550mm aft of Fr.123 running parallel to weld seam between the transverse bulkhead and ballast tank at a height of about 3.5m above the bottom of the cargo tank.</p>
<p>Description of repair</p>	<p>Crack was gouged and re-welded.</p>
<p>Probable cause of damage</p>	<p>Insufficient throat thickness of fillet weld. Misalignment between transverse corrugated bulkhead and supporting bracket in ballast tank.</p>
<p>Recommendation for design improvement</p>	<p>Full penetration welding and good alignment.</p>

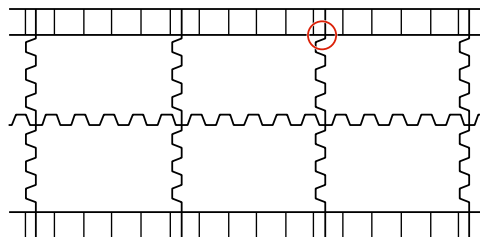
Case 1.23				
Ship-Type	Chemical Tanker		Capacity [dwt]	Abt.33,500
Year of build	1997	Vessels age when damage found		9 years
Main dimensions	L	166 m	B	25 m
	T	12 m	D	15 m
Bulkhead	Vertically corrugated		Transverse bulkhead	
	Height from tank top to deck		--	
Stool	None fitted			
Material	Steel grade EH32			
Overview of damage locationnn

<p>Crack developed at weld seam of transverse corrugated bulkhead (Fr. 47 3/5) in way of lower slope of ballast tank.</p></div>

Case 1.23	
Description of repair	Insert plate in the transverse corrugated bulkhead and the slope of double bottom tank
Probable cause of damage	Insufficient throat thickness of fillet weld. Misalignment between transverse corrugated bulkhead and wing web frame.
Recommendation for design improvement	Full penetration welding and good alignment.
