Tanker Structure Co-operative Forum

Outfitting related structural defects

The paper reviews the outfitting defects based on TSCF member experience and provides analysis on potential causes and repair proposals.

Reference	Revision N°	Revision Date
IP 001/2011	0	2011/03/31

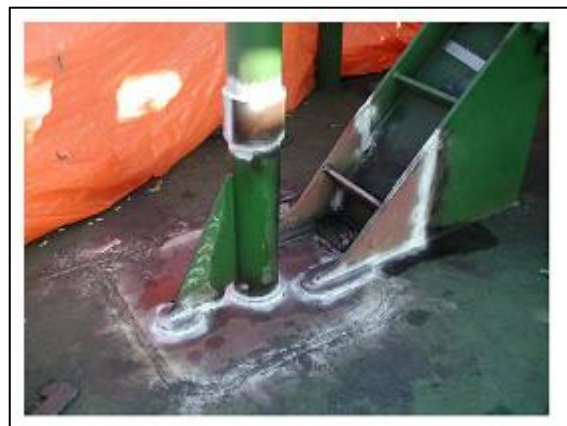
Corrective action

Location:	Pipe Thrust Stopper
Category:	Design
Type of Defect:	Cracks occurred at the toe of the brackets
Cause:	These brackets were originally designed with radii and 10-15 mm toes. The stoppers were not aligned with underdeck longitudinals and were instead supported by transverse stiffeners. Fracture due to stress concentration. As stoppers were not aligned directly with longitudinals, the brackets terminated on soft plate, leading to a stress concentration. Analysis carried out after the incident indicated that the underdeck structure was sufficient for the loads induced by the pipes, however the toes of the brackets did increase the stress in the deck. This stress concentration quickly led to cracks in an already highly stressed deck
Corrective Action:	The vessel in service was retrofitted with additional underdeck support and doublers were added in way of the toes. The doubler pads reduced the stress concentration in the deck sufficiently to eliminate cracking in this area. For the follow ships in this series, it was recommended that the stoppers be aligned with longitudinals or integral doubler plates

Crack at the pipe stopper connection to main deck toe

Recommendation:	Align with underdeck structure and fit well rounded brackets with soft toes, aligned with longitudinal below, with maximum toe height 10-15mm at connection of support to deck. If necessary additional under deck supports to be made to align with brackets

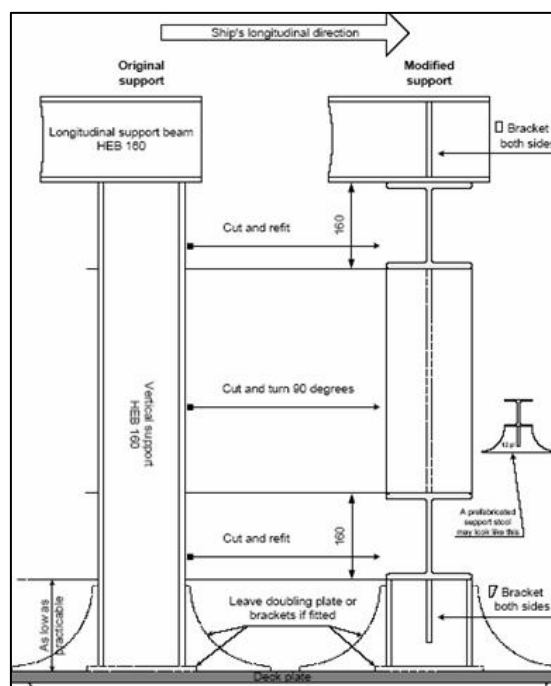
Drawing showing pipe support modification

Crack i.w.o fillet welding i.w.o pipe support connection to upper deck.

Many typical outfit item connections to upper deck – one of which is modified pipe support.

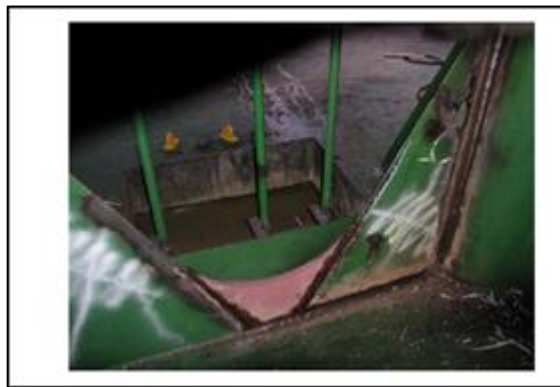
Corrective action

Figure 35 Misalignment Brackets of Vent Riser Pipe Support

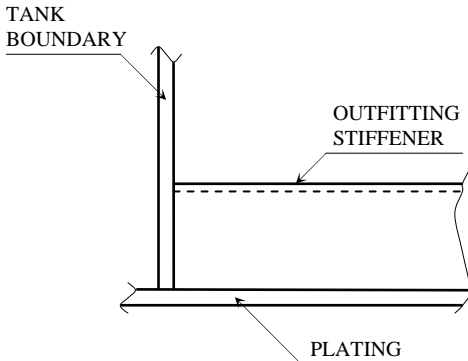
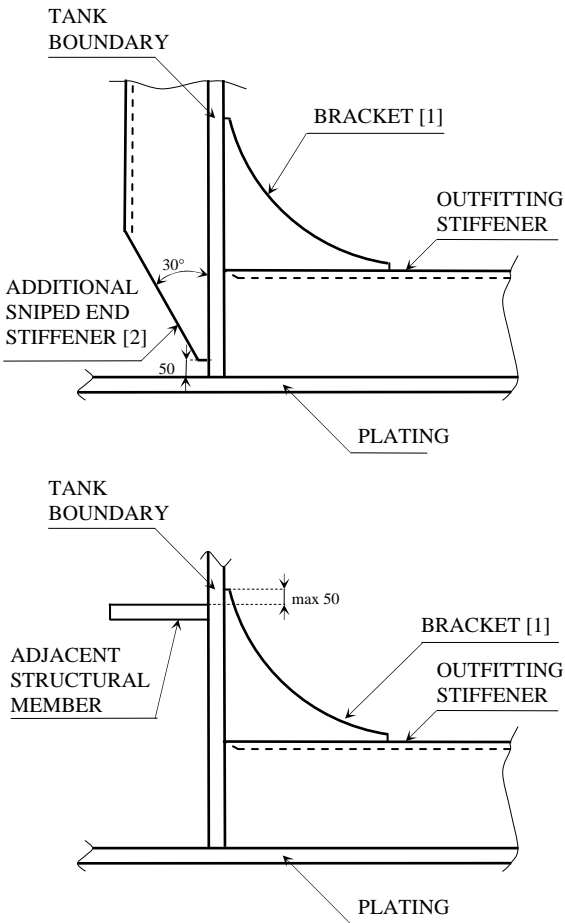
DESCRIPTION: CONNECTION OF OUTFITTING STIFFENER WITH A PLATE CONSTITUTING TANK BOUNDARY		APPENDIX 2
LOCATION: ENGINE ROOM, CARGO HOLD, FORE PART		
TO BE AVOIDED	TYPICAL RECOMMENDATION

REMARKS: [1]: Brackets are to be fitted in compliance with FIGURE 11 [2]: The additional sniped end stiffener is to be aligned with the other stiffener and bracket

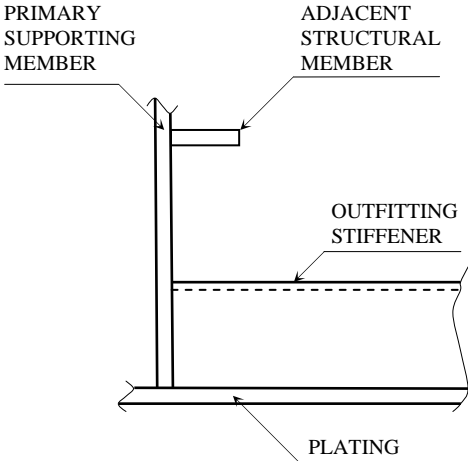
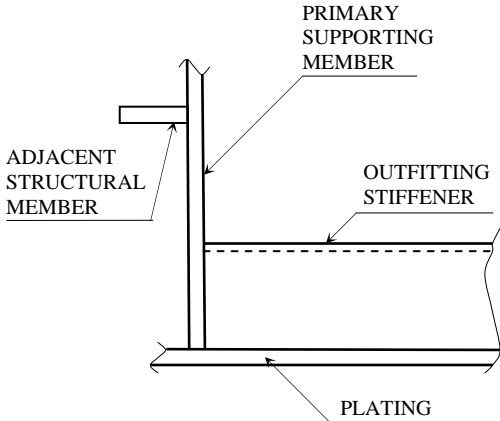
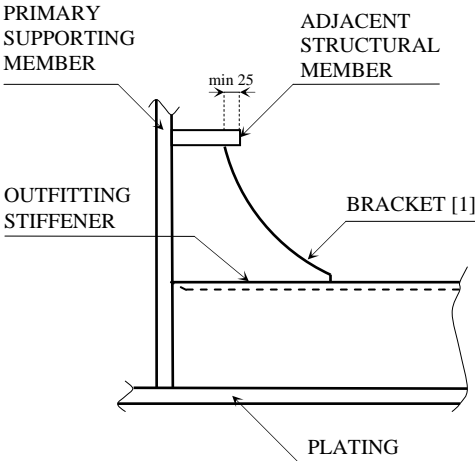
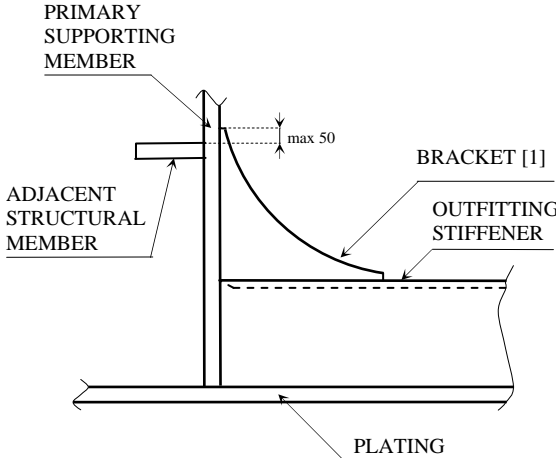
TANKER STRUCTURE CO-OPERATIVE FORUM	SUBJECT: TYPICAL RECOMMENDATIONS FOR OUTFITTING RELATED STRUCTURAL REINFORCEMENT	
		FIGURE 3

DESCRIPTION: CONNECTION OF OUTFITTING STIFFENER WITH ADJACENT STRUCTURAL ELEMENT PRIMARY SUPPORTING MEMBER [2]		APPENDIX 2
LOCATION: ENGINE ROOM, CARGO HOLD, FORE PART		
TO BE AVOIDED		TYPICAL RECOMMENDATION
<div>

</div>
REMARKS: [1]: Brackets and bracket toes are to be fitted in compliance with FIGURE 11 [2]: The details in the present figure are applicable for connection of outfitting stiffener with the flange of L-section primary supporting members

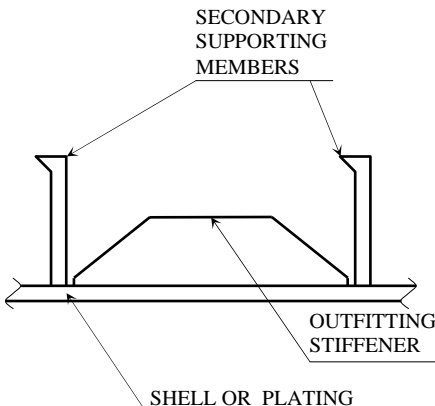
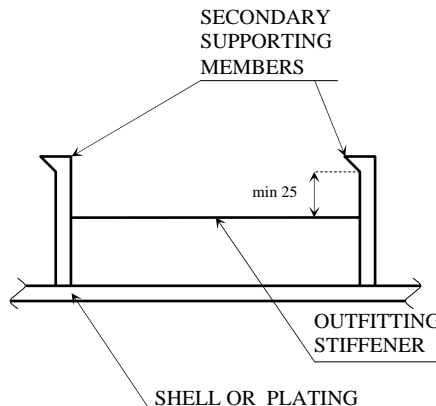
TANKER STRUCTURE CO-OPERATIVE FORUM	SUBJECT: TYPICAL RECOMMENDATIONS FOR OUTFITTING RELATED STRUCTURAL REINFORCEMENT	FIGURE 4

DESCRIPTION: CONNECTION OF OUTFITTING STIFFENER WITH SECONDARY SUPPORTING MEMBERS		APPENDIX 2
LOCATION: ENGINE ROOM, CARGO HOLD, FORE PART		
TO BE AVOIDED		TYPICAL RECOMMENDATION

REMARKS: When any outfitting stiffener has a face plate or flange, it is to be sniped and tapered to an angle not greater than 30°

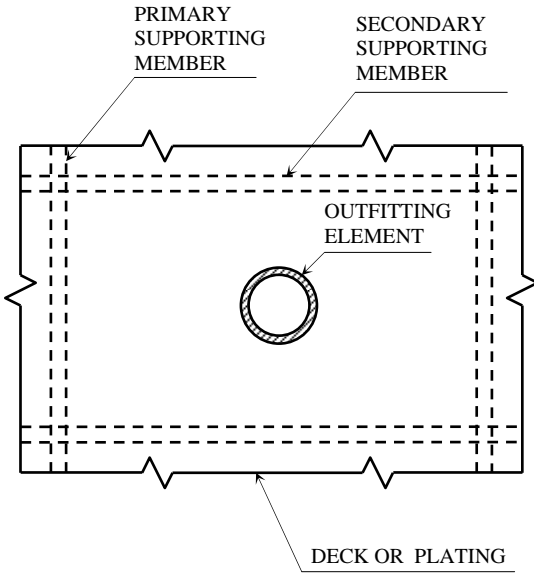
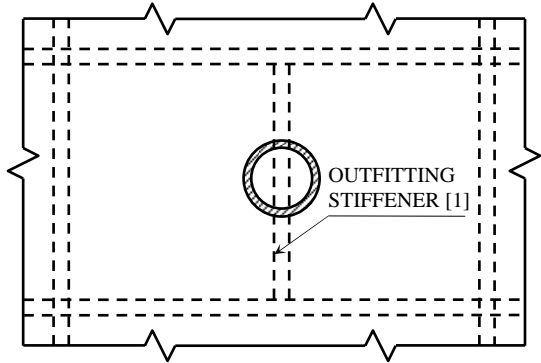
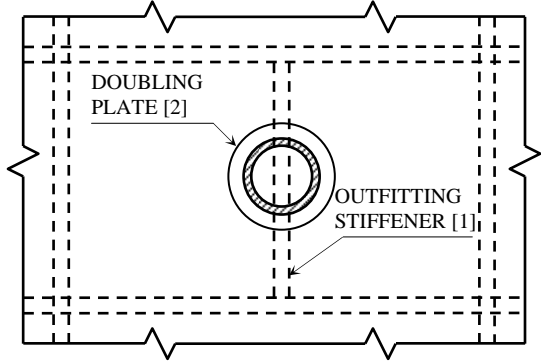
<p>TANKER STRUCTURE CO-OPERATIVE FORUM</p></div>	SUBJECT: TYPICAL RECOMMENDATIONS FOR OUTFITTING RELATED STRUCTURAL REINFORCEMENT	
		FIGURE 5

DESCRIPTION: REINFORCEMENT UNDER DECK OR BULKHEAD DUE TO OUTFITTING ROUND ELEMENT WITH SMALL SECTION UNDER LOW LOAD		APPENDIX 2
LOCATION: ENGINE ROOM, CARGO HOLD, FORE PART		
TO BE AVOIDED	TYPICAL RECOMMENDATION	
<div>

<p>DOUBLING PLATE [2]</p><p>OUTFITTING STIFFENER [1]</p></div>	
REMARKS: [1]: Outfitting stiffeners are to be connected as in FIGURE 4 [2]: Doubling plates are to be used only when appropriate, when under compression only. Doubling plates are to comply with FIGURE 13		
<div>

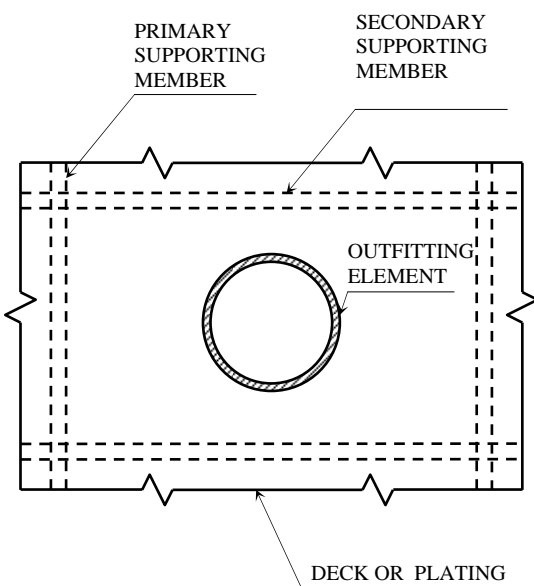
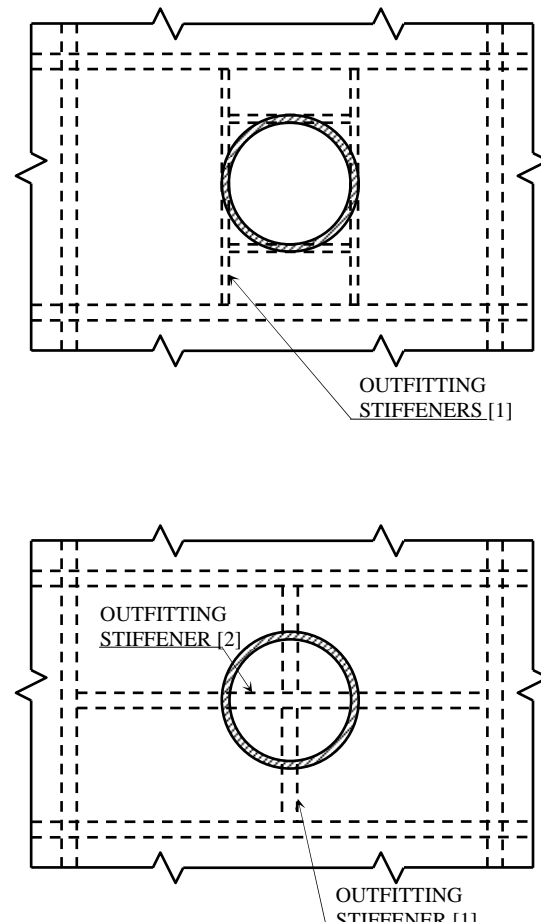
TANKER STRUCTURE CO-OPERATIVE FORUM	SUBJECT: TYPICAL RECOMMENDATIONS FOR OUTFITTING RELATED STRUCTURAL REINFORCEMENT	FIGURE 6

DESCRIPTION: REINFORCEMENT UNDER DECK OR BULKHEAD DUE TO OUTFITTING ROUND ELEMENT WITH LARGE SECTION		APPENDIX 2
LOCATION: ENGINE ROOM, CARGO HOLD, FORE PART		
TO BE AVOIDED		TYPICAL RECOMMENDATION

REMARKS: [1]: Outfitting stiffeners are to be connected with secondary supporting members as shown in FIGURE 4 [2]: Outfitting stiffeners are to be connected with primary supporting members as shown in FIGURE 2 or FIGURE 3, as relevant.

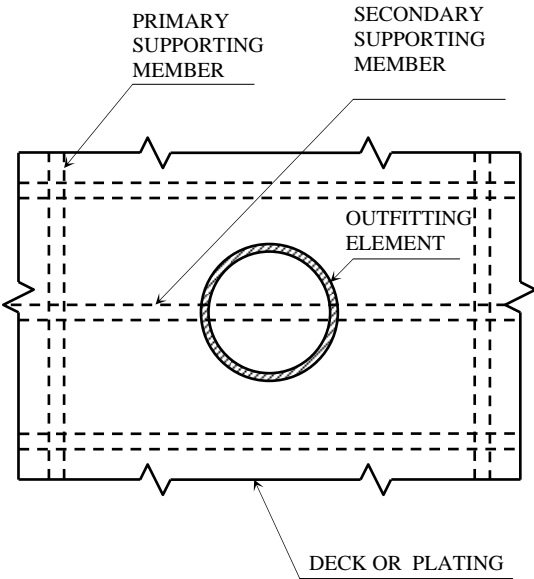
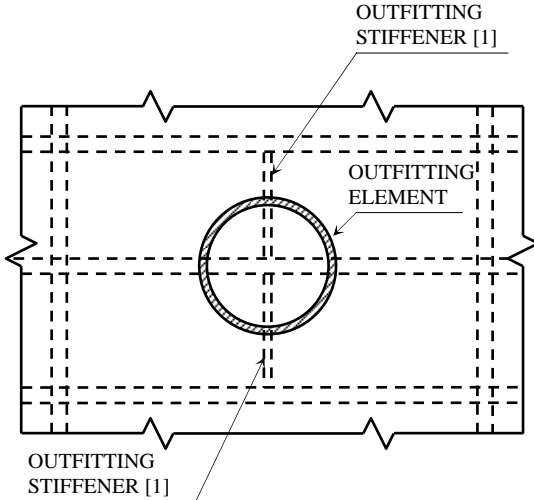
TANKER STRUCTURE CO-OPERATIVE FORUM	SUBJECT: TYPICAL RECOMMENDATIONS FOR OUTFITTING RELATED STRUCTURAL REINFORCEMENT	FIGURE 7

DESCRIPTION: REINFORCEMENT UNDER DECK OR BULKHEAD DUE TO OUTFITTING ROUND ELEMENT IN WAY OF A STIFFENER LOCATION: ENGINE ROOM, CARGO HOLD, FORE PART	APPENDIX 2	
TO BE AVOIDED		TYPICAL RECOMMENDATION

REMARKS: [1]: Outfitting stiffeners are to be connected with secondary supporting members as shown in FIGURE 4

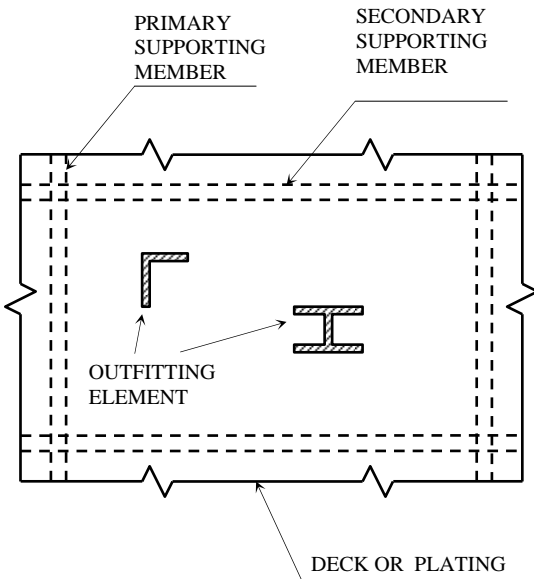
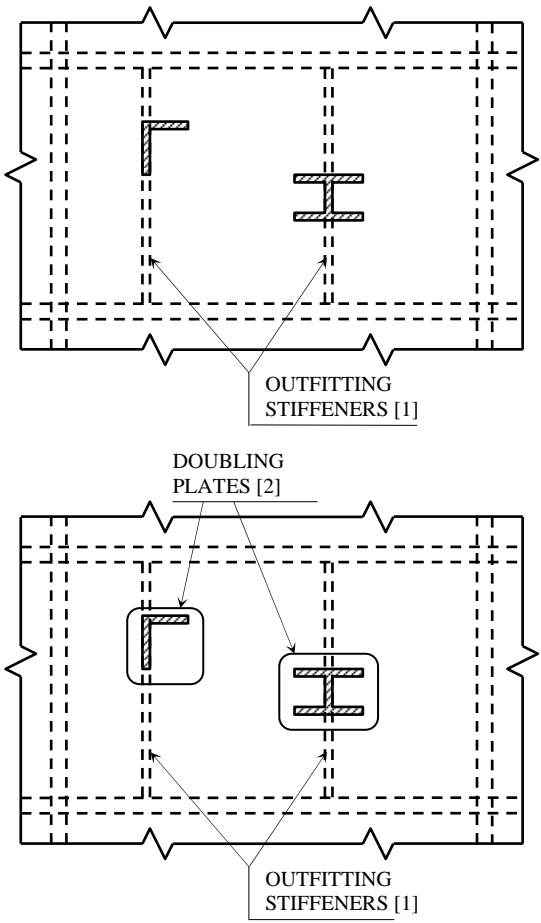
TANKER STRUCTURE CO-OPERATIVE FORUM	SUBJECT: TYPICAL RECOMMENDATIONS FOR OUTFITTING RELATED STRUCTURAL REINFORCEMENT	FIGURE 8

DESCRIPTION: REINFORCEMENT UNDER DECK OR BULKHEAD DUE TO OUTFITTING H or L ELEMENT WITH SMALL SECTION UNDER LOW LOAD		APPENDIX 2
LOCATION: ENGINE ROOM, CARGO HOLD, FORE PART		
TO BE AVOIDED		TYPICAL RECOMMENDATION

REMARKS: [1]: Outfitting stiffeners are to be connected with secondary supporting members as shown in FIGURE 4 [2]: Doubling plates are to be used only when appropriate, when under compression only. Doubling plates are to comply with FIGURE 13

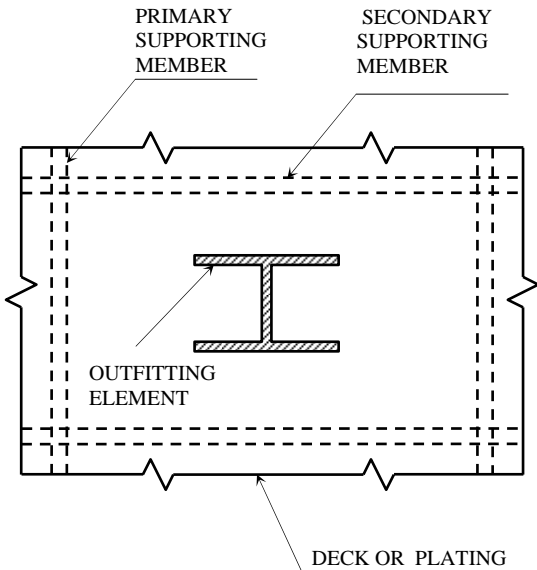
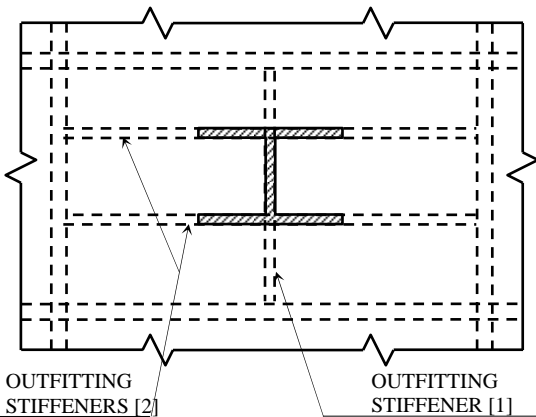
DESCRIPTION: REINFORCEMENT UNDER DECK OR BULKHEAD DUE TO OUTFITTING H ELEMENT WITH LARGE SECTION		APPENDIX 2
LOCATION: ENGINE ROOM, CARGO HOLD, FORE PART		
TO BE AVOIDED		TYPICAL RECOMMENDATION
<div>

</div>
REMARKS: [1]: Outfitting stiffeners are to be connected with secondary supporting members as shown in FIGURE 4 [2]: Outfitting stiffeners are to be connected with primary supporting members as shown in FIGURE 2 or FIGURE 3, as relevant.

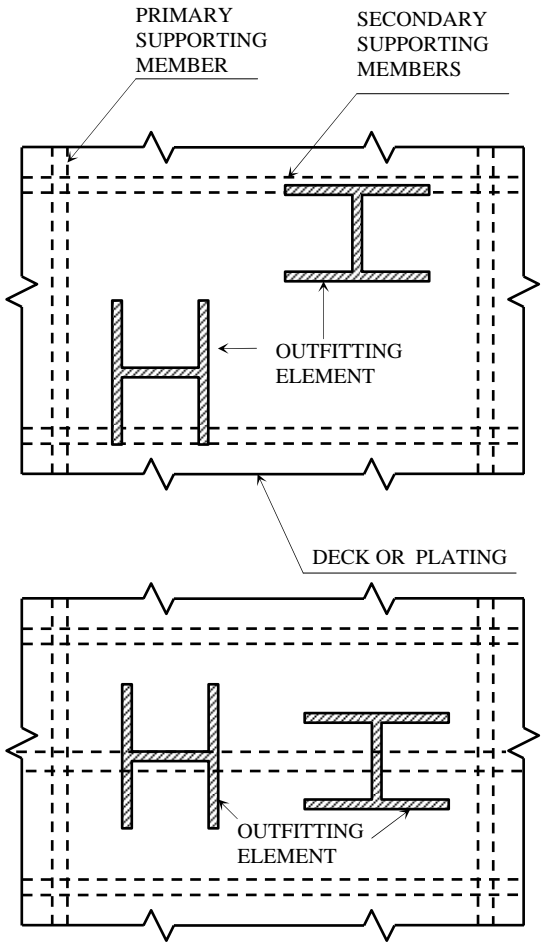
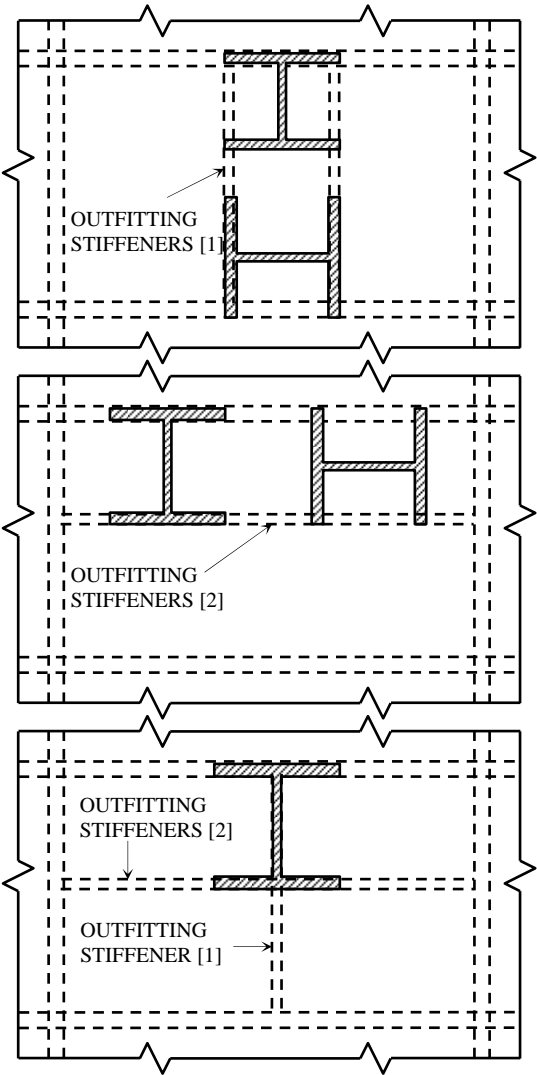
DESCRIPTION: REINFORCEMENT UNDER DECK OR BULKHEAD DUE TO OUTFITTING H ELEMENT WITH LARGE SECTION IN WAY OF PRIMARY OR SECONDARY MEMBER		APPENDIX 2
LOCATION: ENGINE ROOM, CARGO HOLD, FORE PART		
TO BE AVOIDED	TYPICAL RECOMMENDATION

REMARKS: [1]: Outfitting stiffeners are to be connected with secondary supporting members as shown in FIGURE 4 [2]: Outfitting stiffeners are to be connected with primary supporting members as shown in FIGURE 2 or FIGURE 3, as relevant.

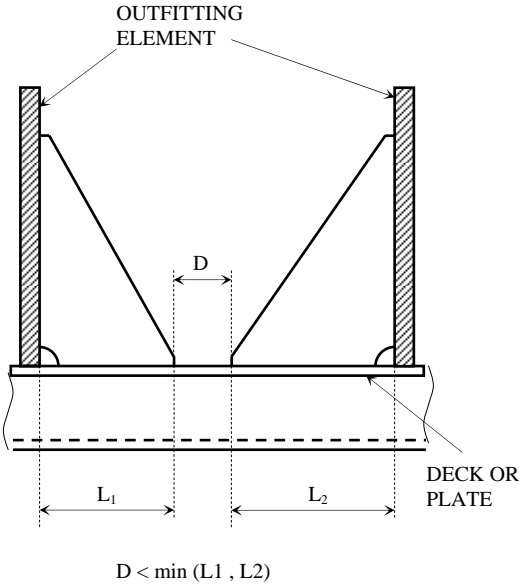
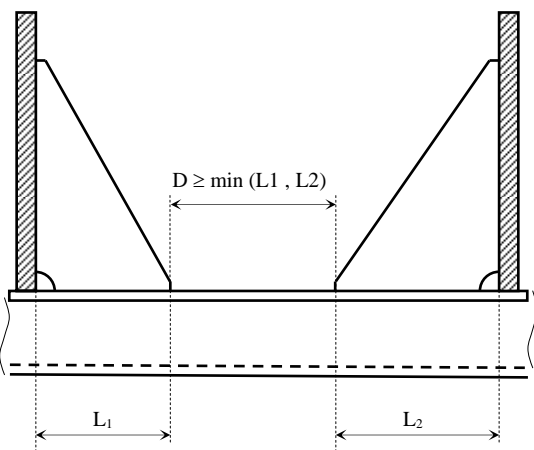
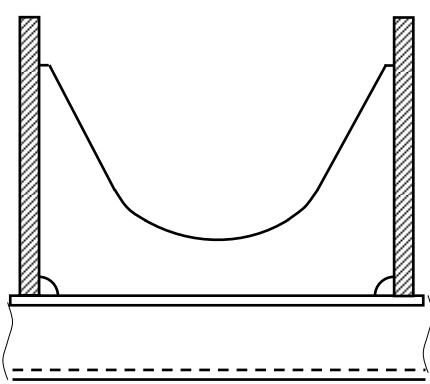
<p>TANKER STRUCTURE CO-OPERATIVE FORUM</p>	<p>SUBJECT: TYPICAL RECOMMENDATIONS FOR OUTFITTING RELATED STRUCTURAL REINFORCEMENT</p> <p>FIGURE 11</p>

DESCRIPTION:	CONNECTIONS WITH BRACKETS OF ADJACENT OUTFITTING ELEMENTS	APPENDIX 2
LOCATION:	ENGINE ROOM, CARGO HOLD, FORE PART	
TO BE AVOIDED		TYPICAL RECOMMENDATION

REMARKS: Brackets and bracket toes are to be fitted in compliance with FIGURE 11.
