**EXPERIENCE WITH DOUBLE HULL TANKERS  
AN OWNER'S VIEWPOINT**

**BERGESEN D.Y. ASA**

**TANKER STRUCTURE CO-OPERATIVE FORUM**

**TOKYO, OCTOBER 2000**

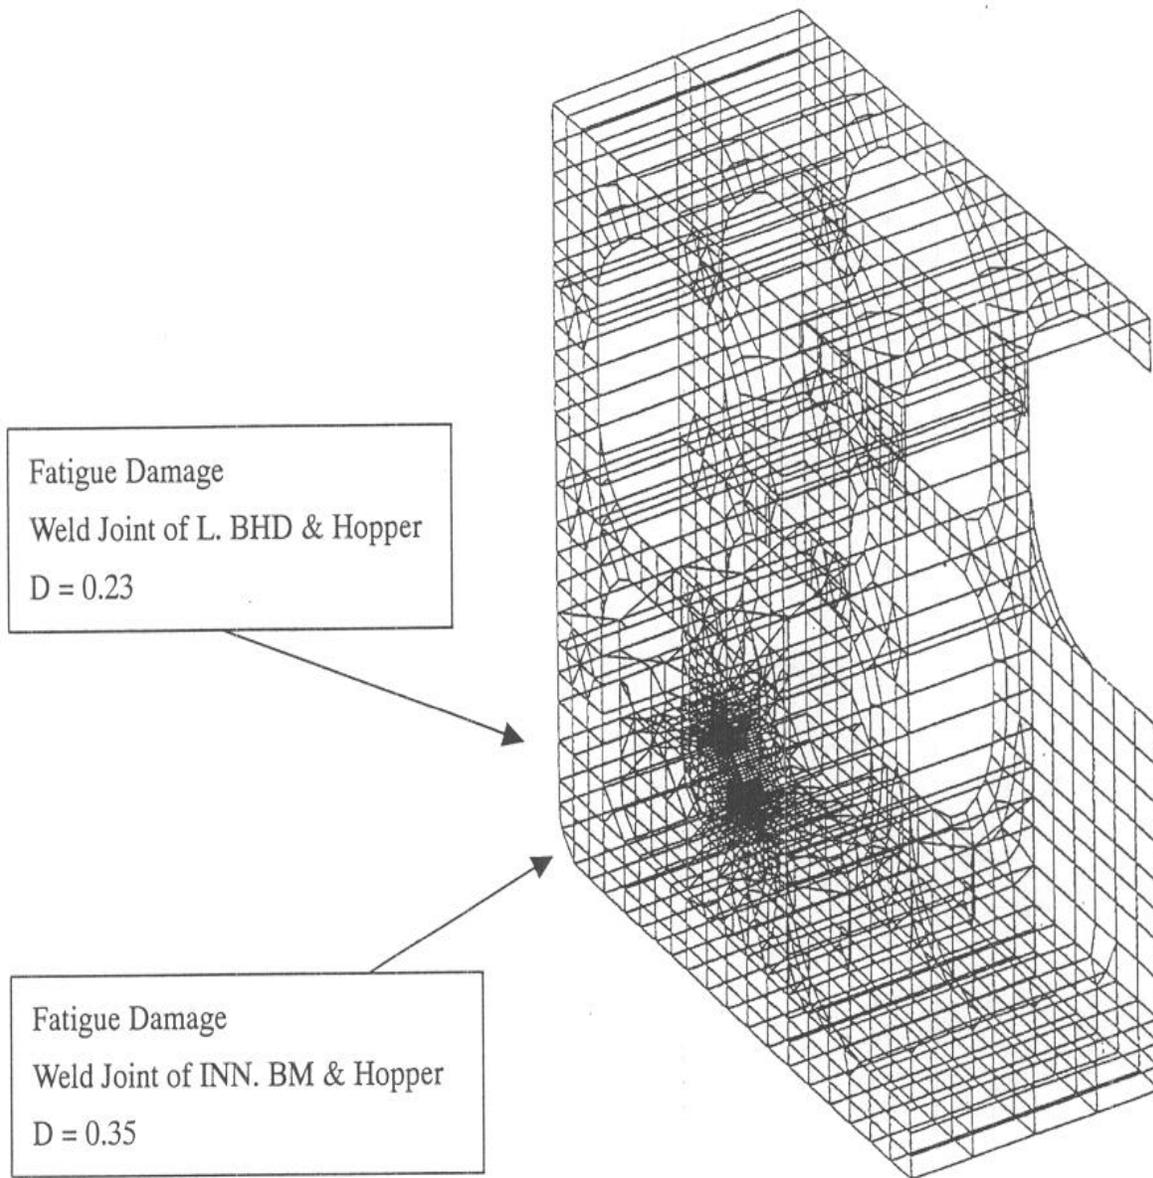
Fig. 2 Fatigue Strength Assessment

- Fatigue calculations to be performed to give an acceptable life time of the side longitudinals for world wide operation – Fig. 2.
- FEM analysis to be carried out on certain structures - Fig 3 & Fig 4.

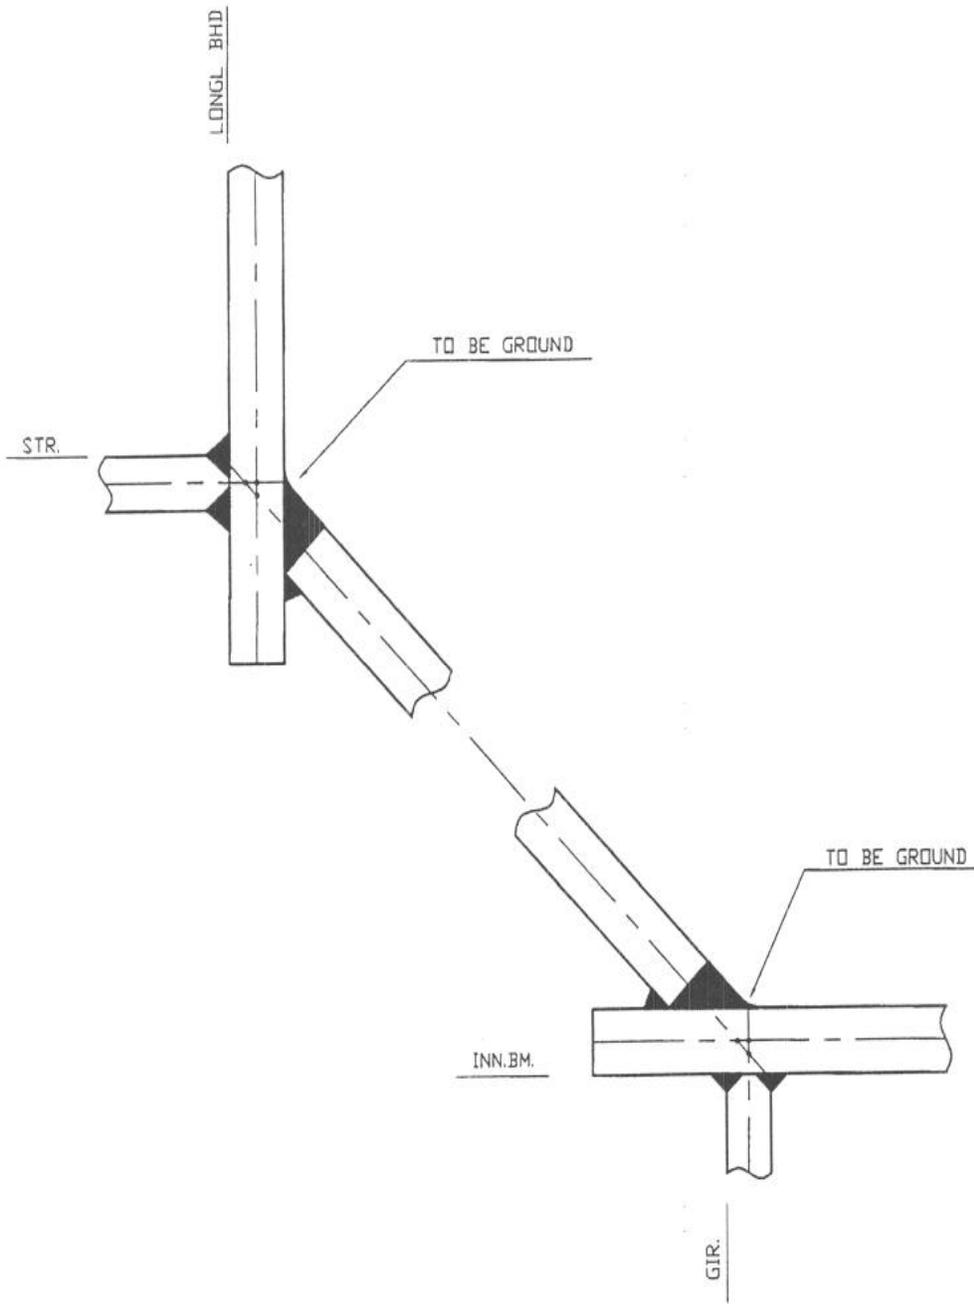
Fig. 5 Weld Detail at Hopper Joints

- Horizontal struts to be arranged in the cargo wing tanks and not in the centre tanks.
- Hopper plate in the cargo wing tanks to be slanted 45 degrees - Fig. 5

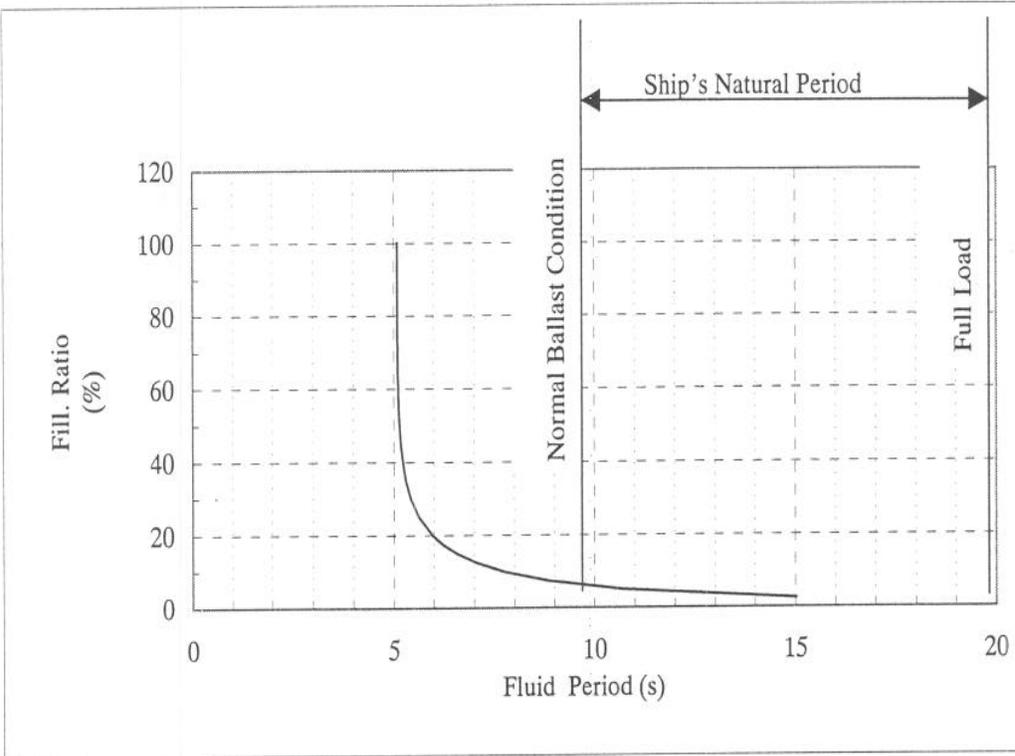
Fig. 6 Fill Ratio VS Natural Period (Roll)

- Grinding of welds where fatigue could be a problem.
- Check the filling ratios of the cargo tanks versus the vessel's natural pitch and roll motions - Fig 6 & Fig 7.

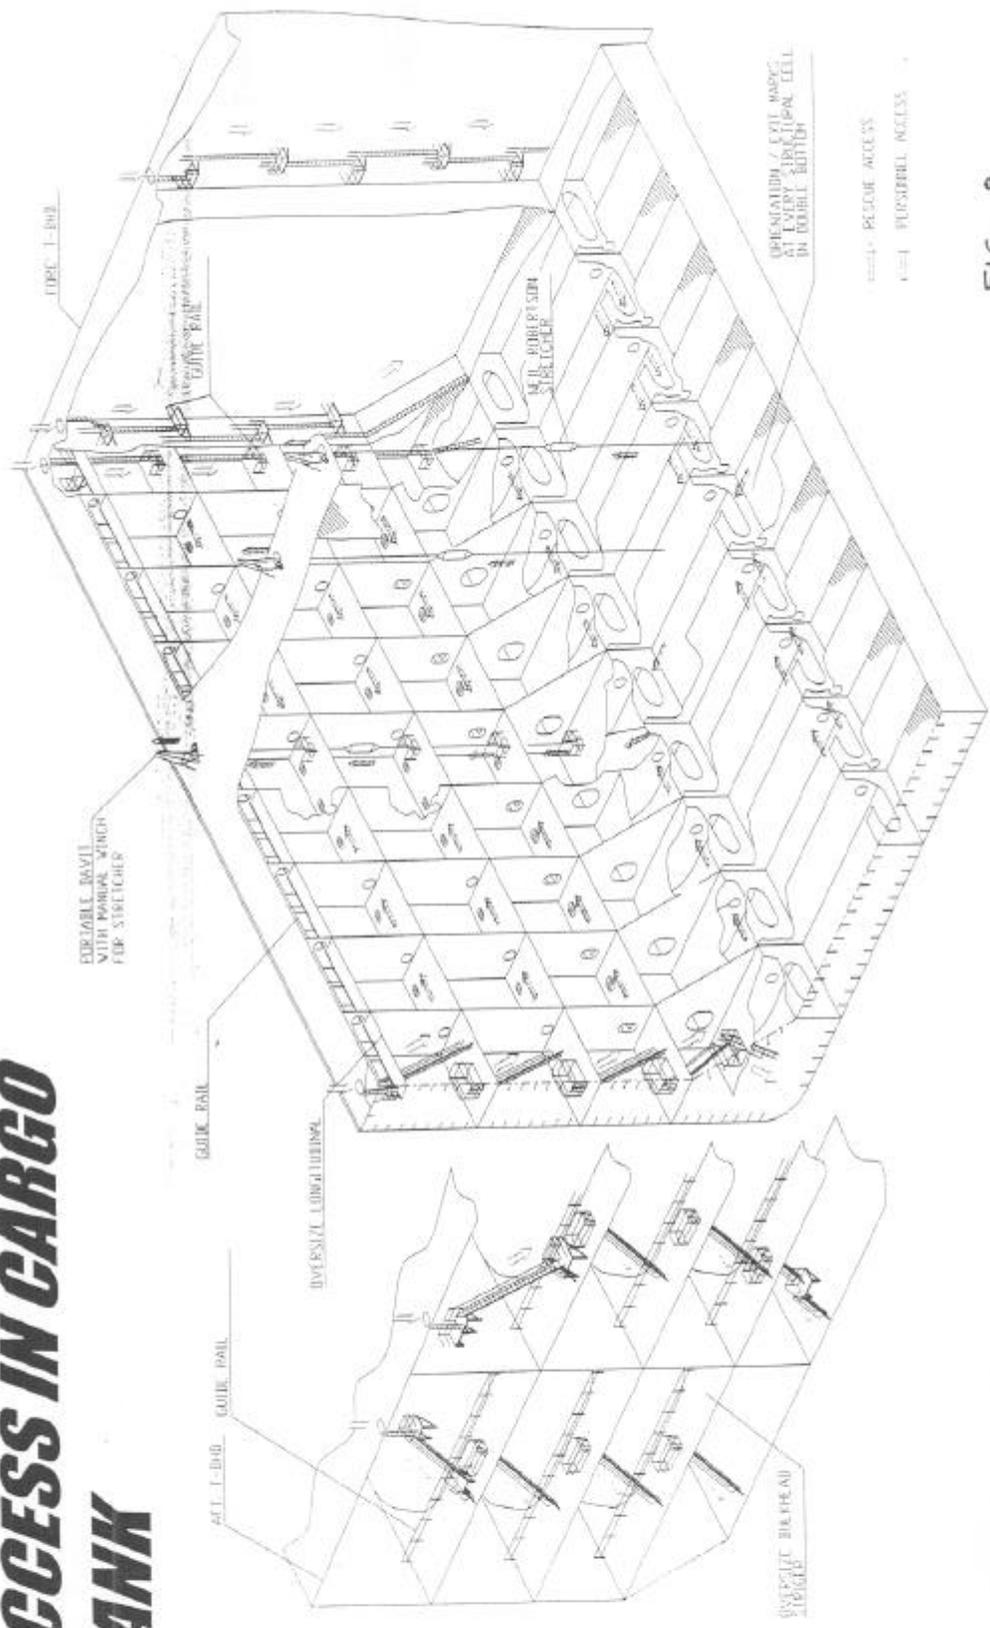
FIG. 8

- Implementing operating experiences with tankers previously built.
- Accessibility for maintenance and inspection from three walk ways - Fig. 8.
- Inerting of ballast tank.
