The implementation process analysis and improvement on PSPC in China shipyards

This paper introduces the PSPC implementation process in China shipyards, combined with the requirement of PSPC and factory practice, summarizes suits the implementation practices on PSPC ships, which provides technical foundation for the construction of PSPC ships.

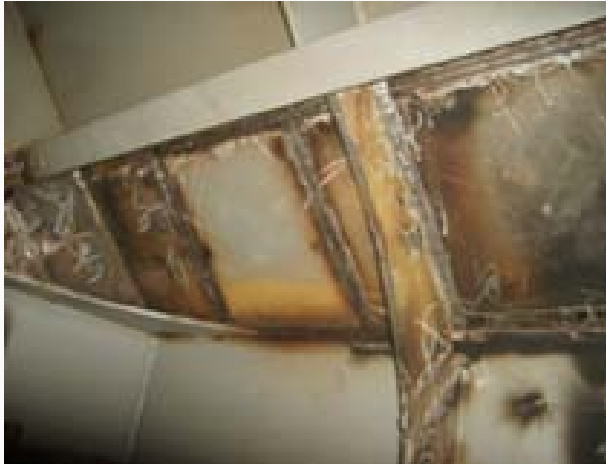
Fig.1 H1053 coating
damage condition (after
erection of the entire tank)

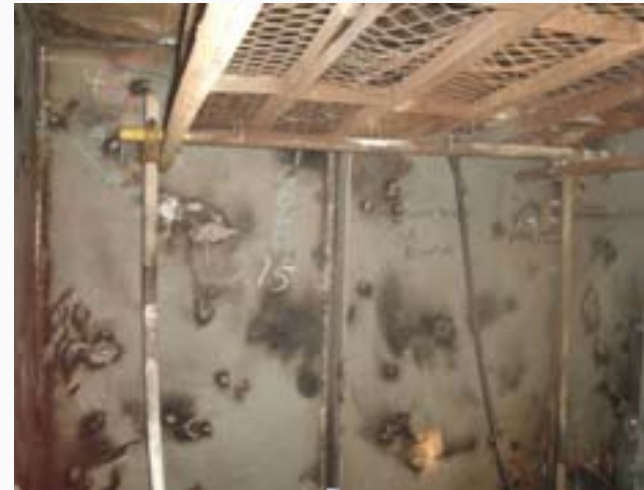
Fig.2 H1053 coating damage
condition (man-made damage)

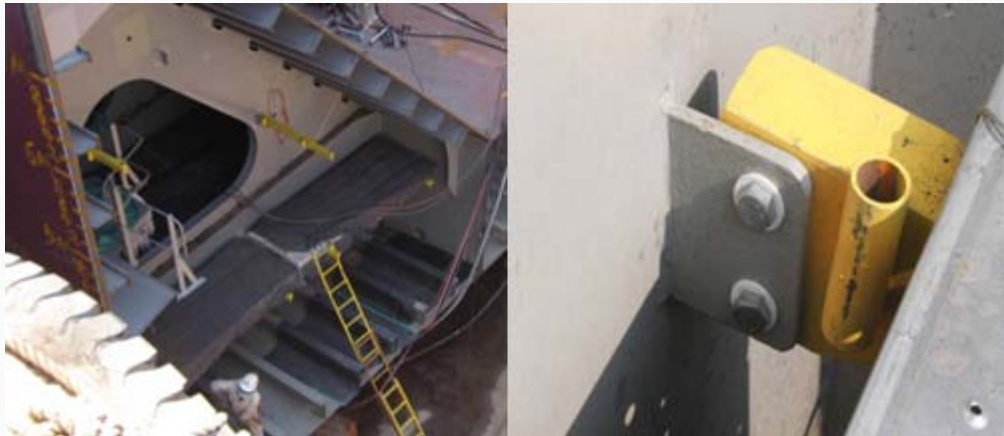
Fig.7 Erection effect drawing of water ballast tanks fabricated scaffold

To avoid scaffold and hull direct contact to damage water ballast tank coatings, the scaffold design amended the original welding erection form, and promote the use of fabricated scaffold in water ballast tanks greatly. In the area of the ballast tanks erection seams and watertight board lay the scaffold pieces, and use the fabricated scaffolds, while the scaffold pieces will be remained in the hull as a permanent piece. In the fabricated scaffolding erection process, the protection measurements on the scaffold pieces are increased that all the contact areas with the scaffold pieces use the rubber pad for protection, which effectively ensures the integrity of the coating, as shown in Fig7.
