**PRESENTATION OF THE 1997 TSCF GUIDANCE
MANUAL FOR TANKER STRUCTURES**

**PRESENTED BY:
GERMANISCHER LLOYD**

**AT
TANKER STRUCTURE CO-OPERATIVE FORUM
2000 SHIPBUILDERS MEETING
TOKYO, OCTOBER 2000**

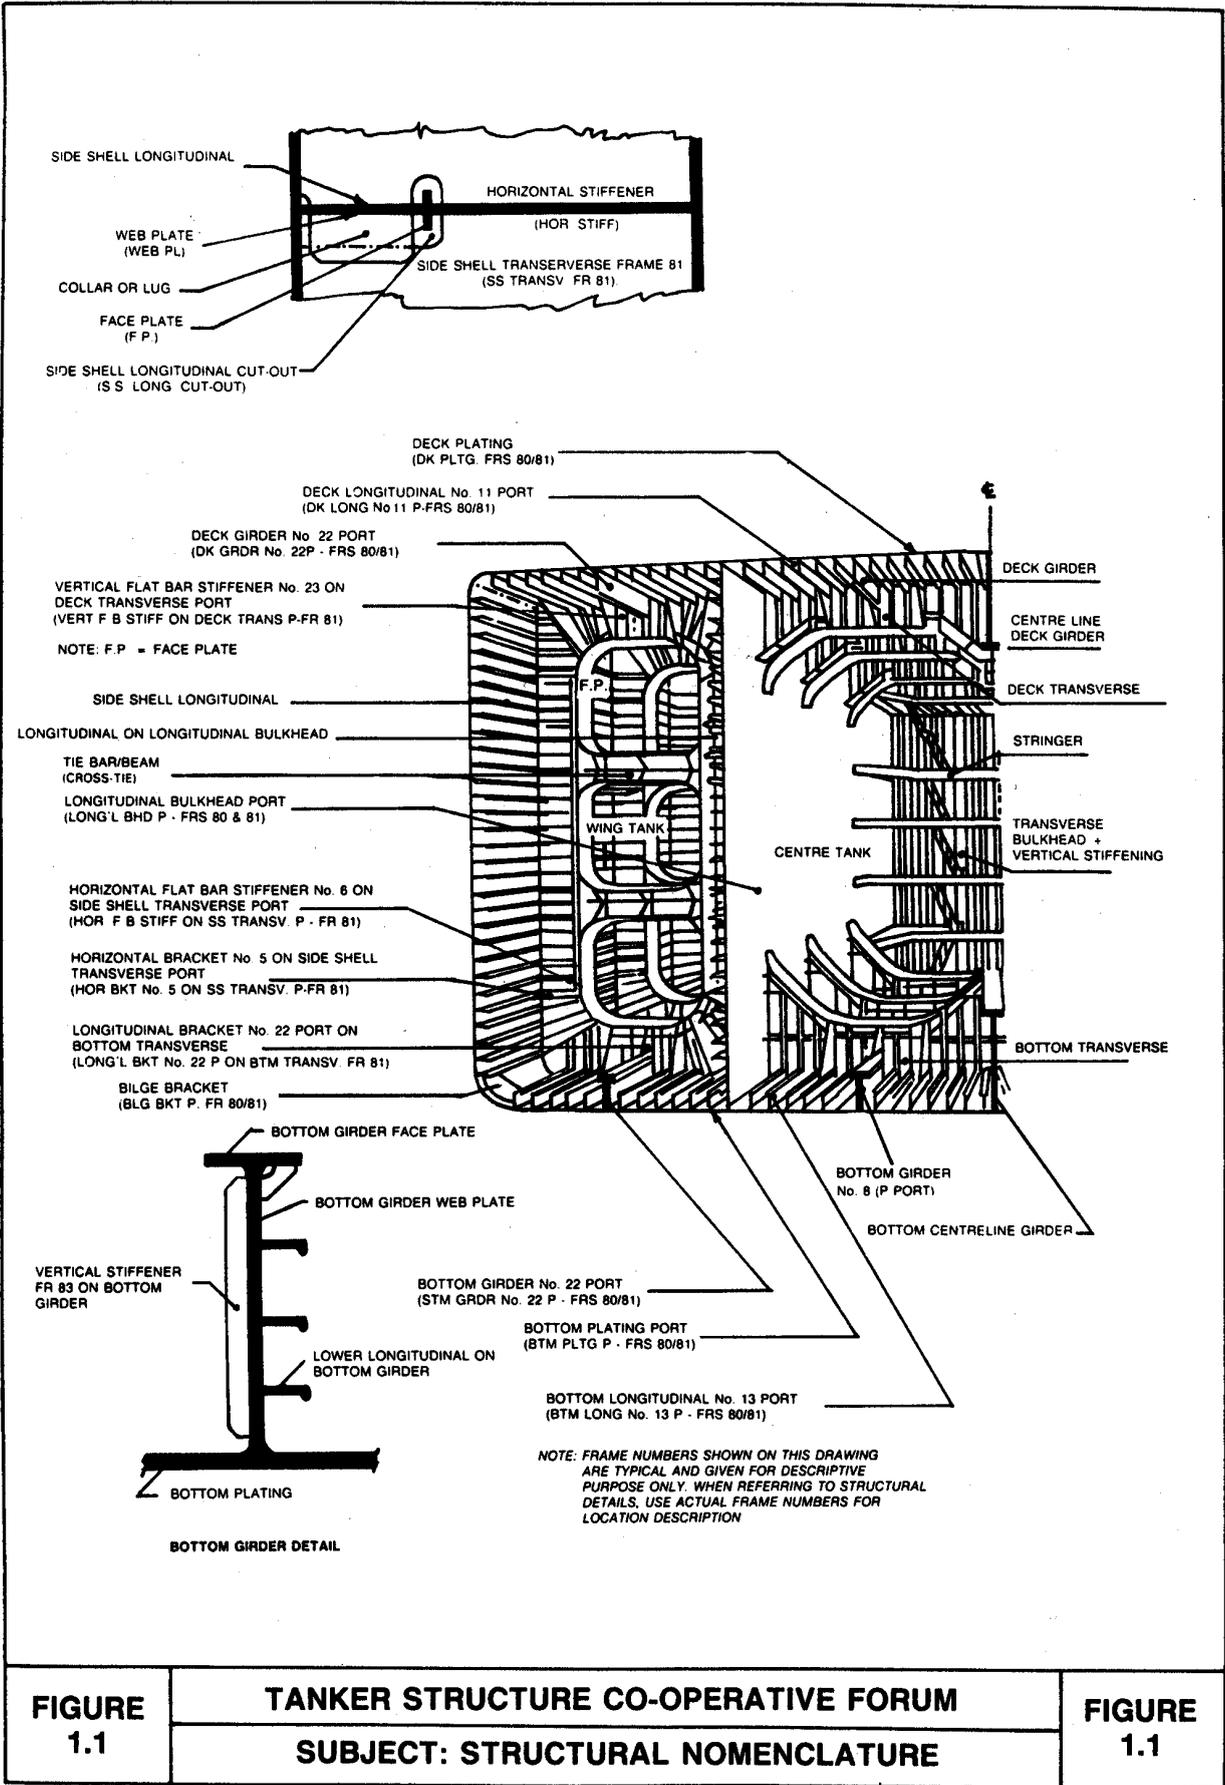
FIGURE 1.1

TANKER STRUCTURE CO-OPERATIVE FORUM
SUBJECT: STRUCTURAL NOMENCLATURE

For reasons of clarity it is recommended to use in reports standard nomenclature for structural elements as shown in Figures 1.1 and 1.2. Figure 1.3 shows typical locations and distribution of fatigue damage. Figure 1.10 shows corrosion rates of a transverse web frame in an uncoated segregated ballast tank where due to high shear stresses in the vertical girders and the horizontal cross ties higher corrosion rates have been observed.

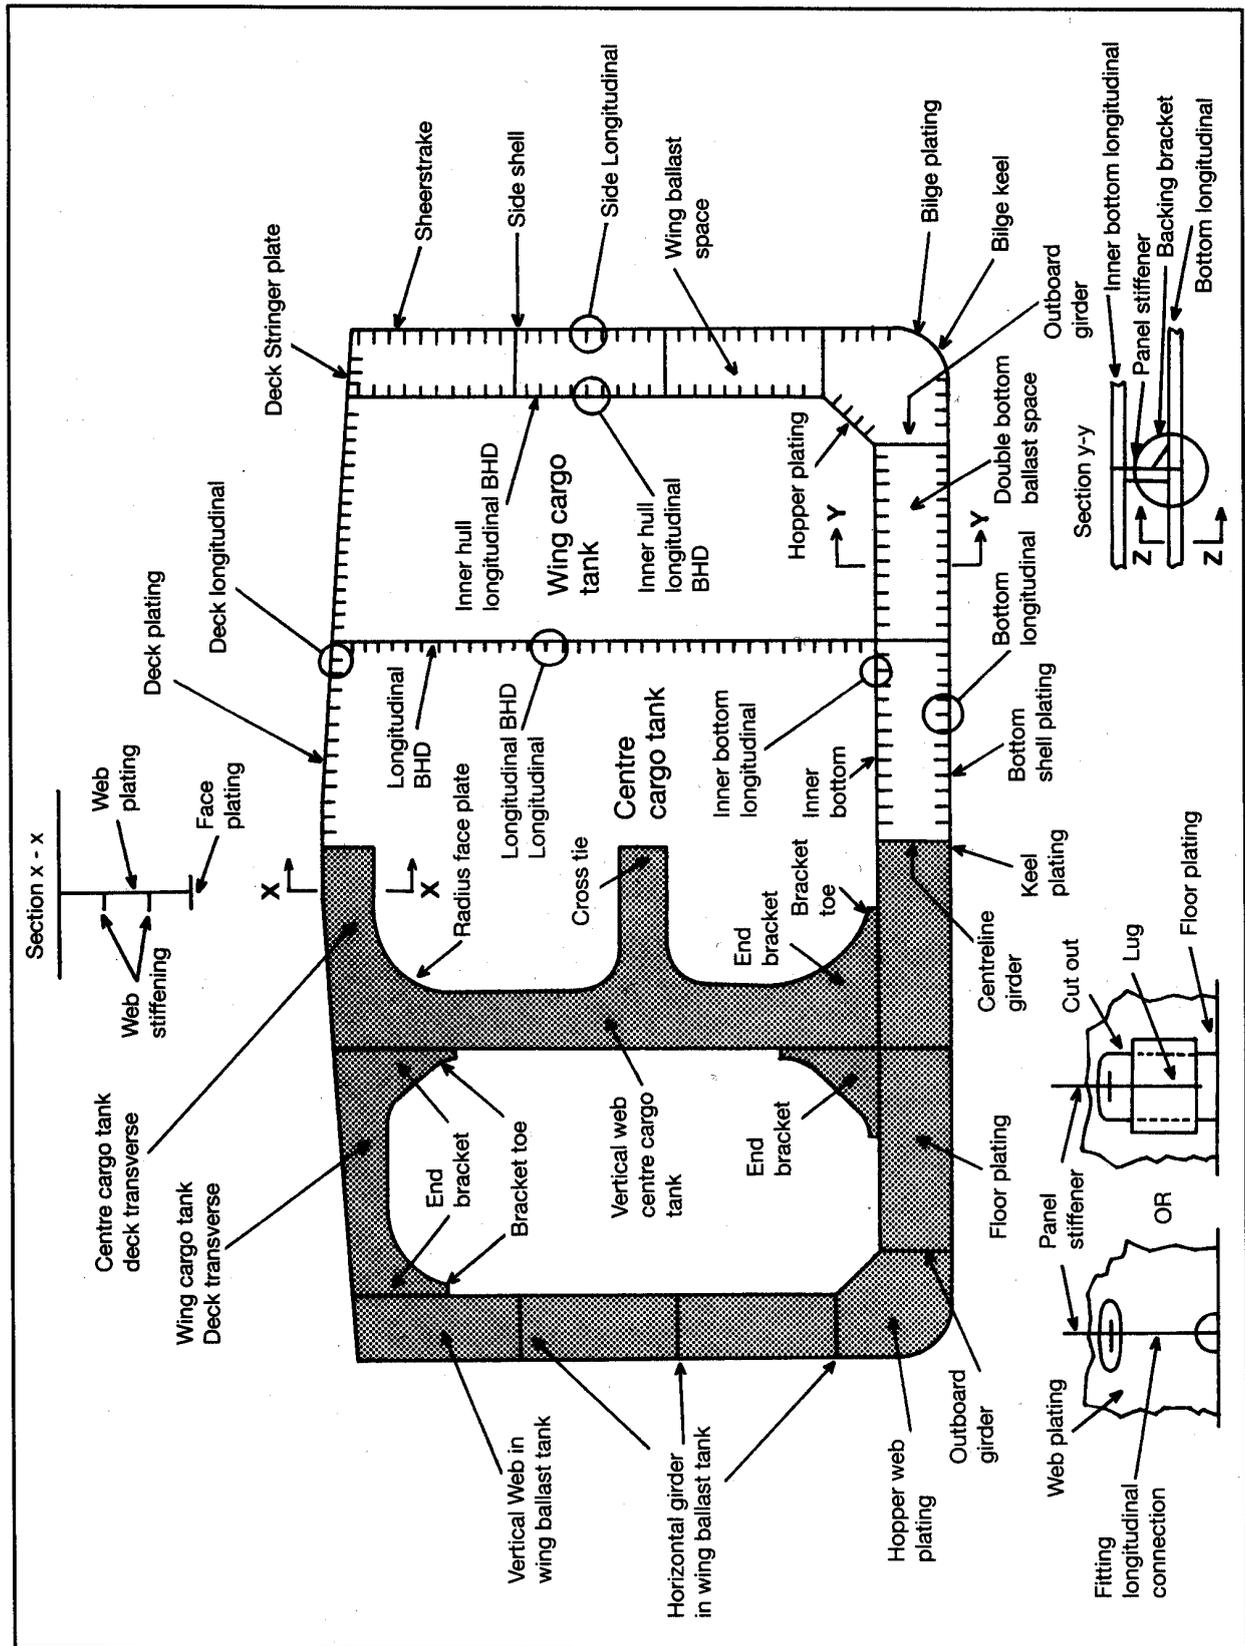
FIGURE 1.2	TANKER STRUCTURE CO-OPERATIVE FORUM SUBJECT: TYPICAL DOUBLE HULL MIDSHIP SECTION NOMENCLATURE	FIGURE 1.2
-----------------------	--------------------------------------------------------------------------------------------------------------------------	-----------------------

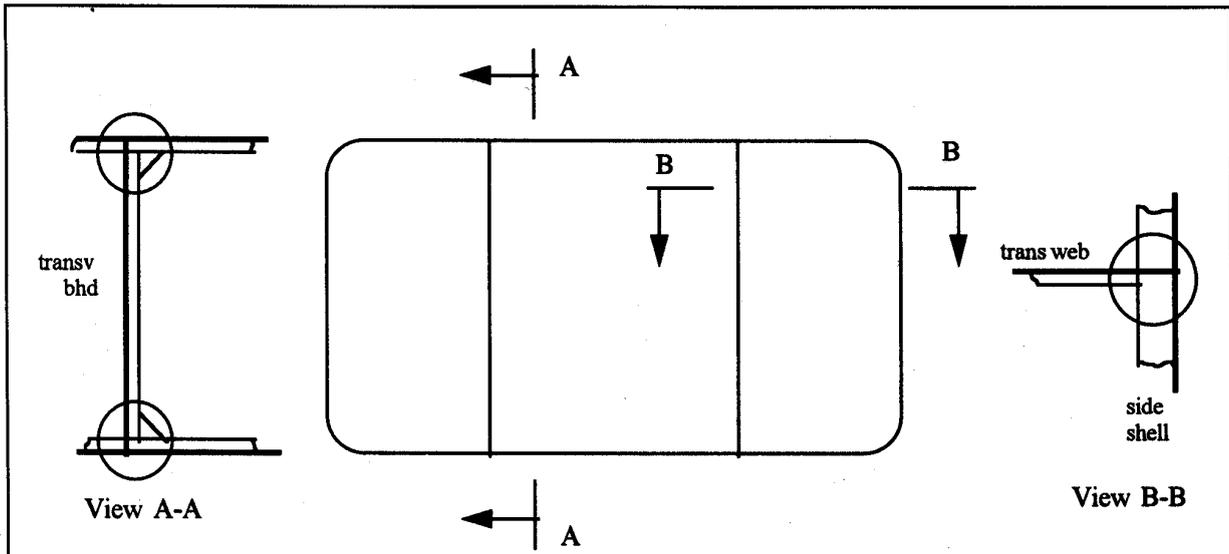
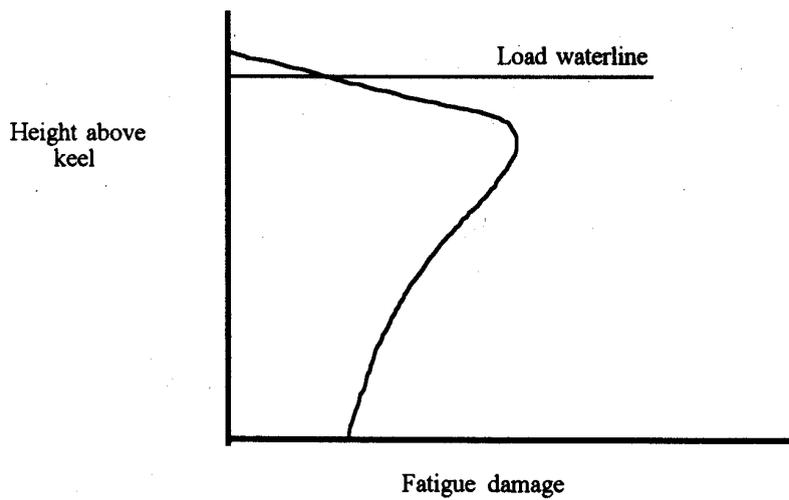
Typical Connections Between Longitudinals and Transverse Web or Bulkhead

Distribution of Fatigue Damage From Wave Loading Over Depth of Vessel

FIGURE 1.3	TANKER STRUCTURE CO-OPERATIVE FORUM	FIGURE 1.3
	TYPICAL FATIGUE DAMAGE LOCATIONS AND DISTRIBUTION

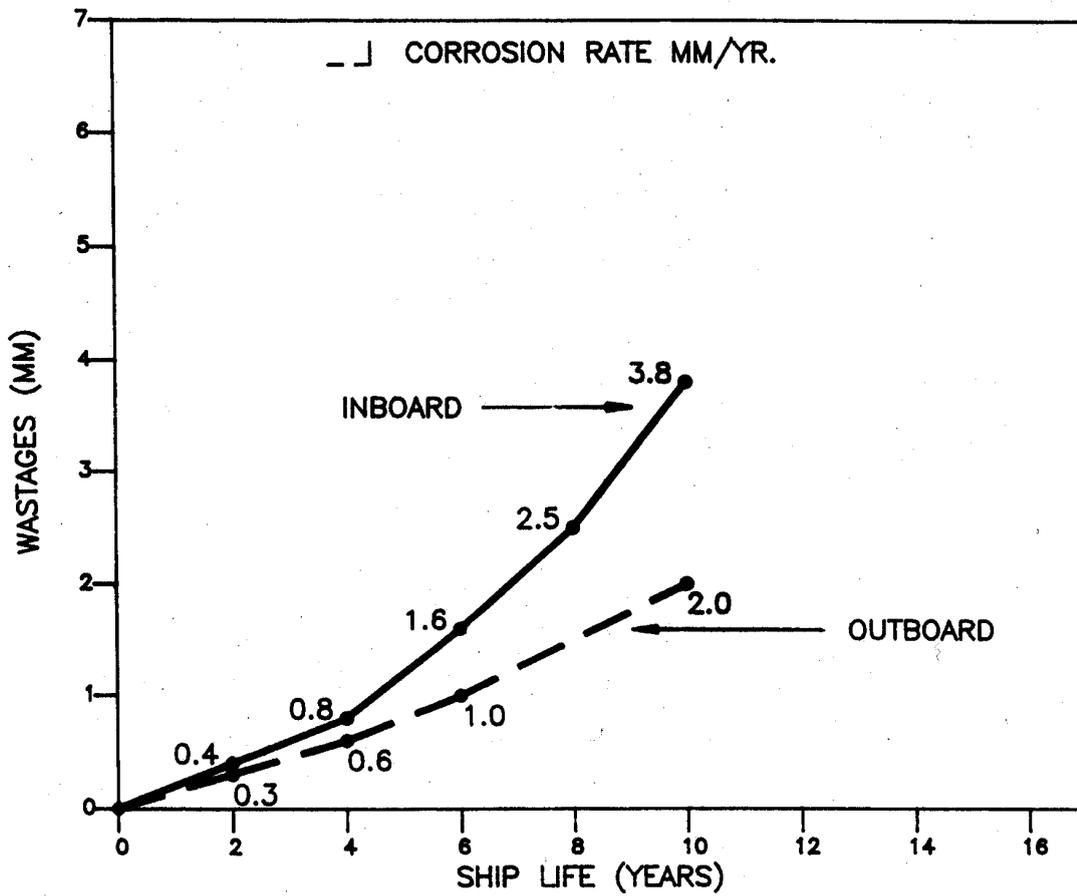
TRANSVERSE WEB FRAME PLATING

FIGURE	TANKER STRUCTURE CO-OPERATIVE FORUM	FIGURE
1.10	ACCELERATED CORROSION UNCOATED SEGREGATED BALLAST TANK	1.10

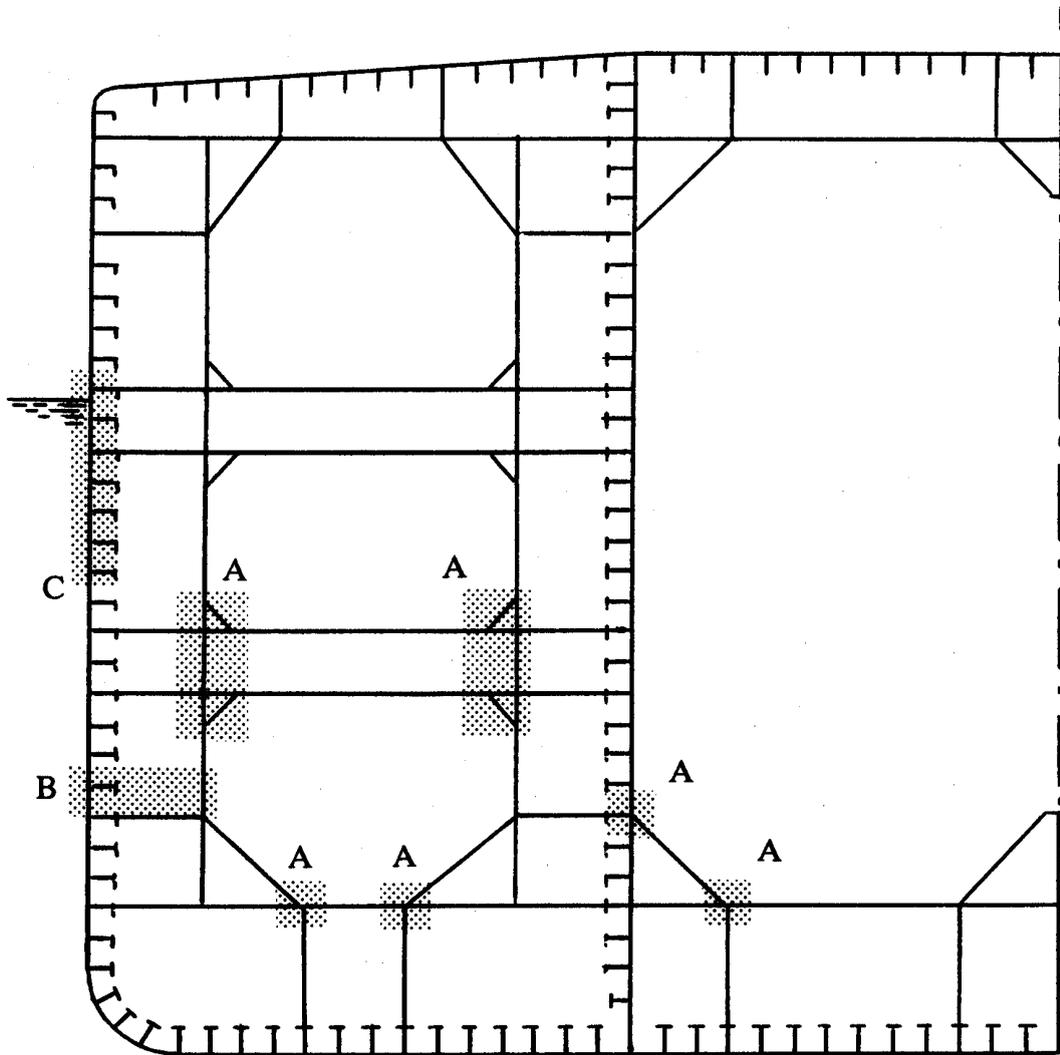
- A - At end of brackets, toes and similar
- B - High shear stress at ends of span
- C - Local high stresses at connections between longitudinals and web frame, particularly within area of wind and water levels where both web and longitudinal exposed.

FIGURE	TANKER STRUCTURE CO-OPERATIVE FORUM	FIGURE
2.1	LOCAL AREAS OF HIGH STRESS IN TRANSVERSE WEB FRAMES	2.1

In these sections the critical areas of main structural elements are described and what kind of wastage or failure from corrosion, fracture or buckling may be expected in these areas. Risky areas of structures that are more prone to corrosion are identified, see Table 2.1. Areas at higher risk from defects due to corrosion, buckling or cracks are also identified, see Table 2.2. Figure 2.1 shows local areas of high stresses in transverse web frames, and Figure 2.2 shows typical wastage of bottom structures.

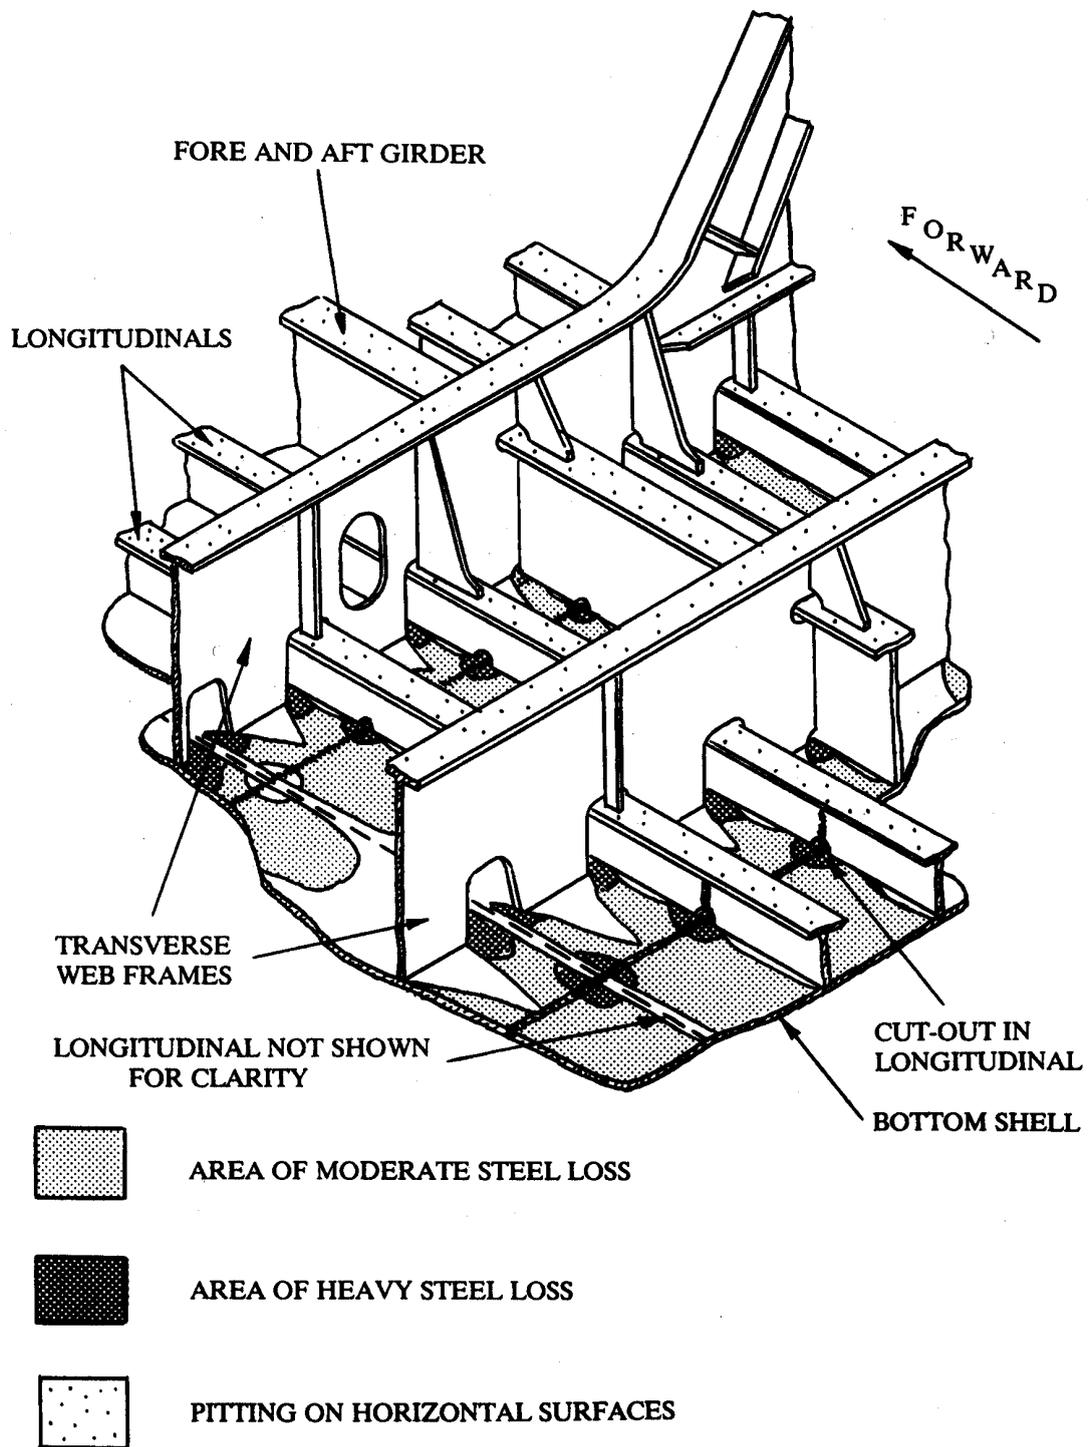
FIGURE 2.2	TANKER STRUCTURE CO-OPERATIVE FORUM	FIGURE 2.2
	TYPICAL WASTAGE OF BOTTOM STRUCTURE

- 1) *Especially exposed items:*
 - *Horizontal stringers.*
 - *Longitudinals on longitudinal bulkhead.*
 - *Longitudinal bulkhead plating.*
 - *Web frames upper part and close to longitudinal bulkheads.*
 - *Cross ties.*
 - *Transverse bulkhead plating, upper part.*
- 2) *Exposed to pitting:*
 - *Horizontal surface of stringers.*
 - *Bottom plating.*
 - *Bottom longitudinal face plates/flanges*
- 3) *Other factors contributing to the risk of corrosion:*
 - *Neighbouring tanks heated.*
 - *Local coating faults due to poor workmanship.*
 - *Unfavourable structural details from coating point of view.*
 - *High local stress areas (See Figure 2.1).*
 - *Areas with high flow rate, i.e. around openings, notches etc (see Figure 2.2).*
 - *Drip locations of cleaning guns.*

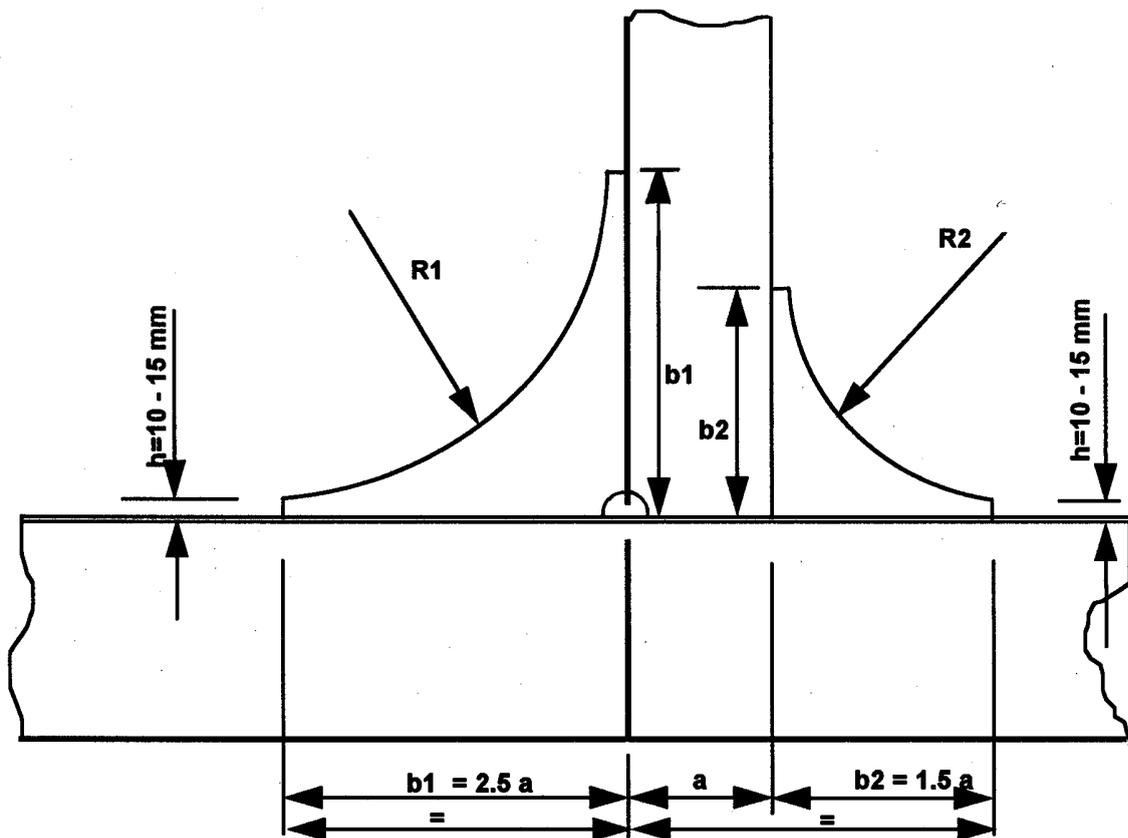
TYPICAL LOCATION: Web Frame / Side Longitudinal

DETAIL TYPE: Connection Brackets

RECOMMENDED DESIGN

- 1 - For a slope at toes max. 1:3, $R1 = (b_1 - h) \times 1.6$ and $R2 = (b_2 - h) \times 1.6$
- 2 - Soft toe bracket to be welded first to longitudinal
- 3 - Scallop in bracket to be as small as possible, recommended max. 35 mm
- 4 - If toes of brackets are ground smooth, full penetration welds in way to be provided
- 5 - Maximum length to thickness ratio = 50 : 1 for unstiffened bracket edge
- 6 - Toe height to be as small as possible (10 - 15 mm)

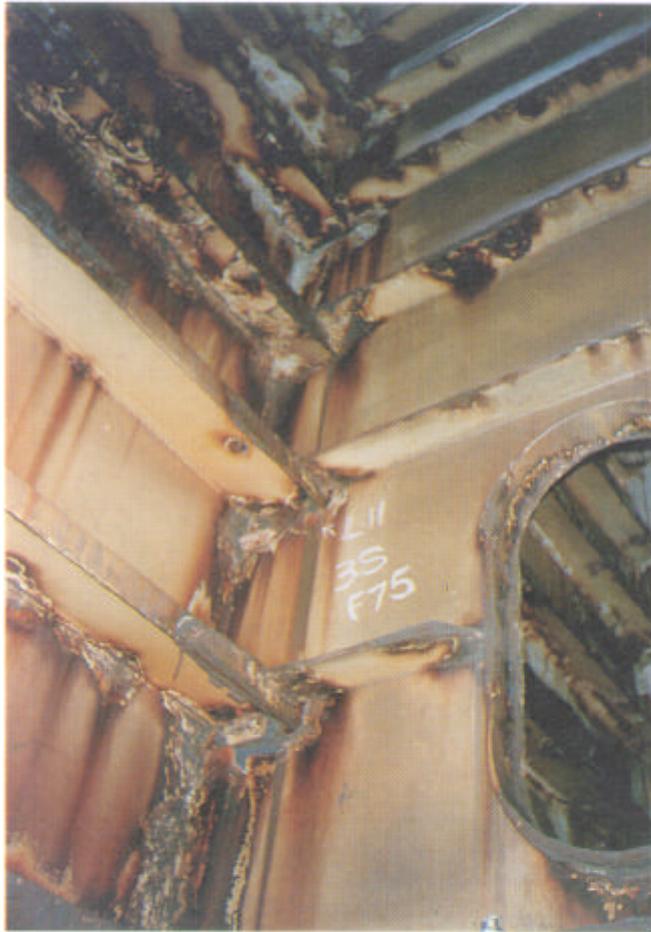
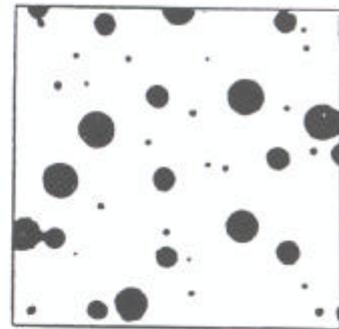
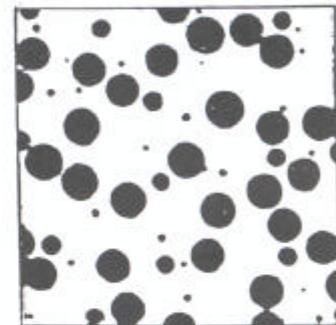
FIGURE
VII.3

COATING CONDITION EVALUATION

ASSESSMENT SCALE:

10%

25%

Annex VII of the Guidance Manual provides considerable material to assist the surveyor in the assessment of the coating condition. Examples are given in Figures VII.3 and VII.13.

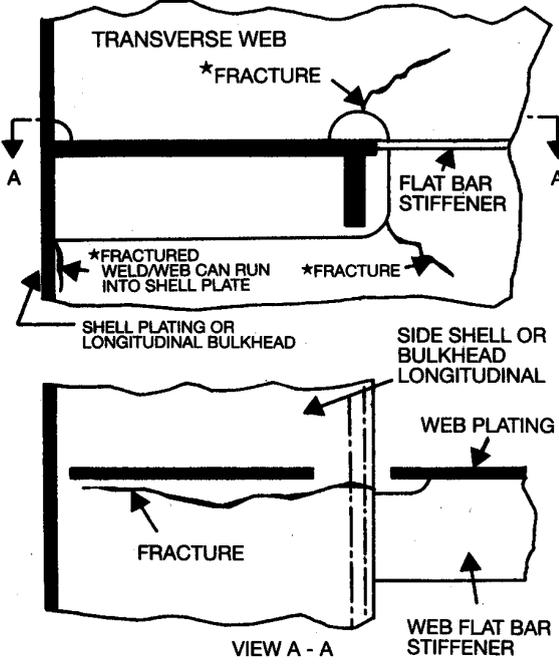
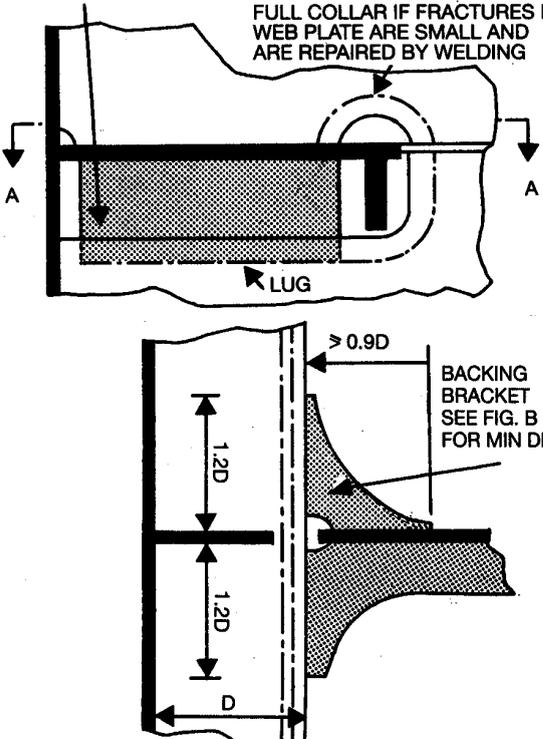
FIGURE 7	TANKER STRUCTURE CO-OPERATIVE FORUM SUBJECT: CATALOGUE OF STRUCTURAL DETAILS	FIGURE 7

LOCATION:	Connection of longitudinals to transverse webs.	GROUP No. 1
EXAMPLE No. 7:	Web and longitudinal fractures. Face plate attached to underside of web. Flat bar butt welded.	
TYPICAL DAMAGE		PROPOSED REPAIR

<p>NOTE: *ONE OR MORE FRACTURES MAY OCCUR</p>		<p>RECOMMENDED TO BE CONNECTED TO SHELL IF CONNECTION WEB/SHELL HAS CRACKED.</p> <p>FULL COLLAR IF FRACTURES IN WEB PLATE ARE SMALL AND ARE REPAIRED BY WELDING</p>

<p>BACKING BRACKET SEE FIG. B FOR MIN DIM.</p>
FACTORS CONTRIBUTING TO DAMAGE		
<ol style="list-style-type: none"> 1. Asymmetrical connection of flat bar stiffener resulting in high peak stresses at the heel of the stiffener under fatigue loading. 2. Higher tensile steel longitudinal resulting in greater stresses. 3. Fabricated longitudinal with welding onto the exposed edge of the web resulting in poor fatigue strength of the connection of the longitudinal to the flat bar. 4. Insufficient area of connection of longitudinal to web plate. 5. Defective weld at return around the plate thickness. 6. High localised corrosion at areas of stress concentration, such as flat bar stiffener connection, corner of cut-out for longitudinal and connection of lug to shell at cut-outs. 7. High shear stress in the web of the transverse. 8. Dynamic sea way loads/ship motions.

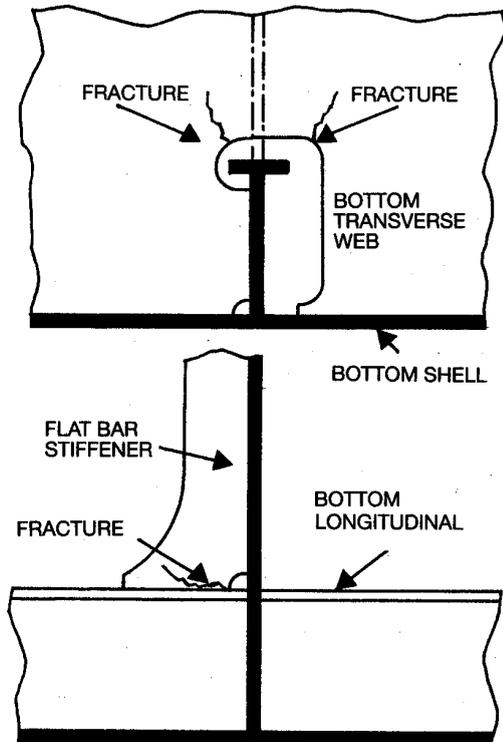
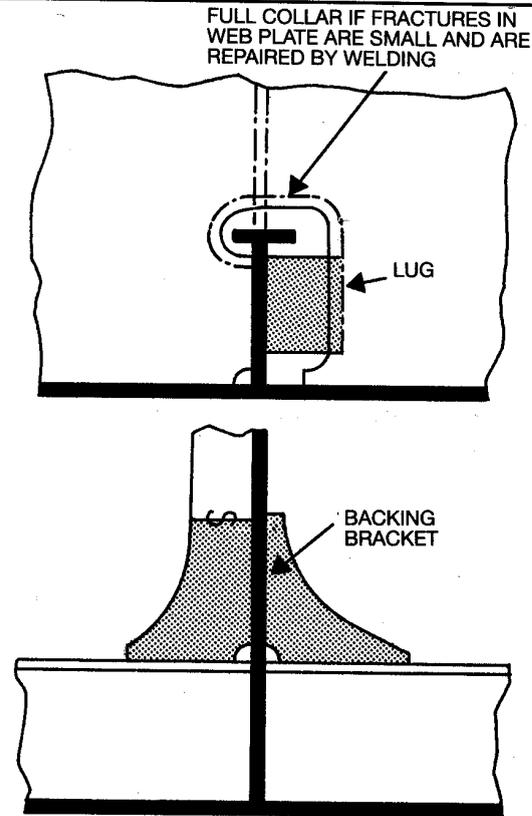
**FIGURE
10**

EXAMPLE No. 8: Bottom web and flat bar fractures at the cut-out for the longitudinal connections.

TYPICAL DAMAGE

PROPOSED REPAIR

1. Asymmetrical connection resulting in high stresses at heel of stiffener.
2. Dynamic sea way loads/ship motions.
3. Insufficient area of connection of longitudinal to web plate.
4. Defective weld at return around the plate thickness.
5. High localised corrosion at areas of stress concentration such as the flat bar stiffener connection and corners of the cut-out for the longitudinal.
6. High shear stress in the web of the transverse.

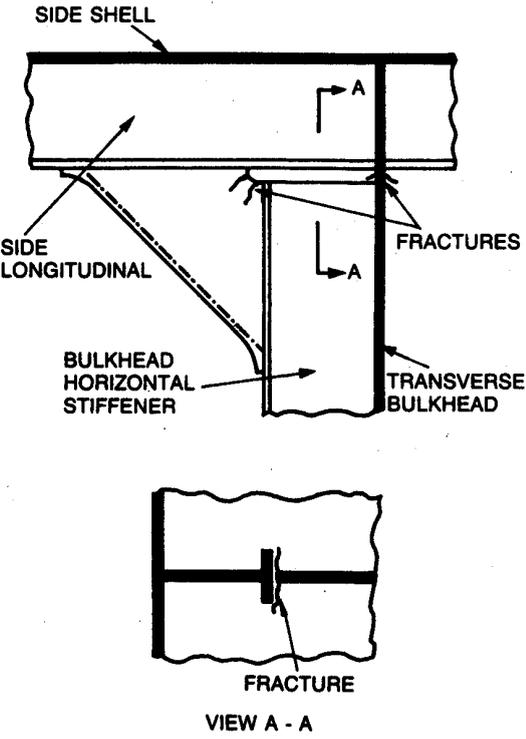
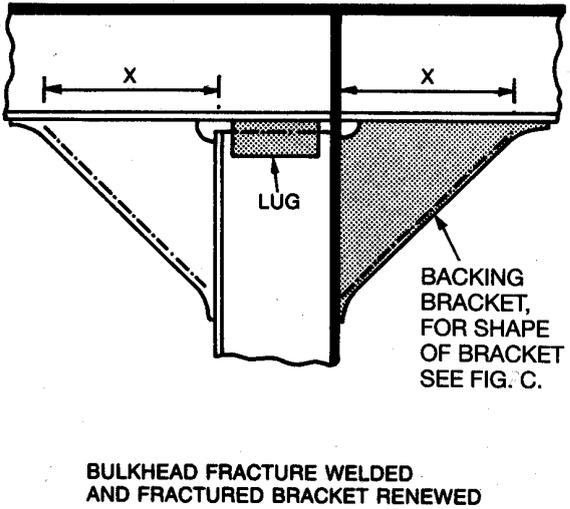
<p>FIGURE 15</p>	<p style="text-align: center;">TANKER STRUCTURE CO-OPERATIVE FORUM</p> <p style="text-align: center;">SUBJECT: CATALOGUE OF STRUCTURAL DETAILS</p>	<p>FIGURE 15</p>

<p>LOCATION: Connection of longitudinals to plane transverse bulkheads</p> <p>EXAMPLE No. 2: Fractured bulkhead end bracket at side shell. Bulkhead horizontally stiffened.</p>	<p>GROUP No. 2</p>	
<p style="text-align: center;">PROPOSED REPAIR</p>

<p style="text-align: center;">BULKHEAD FRACTURE WELDED AND FRACTURED BRACKET RENEWED</p>	
<p>FACTORS CONTRIBUTING TO DAMAGE</p> <ol style="list-style-type: none"> 1. Large unconnected ending of bulkhead stiffener associated with an asymmetrical connection resulting in high stresses at the heel of the stiffener and the bracket. 2. Horizontally stiffened transverse bulkheads causing increased end moment at the side shell longitudinal connection resulting from loading on the transverse bulkhead. 3. Deflection of the adjacent side shell transverse under load. 4. Defective weld at return around plate thickness. 5. Dynamic sea way loads/ship motions.

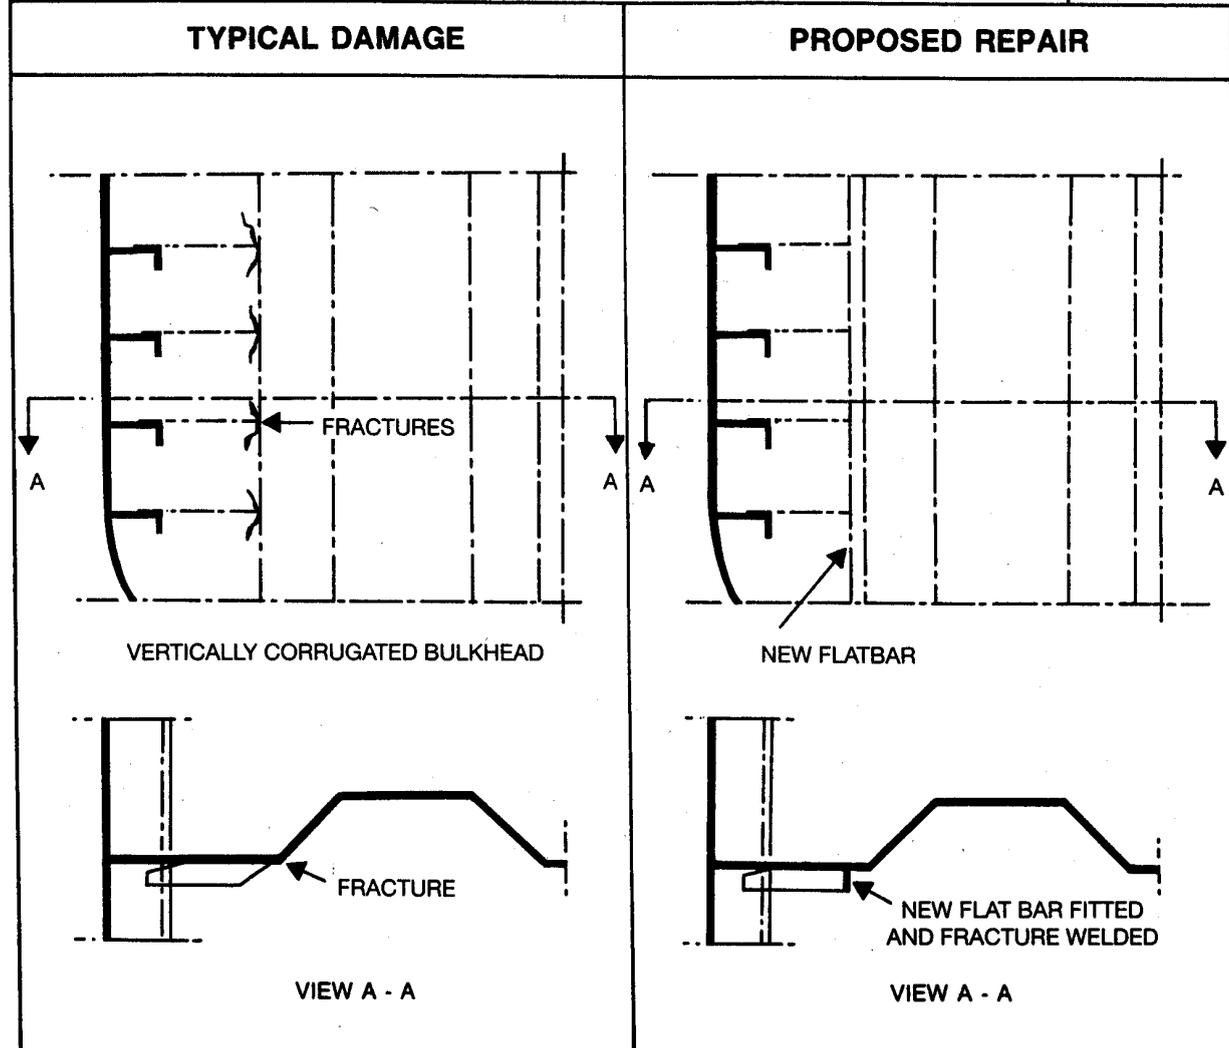
LOCATION:	Connection of longitudinals to corrugated transverse bulkheads	GROUP No. 3
EXAMPLE No. 1:	Bulkhead fracture at toe of horizontal flatbar stiffener. Vertically corrugated bulkhead.

1. Sniped stiffener ending close to corrugation knuckle forming a hard spot under deflection of the corrugation and rotation of the longitudinal.
2. Insufficient stiffener end connection at the knuckle in the corrugation.
3. Dynamic seaway loads/ship motions.

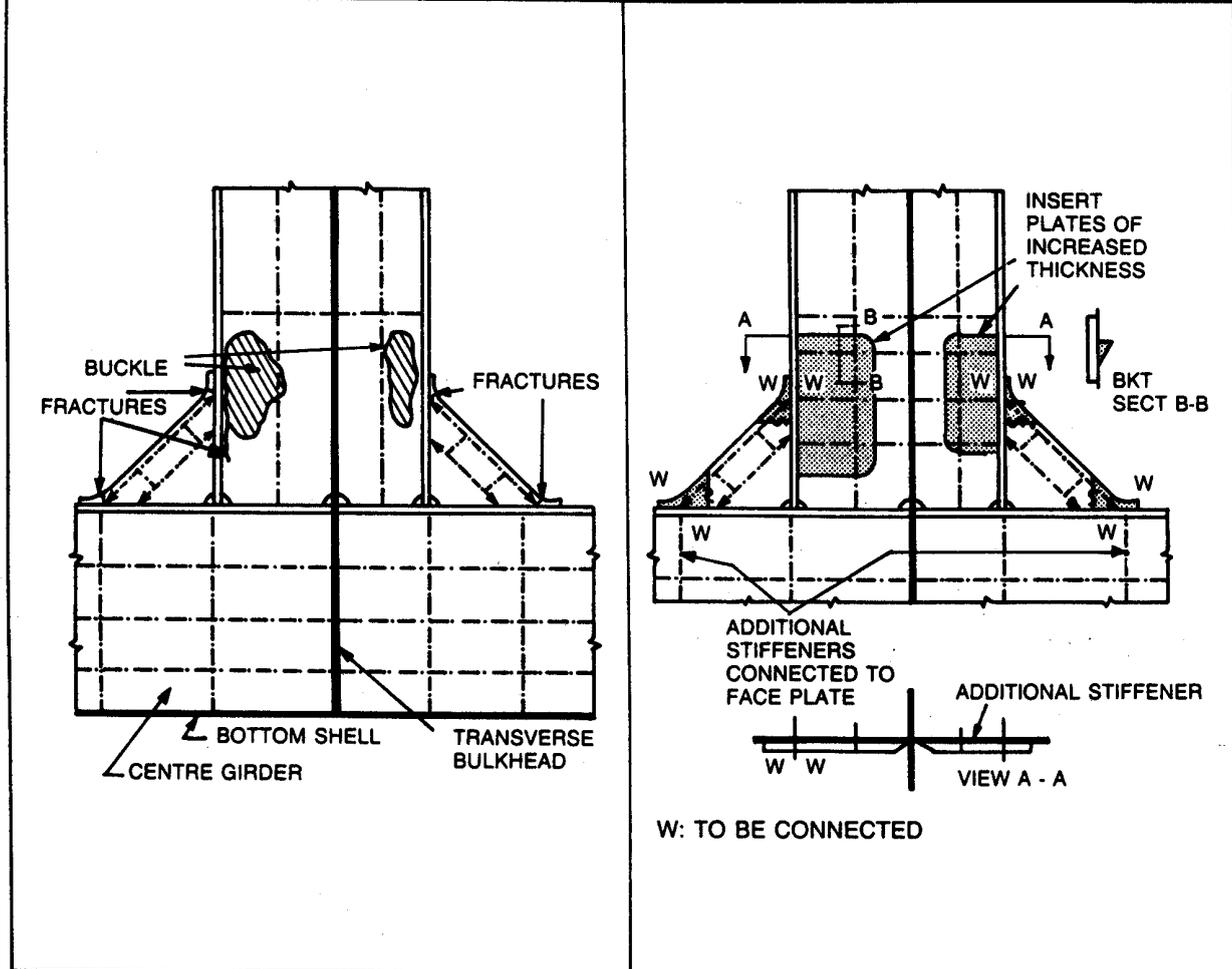
FIGURE 39	TANKER STRUCTURE CO-OPERATIVE FORUM	FIGURE 39
	SUBJECT: CATALOGUE OF STRUCTURAL DETAILS

LOCATION:	Longitudinal girder end brackets	GROUP No. 6
EXAMPLE No. 4:	Buckled and fractured vertical web and bottom centreline girder bracket connection

TYPICAL DAMAGE	PROPOSED REPAIR
-----------------------	------------------------

1. Insufficient panel stiffening on vertical web.
2. Stress concentration at bracket toes with sniped face plate.

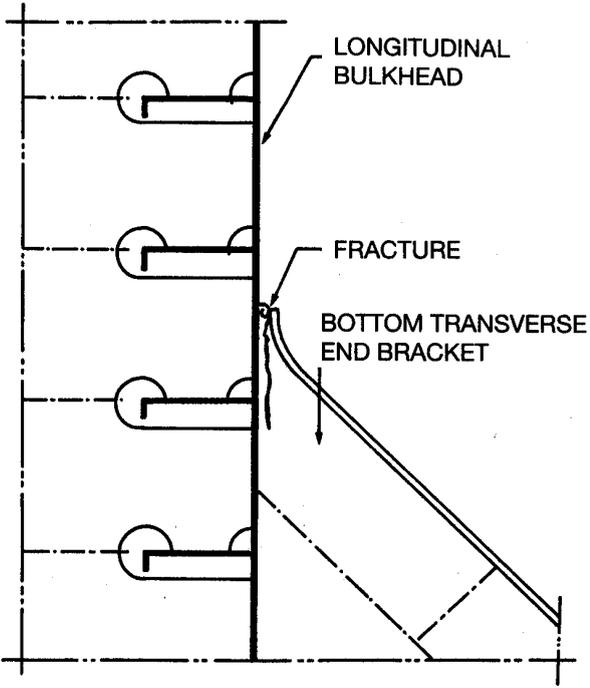
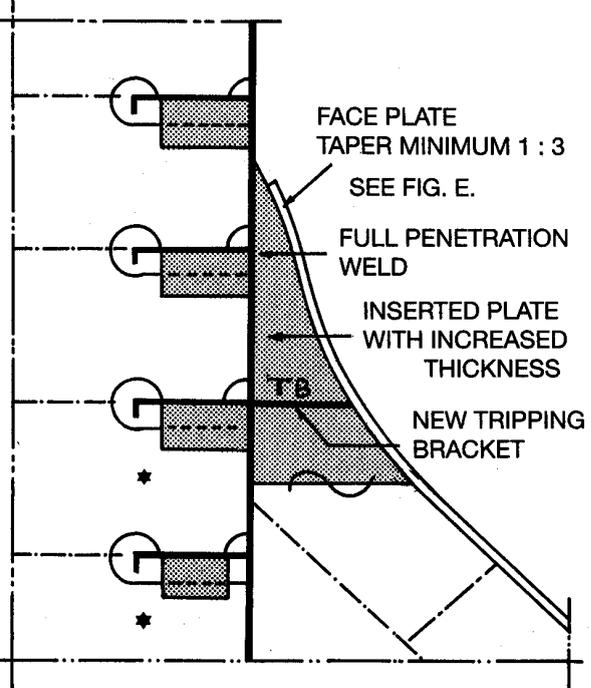
LOCATION: Transverse web frame end brackets EXAMPLE No. 4: Fractured centre tank bottom transverse end bracket. Symmetrical face plate.	GROUP No. 7	
TYPICAL DAMAGE	PROPOSED REPAIR

<p style="text-align: center;">★ NEW LUGS RECOMMENDED</p>	
FACTORS CONTRIBUTING TO DAMAGE <ol style="list-style-type: none"> 1. Bracket face plate in way of toe with insufficient taper. 2. Localised corrosion at bracket toe. 3. Insufficient bracket size resulting in high nominal stress. 4. Deficient weld around bracket toe. 		
FIGURE 52	TANKER STRUCTURE CO-OPERATIVE FORUM SUBJECT: CATALOGUE OF STRUCTURAL DETAILS	FIGURE 52

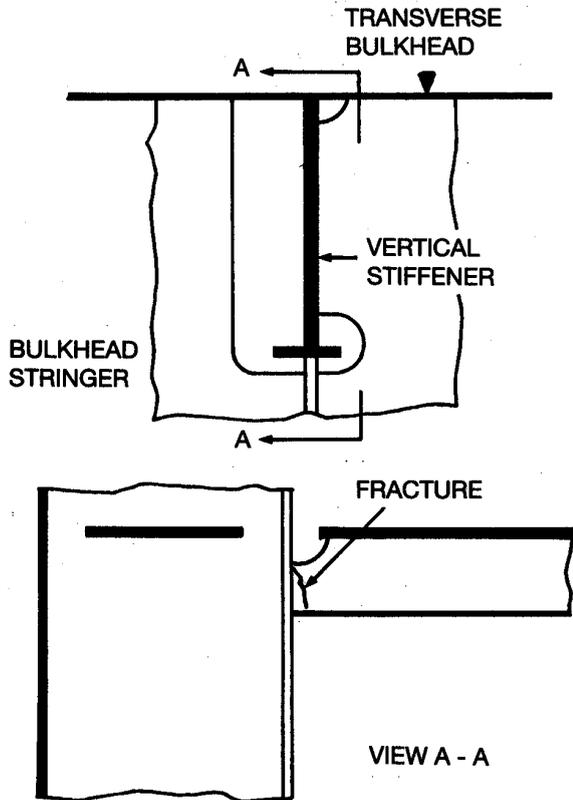
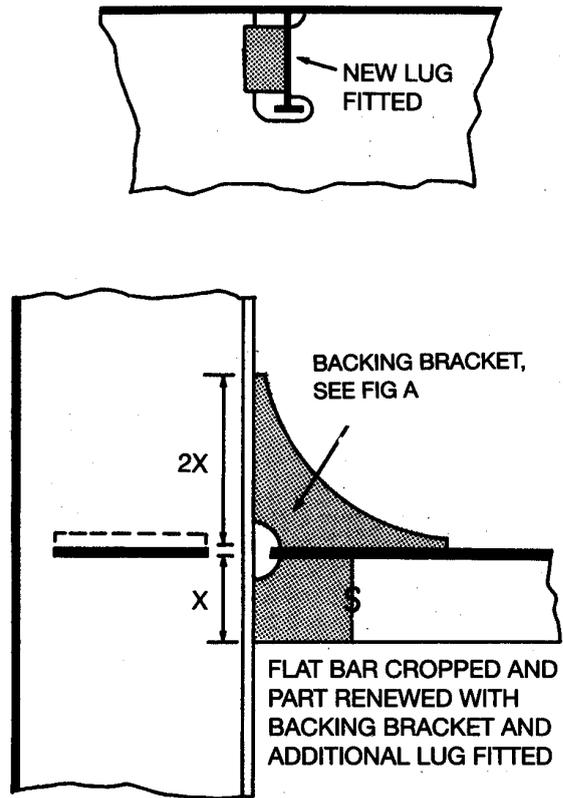
LOCATION: Transverse bulkhead stiffener/primary web intersection.

EXAMPLE No. 2: Fractured flat bar connection to vertical stiffener.

TYPICAL DAMAGE

PROPOSED REPAIR

1. Dynamic internal loads in full tanks due to ship motion.
2. Sloshing loads where tanks are partially filled.
3. Insufficient area of stringer web stiffener.
4. Insufficient area of connection of vertical stiffener.
5. Bad return of weld around the stiffener plate thickness.
6. Asymmetrical connection with flat bar stiffener.
